Householder Application for Planning Permission
for works or extension to a dwelling and listed building consent.
Town and Country Planning Act 1990

Proposed single storey extension to listed farmhouse. Alterations to existing ancillary store building to create kitchen. Internal alterations including upgrading existing attic space to create habitable rooms with insertion of velux windows to south facing roof slope.

HIGHER LICKHURST FARMHOUSE, BOWLAND-WITH-LEAGRAM, LANCASHIRE, PR3 2QT:

Single storey extension and alterations to the Grade II Listed Farmhouse

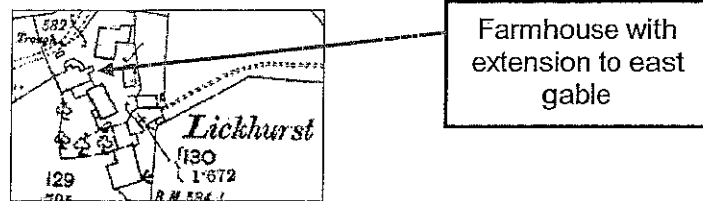
Ordnance Survey 1:2500 map, c.1895

- 3.3 Attached to the house's east gable is a small (approximately 6.7m by 4.0m), plainly built, single storey addition of early to mid 19th century date: maps show that it was present by the 1890s, albeit perhaps with a slightly different outline. This is subject to the same statutory designation as the house itself, although not noted in the description above. It has walls of random sandstone rubble which are ribbon-pointed, and a stone slate roof. There is a blocked doorway to the south elevation, a similar double-width opening in the east gable, now reduced to a narrower doorway, and to the rear, a third such doorway and a window with boldly tooled sandstone surround. The interior forms a single space open to the roof (borne on softwood purlins) and has no features of interest (see photographs below). It seems to have been intended as a domestic rather than agricultural outbuilding although its original function is not known.

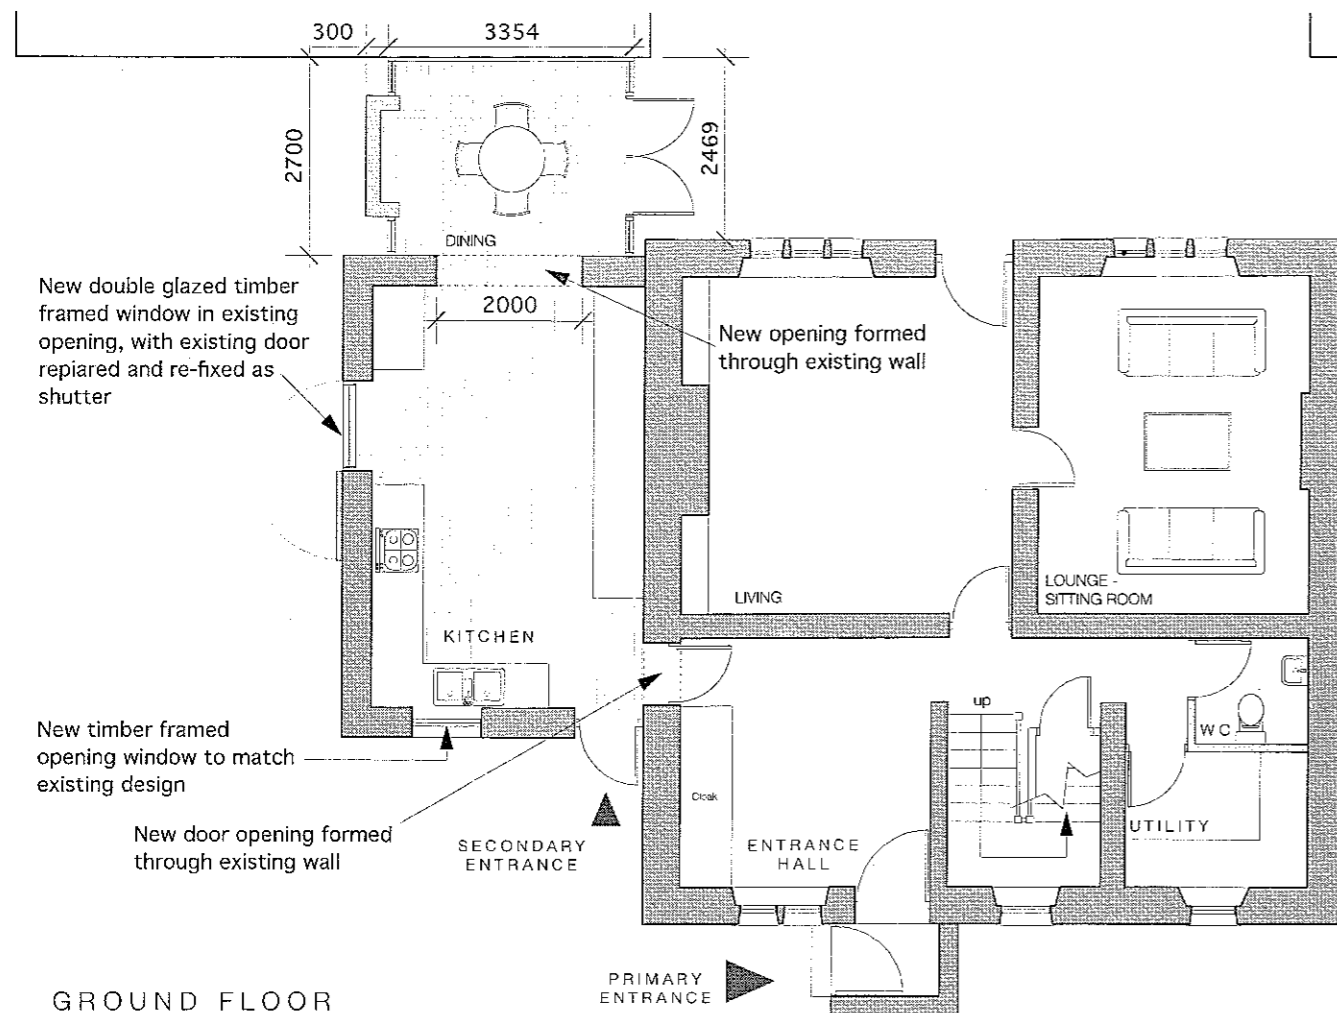
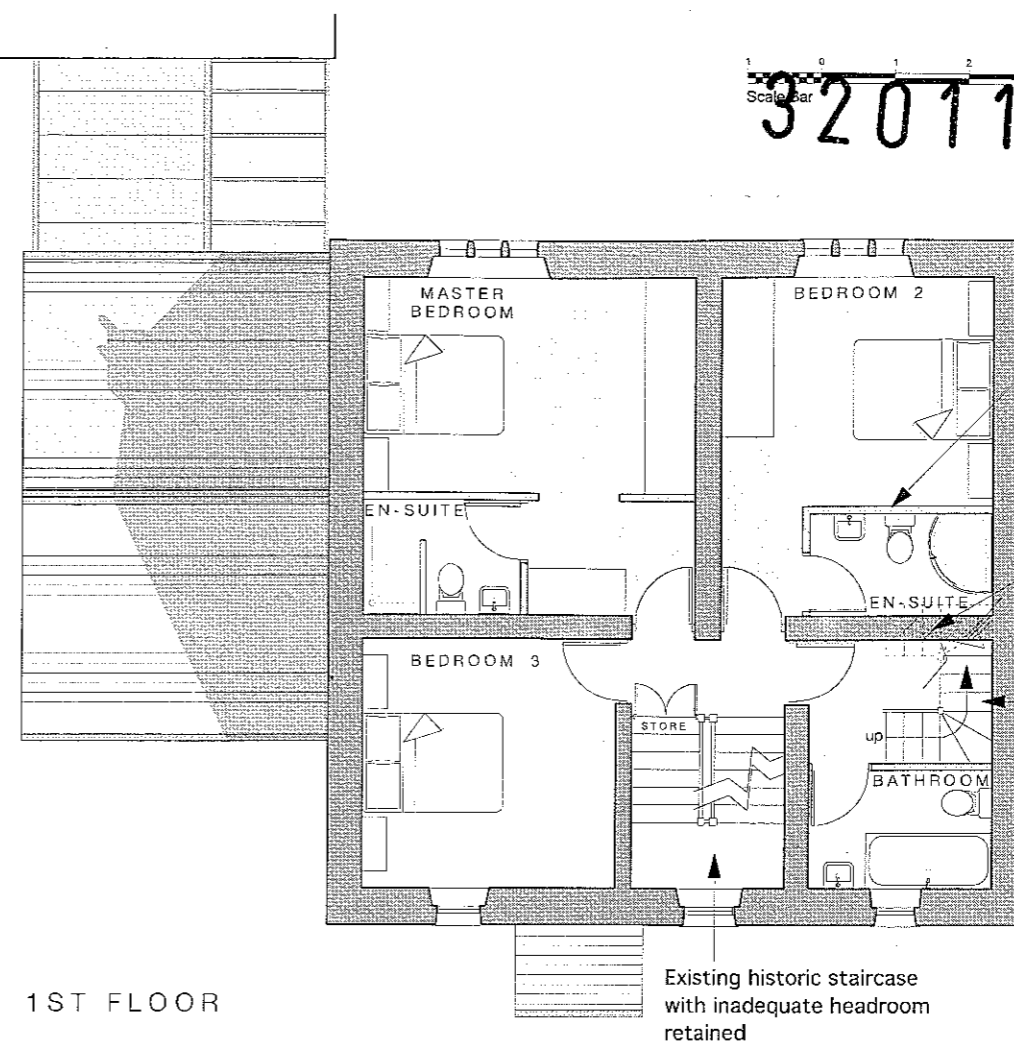
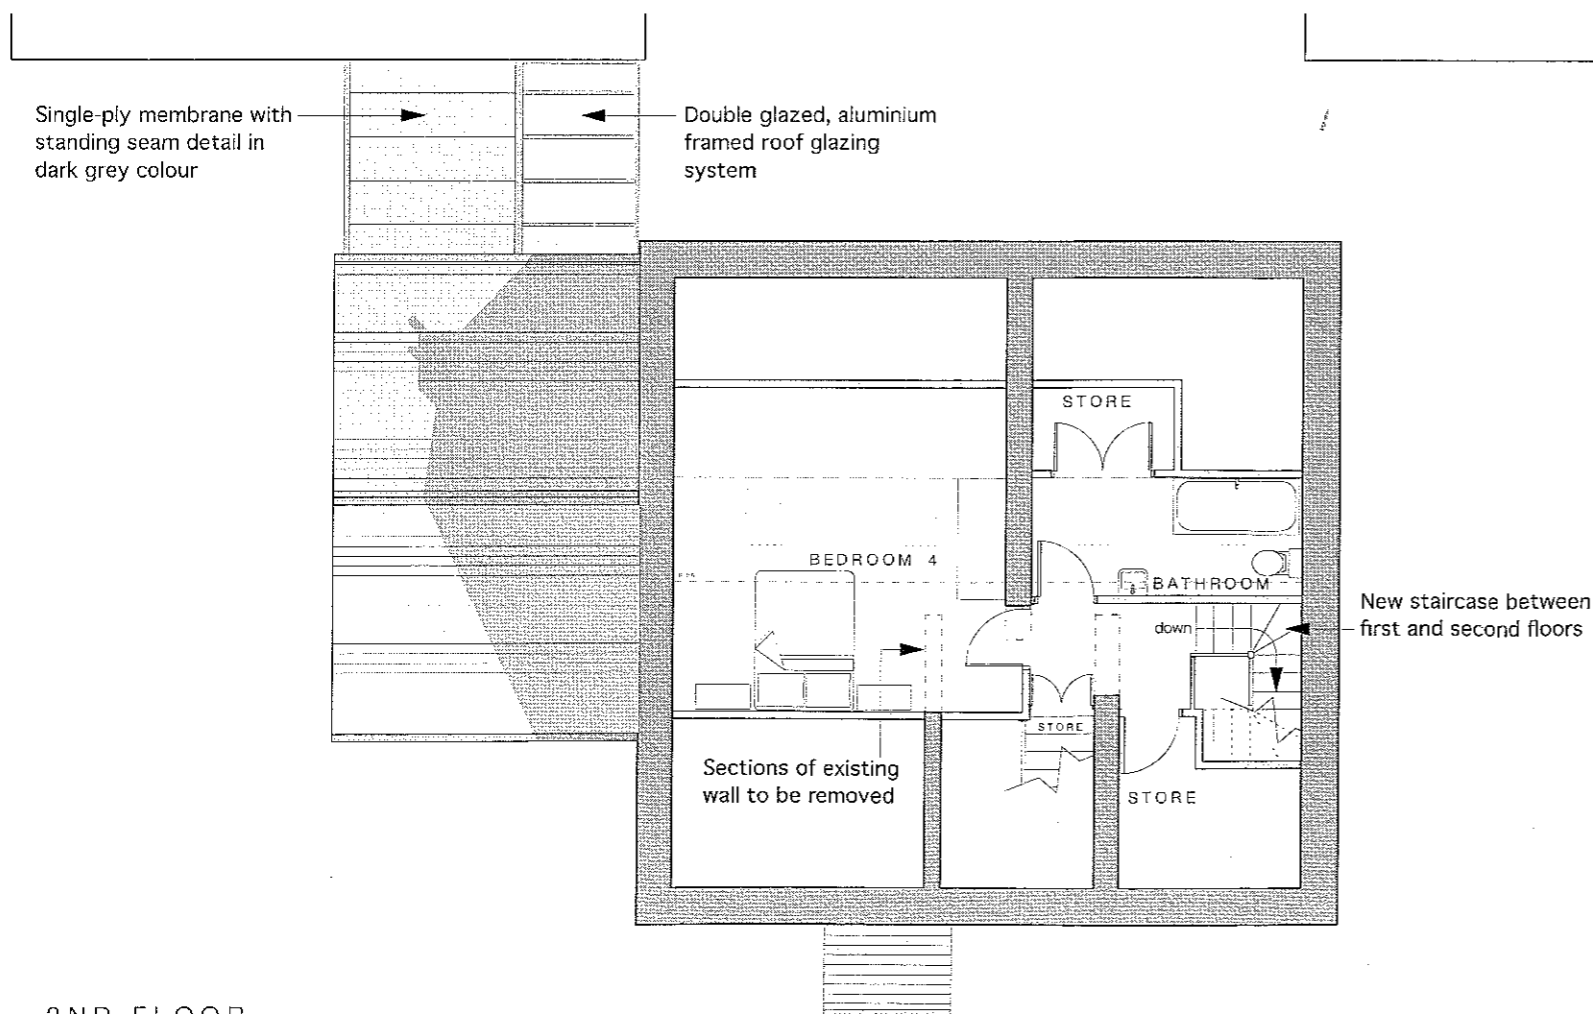
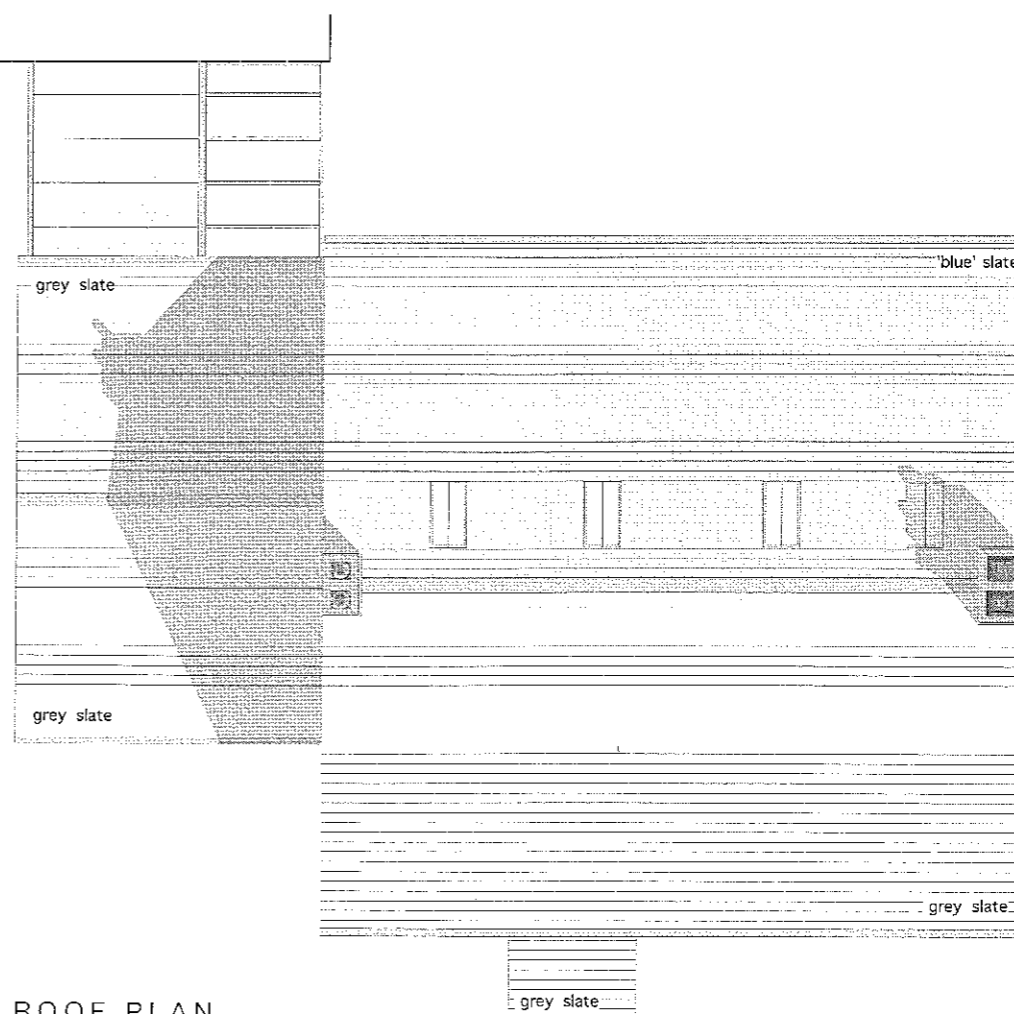
New studwork walls built off existing floors - wall finish to be scribed round any historic coving / skirting etc to preserve historic fabric

Existing historic staircase with inadequate headroom retained

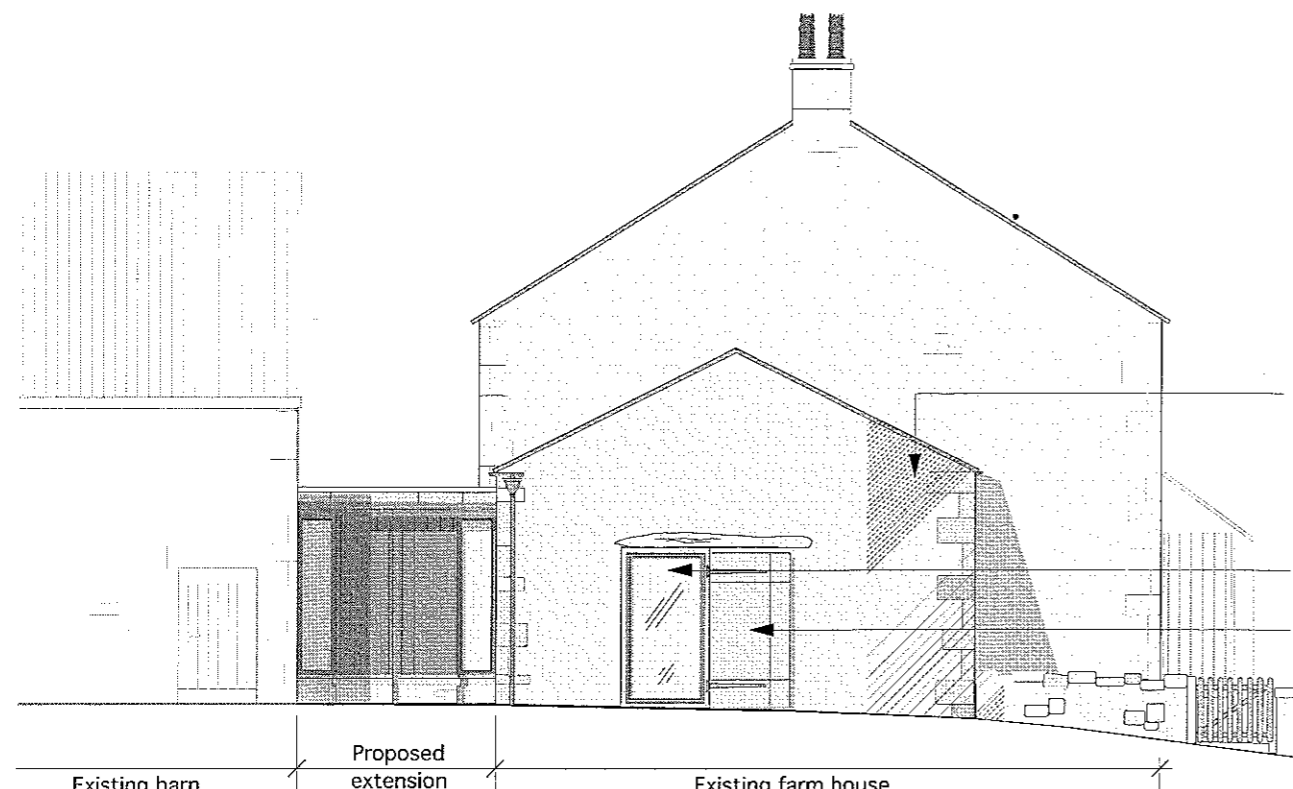
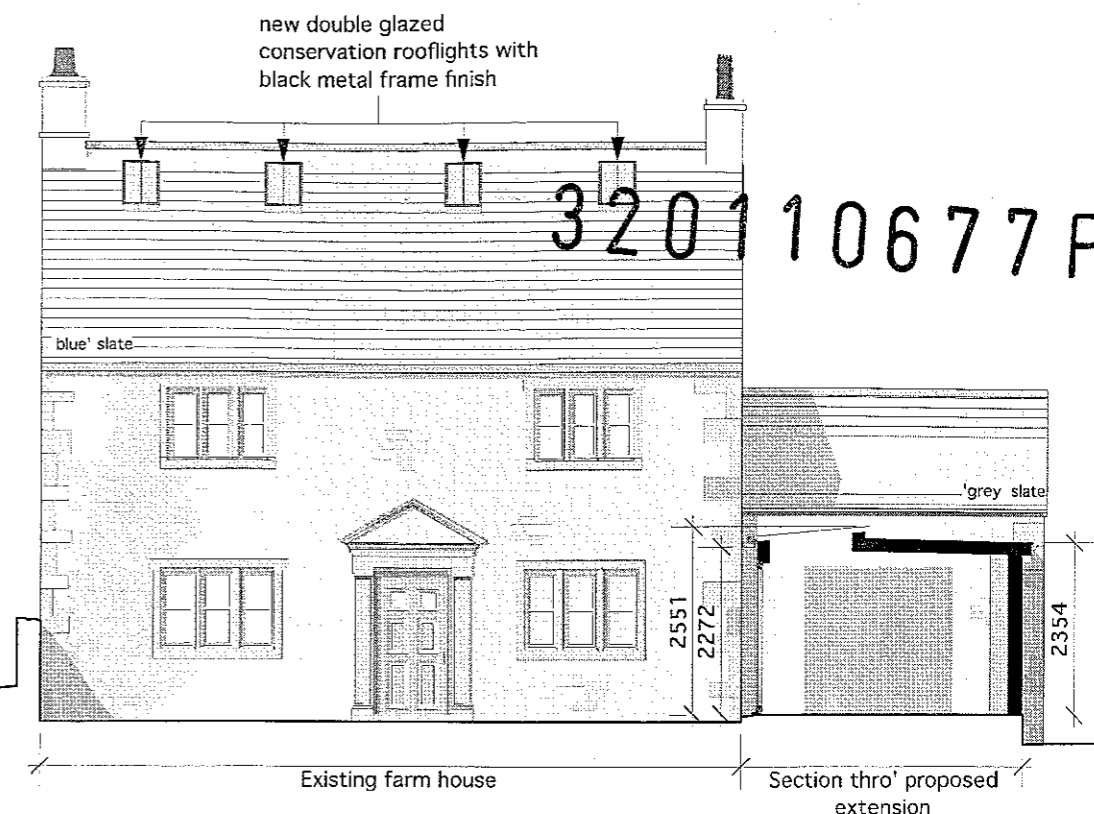
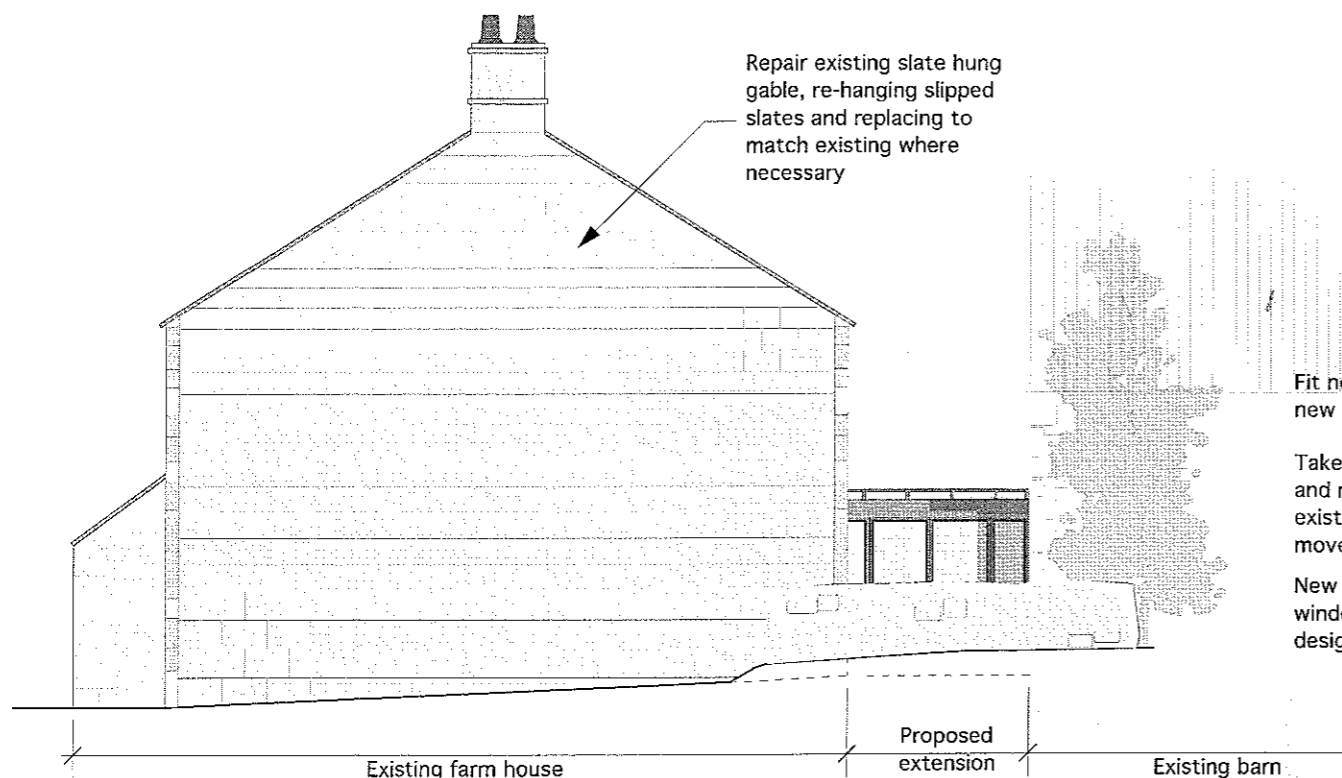
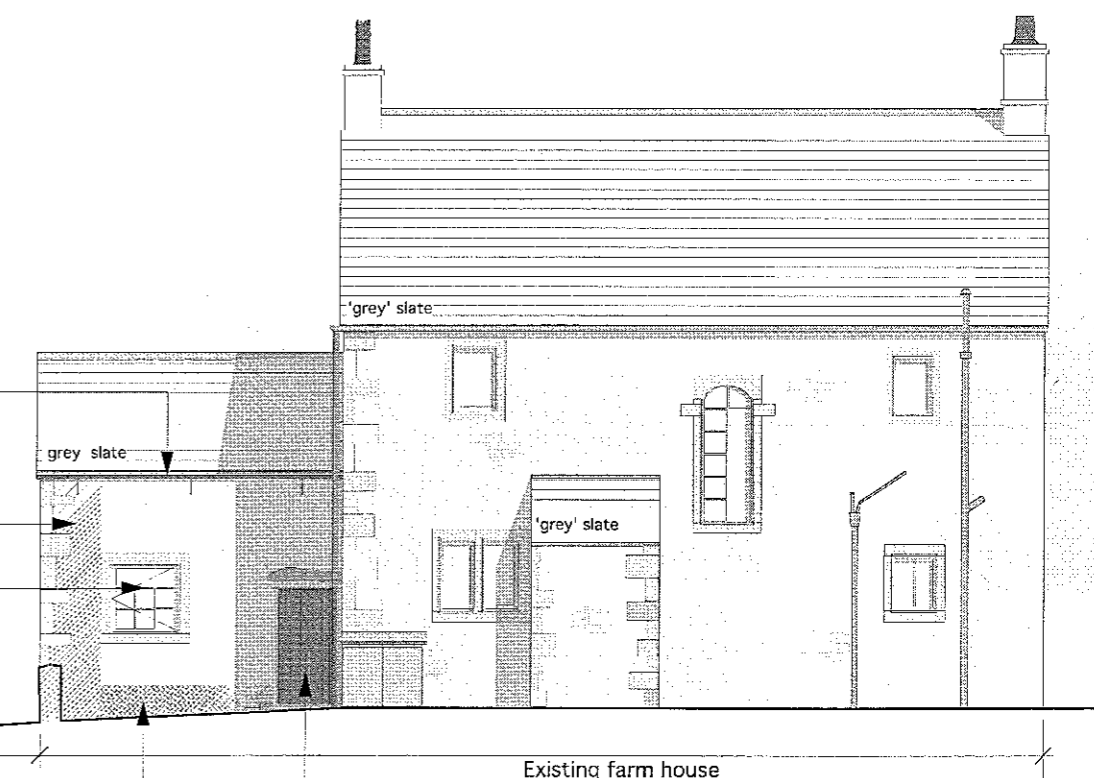
- Fit new cast iron gutter on new wall brackets
- Take down corner of wall and rebuild to match existing, to repair movement damage
- New timber framed opening window to match existing design

- New timber boarded door and frame with stain finish
- Rebuild lower section of wall - square off door opening at low level and install new natural stone cill to match elsewhere

Repointing work to farm house:
Generally, cement pointing and any defective pointing to be carefully raked out and repointed in lime mortar.

Reroofing work to farm house:
'Blue' and 'grey' slate roofs to be stripped and relaid using original materials onto new slating battens. Any damaged and unusable slates to be replaced with new to match existing. All lead flashings to be replaced to match existing. Rainwater gutters and downpipes to be repaired / replaced to match existing where required.

Extension materials:
Walls: Vertical Cedar (or similar) cladding with stain finish; plinth in coursed natural stonework and natural stone cill to match existing;
Roof glazing: Double glazed aluminium framed roofing system;
Roof covering: Single-ply membrane with standing seam detail, in dark grey colour;
Windows: double glazed timber framed windows with stain finish;
Doors: double glazed timber framed doors and frame with stain finish;
Rainwater: profiled metal gutters and square or circular downpipes finished black;
