Householder Application for Planning Permission  
for works or extension to a dwelling and listed building consent.  
Town and Country Planning Act 1990

Proposed single storey extension to listed farmhouse. Alterations to existing ancillary store building to create kitchen. Internal alterations including upgrading existing attic space to create habitable rooms with insertion of velux windows to south facing roof slope.

## DESIGN AND ACCESS STATEMENT

Single storey extension and alterations to the Grade II Listed Farmhouse

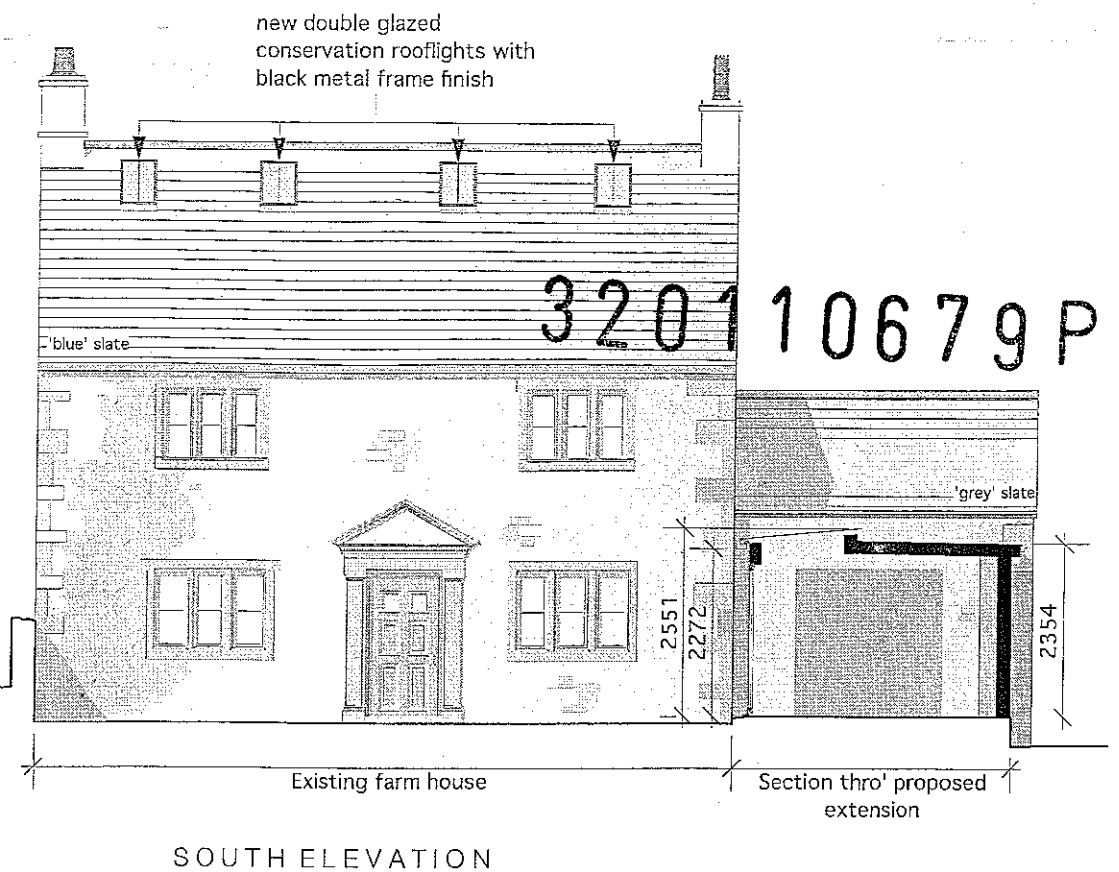
**Repointing work to farm house:**  
Generally, cement pointing and any defective pointing to be carefully raked out and repointed in lime mortar.

**Reroofing work to farm house:**  
'Blue' and 'grey' slate roofs to be stripped and relaid using original materials onto new slating battens. Any damaged and unusable slates to be replaced with new to match existing. All lead flashings to be replaced to match existing. Rainwater gutters and downpipes to be repaired / replaced to match existing where required.

**Extension materials:**  
Walls: Vertical Cedar (or similar) cladding with stain finish; plinth in coursed natural stonework and natural stone cill to match existing;  
Roof glazing: Double glazed aluminium framed roofing system;  
Roof covering: Single-ply membrane with standing seam detail, in dark grey colour;  
Windows: double glazed timber framed windows with stain finish;  
Doors: double glazed timber framed doors and frame with stain finish;  
Rainwater: profiled metal gutters and square or circular downpipes finished black;

**Remedial work to farm house:**  
Generally, correct pointing and any defective pointing to be carefully raked out and repointed in lime mortar.

**Roofing work to farm house:**  
Blue and grey slate roofs to be stripped and raked using original materials onto new slating battens. Any damaged and unusable slates to be replaced with new to match existing. All roof fixings to be repaired to match existing.

**Extension materials:**  
Walls: vertical softwood cladding with stain finish; plank in eucalyptus natural stone work and natural stone sill to match existing.  
Roof glazing: Double glazed aluminium framed roofing system.  
Roof covering: Single-ply membrane with standing seam detail, in dark grey colour.  
Windows: double glazed timber framed windows with stain finish.  
Doors: double glazed timber framed doors and frames with stain finish.  
Rainwater profiled metal gutters and square or circular downpipes finished black.
