Application for Planning Permission.  
Town and Country Planning Act 1990

Change of use of agricultural barn to residential unit and to include retention of existing detached garage to be used as domestic garaging.

Protected Species Survey: agricultural buildings at Wheatley Farm, Thornley, Chipping, Preston, PR3 2TD

**STRUCTURAL REPORT  
WHEATLEY FARM  
FOUR ACRE LANE  
THORNLEY WITH WHEATLEY  
PR3 2TD**

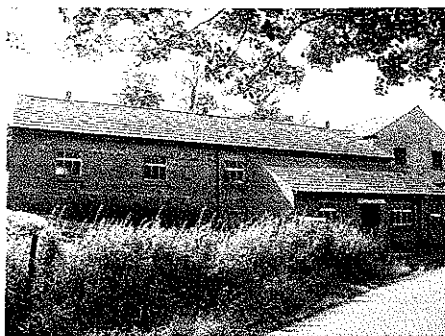
Figure 2: Brick shippon – building C

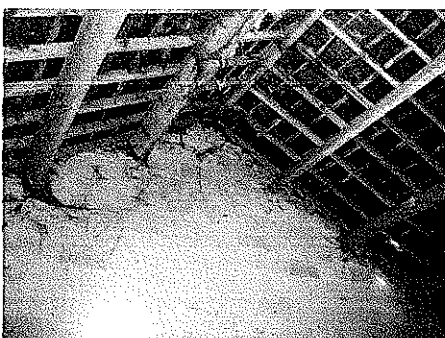
Figure 8: Barn B - roof detail

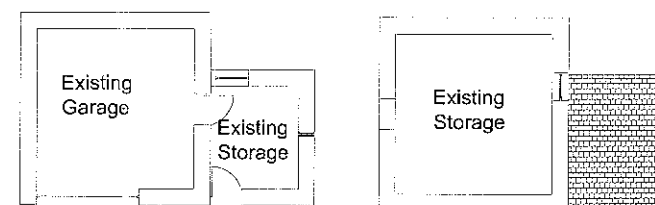
Existing Floor Plans
