Application for Planning Permission and conservation  
area consent for demolition in a conservation area.  
Town and Country Planning Act 1990

**English Martyrs R.C. Church**  
**Boundary walls**  
**WHALLEY**  
**LANCASHIRE**

**Archaeological Desk-Based Assessment****Draft 1**

**PROPOSED REMEDIAL REPAIR WORKS TO BOUNDARY WALLS  
ENGLISH MARTYRS  
THE SANDS, WHALLEY  
CLITHEROE BB7 9TN**

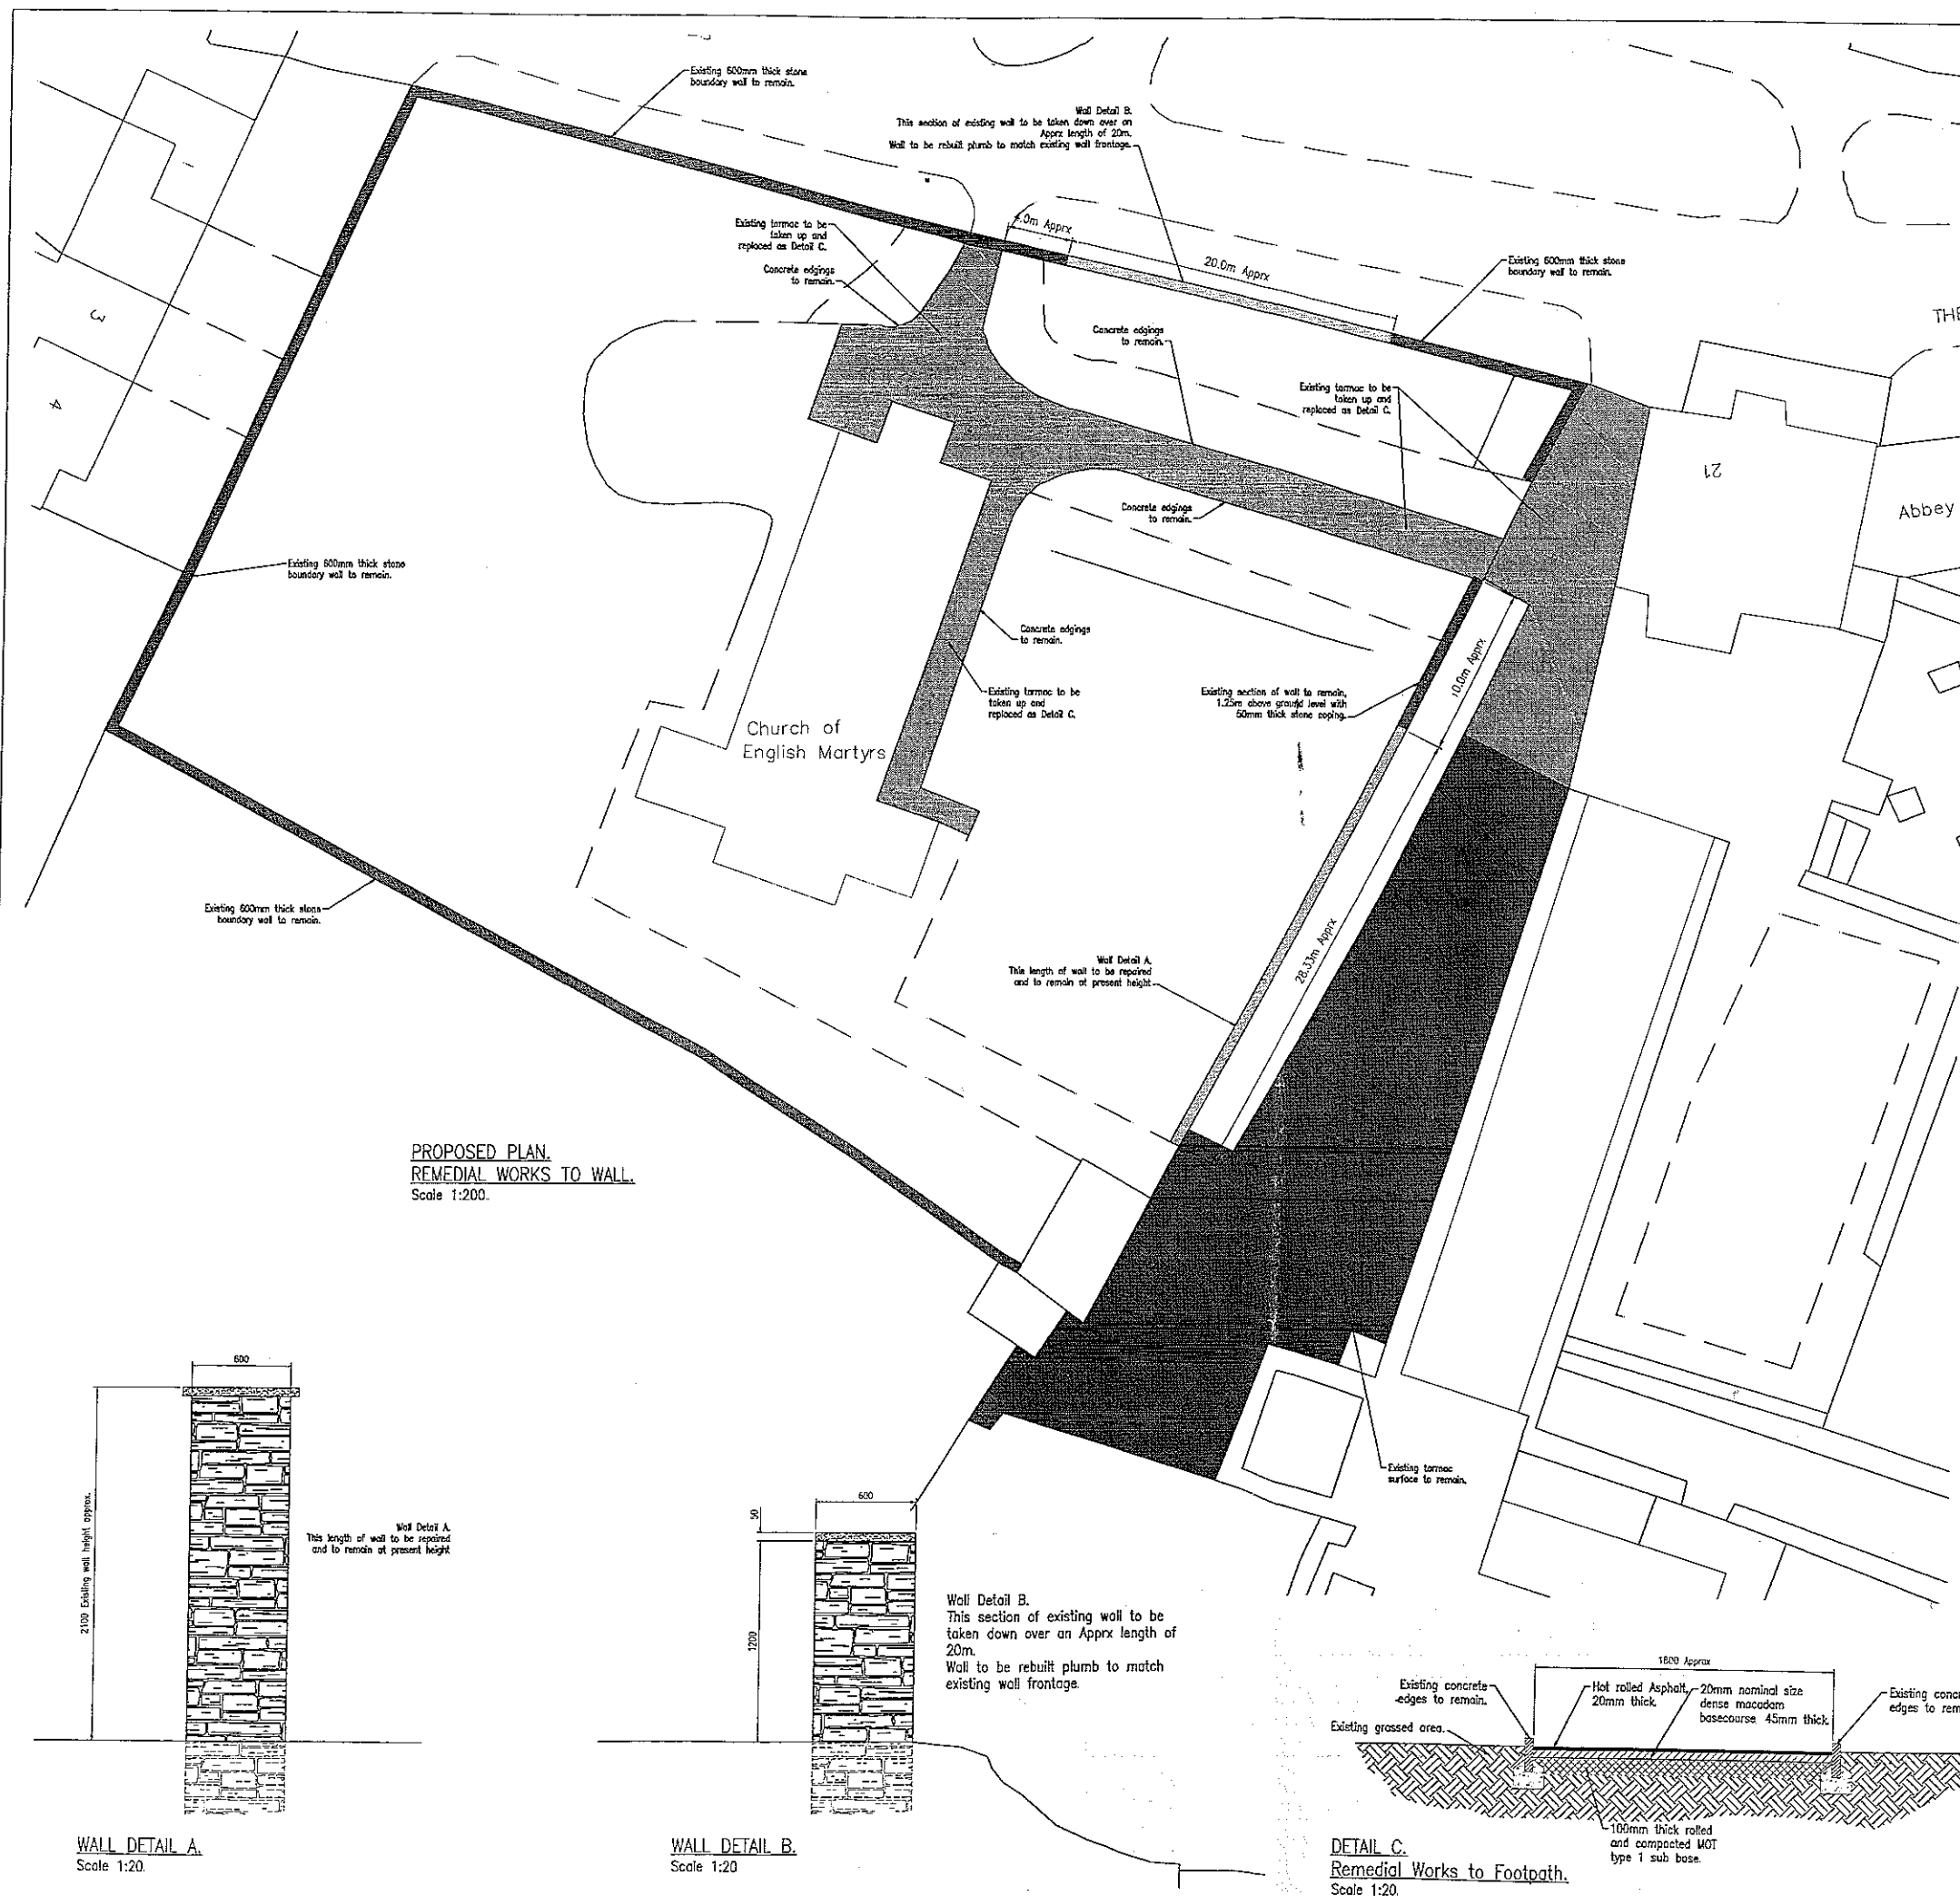
| A Wall detail A amended. | | 28.06.11 | PS | |

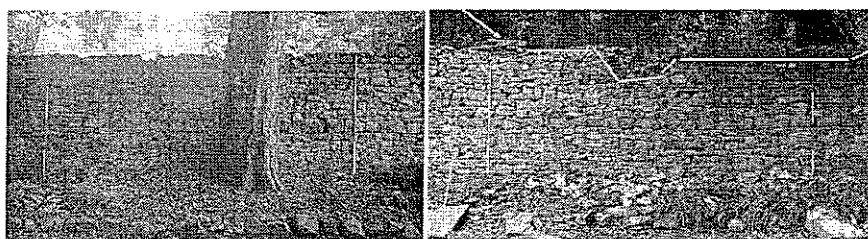
- 3.1.2 Approximately 28 metres of the east wall of the church enclosure wall survives to (up to) 2.1 metres in height, but much of this length is leaning badly to the West, only one or two coping stones remain *in situ*, the southern c. 1.5 metre has been partly demolished at the SE gate, and the upper facing courses on the west side have collapsed over a length of c. 10 metres (Figs 15-17). The lime-mortared wall is roughly coursed, more evenly so in the lower c. 1.25 m than in the upper reaches. The bottom c. 0.50 m is largely comprised of thinner stones, especially on the outer (east) face. The northern c. 3 m of the 'tall wall' has evidently been re-built, rather crudely, with poorly orientated stones (jagged corners projecting), cement rather than lime mortar bonding, and many air spaces. A c. 10 metre stretch of wall to the north of the 'tall wall', as far as the entrance close to the Presbytery, and a further stretch beyond the entrance as far as the NE corner, have been reduced in height to c. 1.25 metres, inclusive of a concrete capping (Fig 18). This work is reported by Fr Philip Price (pers. comm., 11 Sept 2011) to have been done during his predecessor Fr. Ryan's incumbency, in c. 1996-2001. It is not known at what date the whole of the north wall (c. 70 m), parallel to The Sands, was reduced in height (Fig 19), but the 'slobbered' style of the concrete capping suggests that this work was considerably earlier, perhaps around the time the church opened in 1926. *Further archive photographic research is required to establish the date of this work.*

(Left) Fig 15: part of the east face of the 'tall' east wall; (Right) Fig 16: part of the west face of the east wall, showing (highlighted in yellow) areas of collapse. Scales 2 m

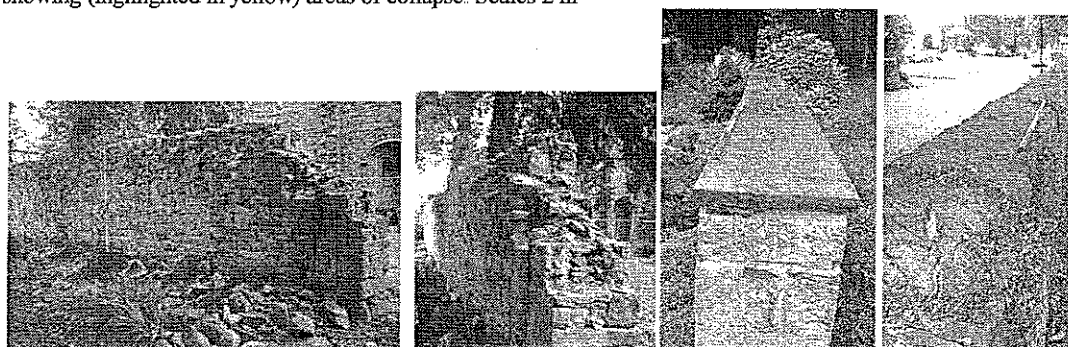
(Left) Fig 17a and b: collapsed S end of east wall; (Centre) Fig 18: recent concrete slab capping of northern part of east wall; (Right) Fig 19 older 'slobbered' concrete wall-head of north wall, parallel to The Sands. Scales 2m

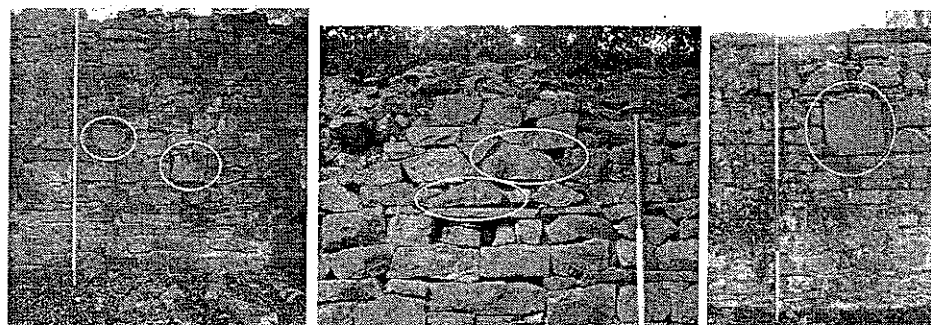
- 3.1.3 **Re-used medieval architectural fragments:** the east wall of the enclosure – closest to the West Range of the abbey cloisters – appears to contain a significant number of re-used architectural fragments, probably of medieval date. Probable window mullion fragments, and square-section tooled stones are apparent in both the east and west faces. It is likely that there are more such fragments than were seen in such a rapid inspection, since some will have been re-tooled to suit their new use, or had characteristics on the exposed face eroded. Others may be present in the core-work of the wall. Fewer, but larger, architectural fragments were apparent in the south wall, and none were identified in the west or north walls.

(Left) Fig 20: examples of possible medieval architectural fragments incorporated in the east face of the east boundary wall, and (Centre) Fig 21: in the west face. (Right) Fig 22: large re-used architectural fragment in the south wall (Scales 2m, with 500 mm divisions)

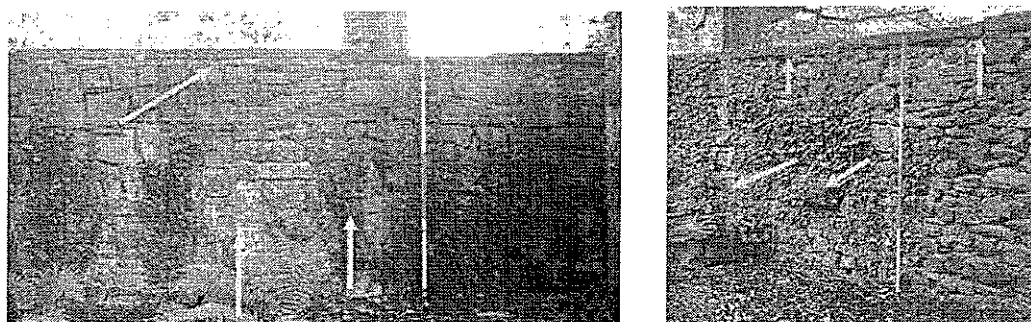
(Left) Fig 23: repaired stretch at east end of south wall, showing pale cement, and blocked doorway; (Right) Fig 24: very large original capping stone, and through/projecting stones, in south wall (Scales 2m, 500 mm divisions)

- 3.2.2 However, even in these areas of better-preserved walling, previous and urgently-needed repairs are apparent. The south-eastern c. 13 m of the south wall has been heightened and re-capped with smaller (250-350 mm long) flags of similar width and thickness, but using pale brown sandy cement, rather than lime mortar (Fig 23). This work seems to have been occasioned by

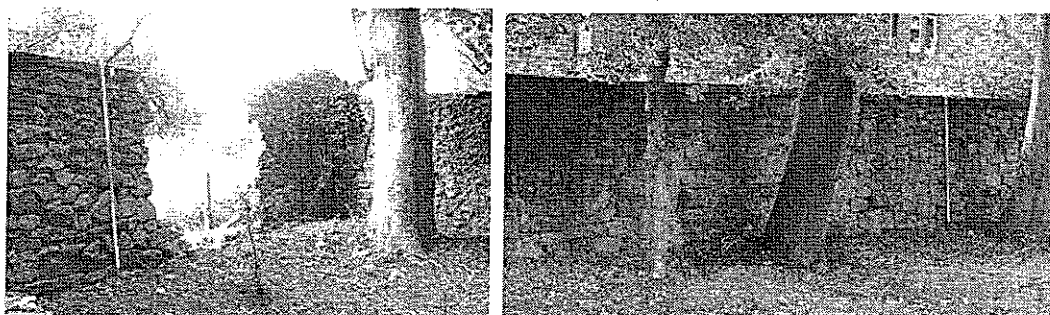
removal of an outshut building shown on the OS (1938) map, adjacent to a blocked doorway in the wall. An area at the SW corner has collapsed completely (**Fig 25**); the exposed core-work and rubble show that the wall had previously been repaired using a mixture of stone and recent machine-made Accrington brick, again using cement rather than lime mortar. The northern half of the west wall, and the whole length of the north wall, parallel to The Sands, has been reduced in height, without replacing the coping, and with a roughly 'slobbered' cement cap. In places the south and west walls have 'slobbered' pointing (**Fig 27**) – a typical feature of late seventeenth and early eighteenth century garden walling, though probably not original here – but no actual render is apparent.

(Left) **Fig 25**: recent collapse of previously-rebuilt section of wall at SW corner; (Right) **Fig 26**: southern end of west wall, standing to original height. Scales 2 m.

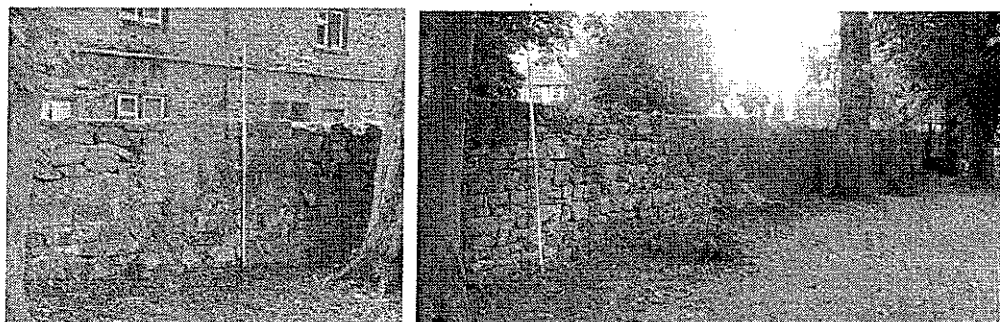
(Left) **Fig 27**: northern end of west wall, reduced in height and with coping removed, and exhibiting slobbered pointing; (Right) **Fig 28**: north wall, west of lych-gate, reduced in height and with coping removed. Scales 2 m.

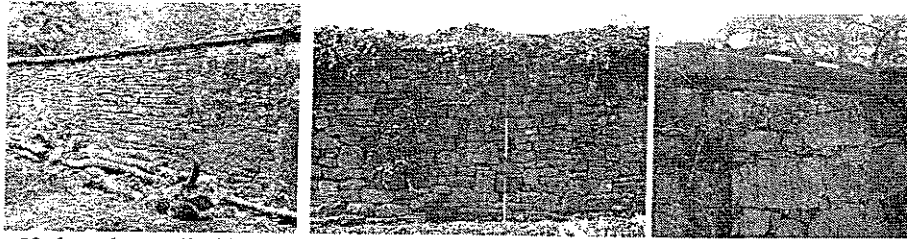
(Left) Fig 29: boundary wall of kitchen garden at Turton Tower, Darwen, similar to English Martyrs church wall but probably early Victorian. Ht c. 2.2 m; (Centre) Fig 30: late seventeenth / early eighteenth-century wall at west side of approach to NE Gatehouse of Whalley Abbey. Inner face is of brick. Scale 2m; (Right) Fig 31: detail showing surviving moulded stone coping. Scale 300 mm.

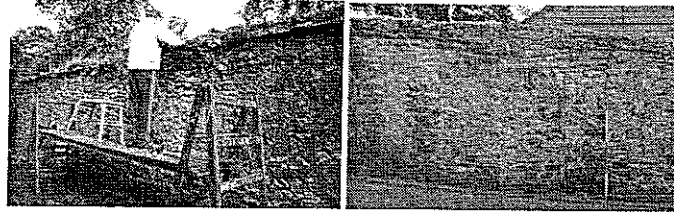
- 4.2.5 Only two other example of similar boundary walling have been recognised regionally – at Levens Hall, Cumbria (**Fig 32**), the other at Marshrange in Lancaster (**Fig 33**), both documented as dating from the late 1600s, and employing much smaller coping stones than at Sands Orchard. and The English Martyrs / Sands Orchard wall may represent the next phase in the development of gentry boundary walls to these three pre-c. 1700 examples, before lower walls with similar coping became popular in the late eighteenth / early nineteenth centuries, and then half-round, triangular, and ‘soldier’ copings in the later nineteenth century.

(Left) Fig 32: repair works in progress, 2005, on Ninezergh Lane wall to Levens Hall, Cumbria, dated to 1695, showing projecting coping course with overlying blocky courses; (Right) Fig 33: boundary wall at Marshrange, Lancaster, dated 1687 (photo 2007, now altered). Coping course overlain by (?later) blocky courses. Scale 2m.

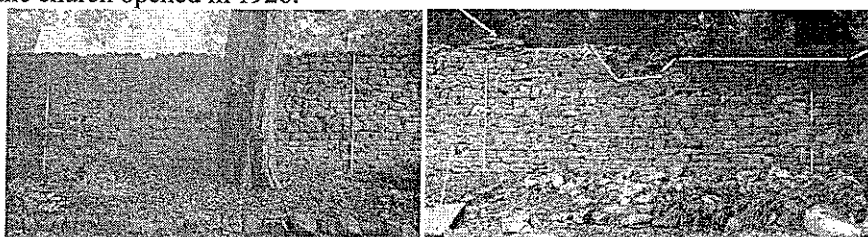
- 3.2 Approximately 28 metres of the east wall of the church enclosure wall survives to (up to) 2.1 metres in height, but much of this length is leaning badly to the West, only one or two coping stones remain *in situ*, the southern *c.* 1.5 metre has been partly demolished at the SE gate, and the upper facing courses on the west side have collapsed over a length of *c.* 10 metres (Figs 7-9). The lime-mortared wall is roughly coursed, more evenly so in the lower *c.* 1.25 m than in the upper reaches. The northern *c.* 3 m of the 'tall wall' has evidently been re-built, rather crudely, with poorly orientated stones, cement rather than lime mortar bonding, and many air spaces. A *c.* 10 metre stretch of wall to the north of the 'tall wall', as far as the entrance close to the Presbytery, and a further stretch beyond the entrance as far as the NE corner, have been reduced in height to *c.* 1.25 metres (Fig 10), reportedly (Fr Philip Price, pers. comm., 11 Sept 2011) during Fr. Ryan's incumbency, in *c.* 1996-2001. It is not known at what date the whole of the north wall (*c.* 70 m), parallel to The Sands, was reduced in height (Fig 19), but the 'slobbered' style of the concrete capping suggests that this work was considerably earlier, perhaps around the date the church opened in 1926.

(Left) Fig 7: part of the east face of the 'tall' east wall; (Right) Fig 8: part of the west face of the east wall, showing (highlighted in yellow) areas of collapse. Scales 2 m

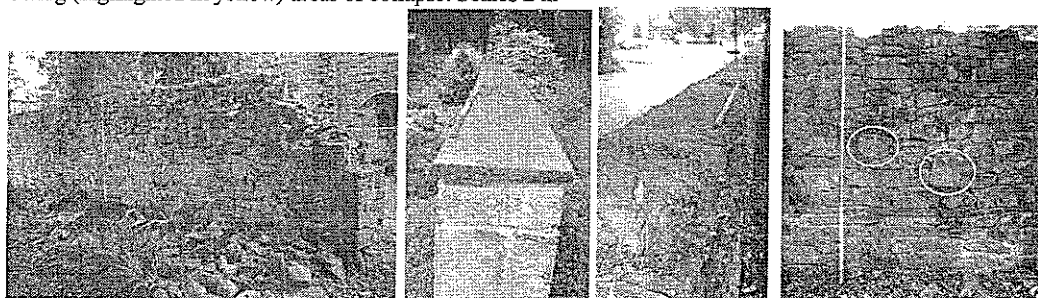
(Left) Fig 9: collapsed S end of east wall; (Centre left) Fig 10: recent concrete capping of northern part of east wall; (Centre right) Fig 11 older 'slobbered' concrete wall-head of north wall; (Right) Fig 12: possible medieval architectural fragments incorporated in the east face of the east boundary wall. Scale 2m, with 500 mm divisions

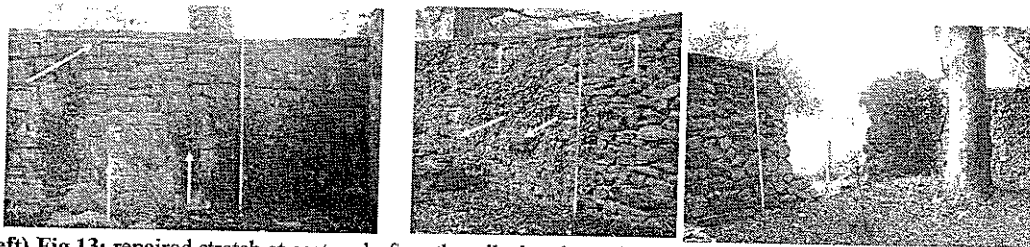
- 3.4 **The original appearance of the orchard walls:** most of the length of the south wall of the enclosure, and the southern half of the west wall, appear to be standing to their full original height – c. 1.6m and 2.0 m – and retain either their original coping or a passable replication. The coping (Figs 13) comprises extremely large flagstones, between c. 350 mm and 950 mm in length, and 90 to 95 mm in depth. Projecting or ‘through’ stones are present in the south wall (Fig 14), though few if any in the east and northern walls. The SE c. 13 m of the south wall has been re-capped with smaller flags, using sandy cement, rather than lime mortar (Fig 13). An area at the SW corner has collapsed completely (Fig 15); this part of the wall had previously been repaired poorly using stone with brick, and cement rather than lime mortar. The northern half of the west wall, and the whole of the north wall, parallel to The Sands, has been reduced in height, without replacing the coping, and with a roughly ‘slobbered’ cement cap.

(Left) Fig 13: repaired stretch at east end of south wall, showing pale cement, and blocked doorway; (Centre) Fig 14: very large original capping stone, and through stones, in south wall; (Right) Fig 25: recent collapse of previously-rebuilt section of wall at SW corner. Scales 2m, 500 mm divisions.
