Application for Planning Permission.  
Town and Country Planning Act 1990

Conversion of 1no. former milking parlour to 2no. residential dwellings with associated parking and landscaping

# CONVERSION OF DISUSED MILKING PARLOUR TO 2 DWELLING HOUSES

**Bat Survey**  
**Barn at Watts Close Farm, Gisburn**

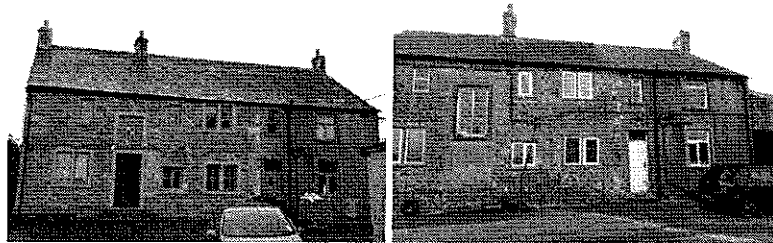
- 2.1.3.1. Farmhouse with late 19<sup>th</sup> extension to the west. (Not part of the application site). The farmhouse is reputed to have functioned as an Quaker Meeting House.; likely considering the proximity to Pendle Hill and the founding of the Society of Friends (Quakers) in 1648. The window light over the reinstated door and the arrangement of rooms at ground and first floors support the argument that the easterly accommodation functioned as some form of meeting room or chapel.

Farmhouse showing the C19th extension to the rhs, (brickwork with roughcast render). Facade recently repointed and entrance door reinstated.

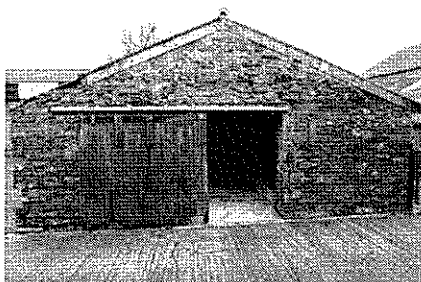
2.1.3.3. Small stone barn; this forms part of the application site and it is proposed to use this building as a garage for 2 cars.

Existing small stone barn part of the application site

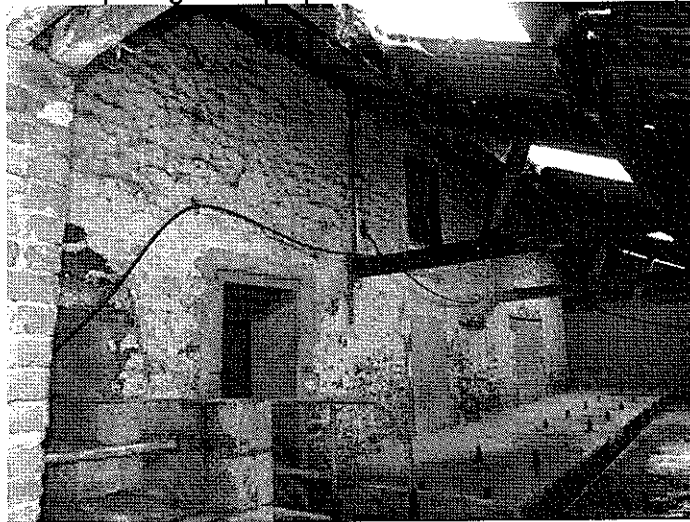
Existing west elevation currently concealed by a lean-to structure

2.6.3.1. The proposed layout will utilise existing window and door openings. It is proposed to form 3 new window openings at first floor.

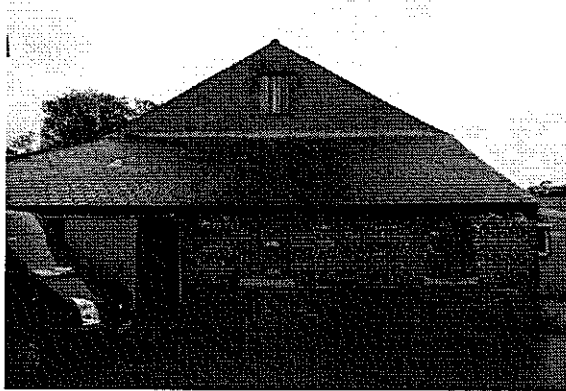
Existing south elevation; showing brick lean to structure

- 2.6.4. The existing brick agricultural extension will be insulated and rendered in a rough cast render with a natural finish to match the render of the existing farmhouse.
- 2.6.5. The proposed rooflights at 2<sup>nd</sup> floor will be of a conservation type.
- 2.6.6. The re-pointed stone work, new roughcast render etc will contrast with the use of natural stone dry stone walling boundary walls formed predominantly from stone off the farm.

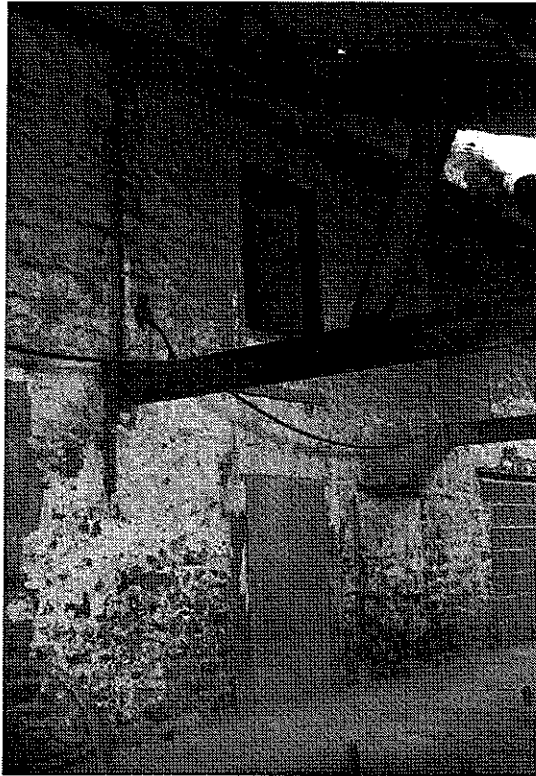
- 4.6. The West elevation appears to show two different types of stone coursing at low level and high indicating that the Parlour could have originally been single storey and

later increased in height to double storey.

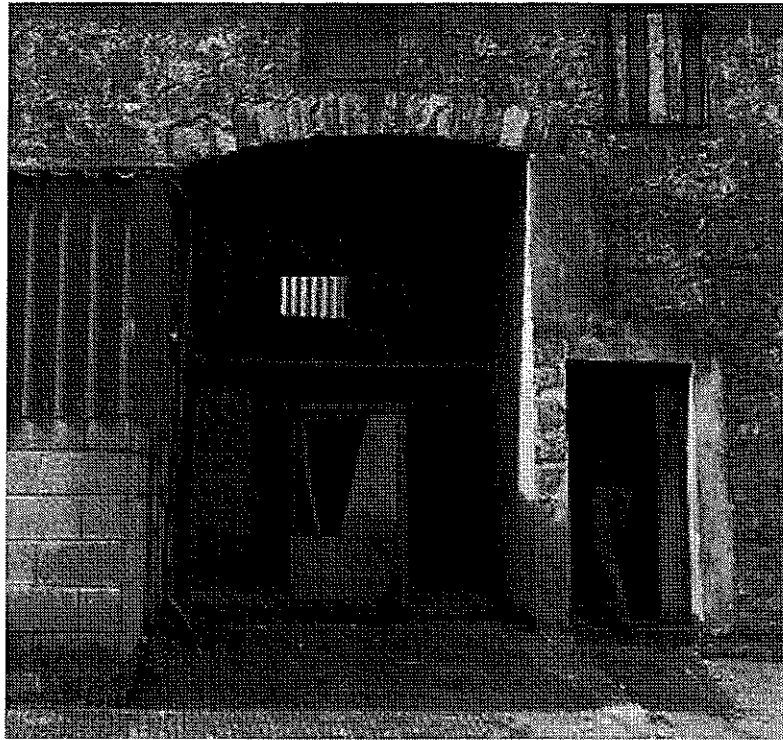
5.7.1. The curvature of the arch appears foreshortened on its North side due to the construction of a concrete blockwork wall within.

- 5.7.2. The existing large arched opening is to be retained and glazed
- 5.8. Ground Floor openings
- 5.8.1. A number of the ground floor openings feature cut stone lintels and jambs.
- 5.8.2. A closed up door opening on the West elevation features cut stone jambs, a cut stone lintel, an oak lintel and a brick arch head. It is surmised that the brick arch was installed at a later date, possibly due to the oak lintel or stone lintel failing.

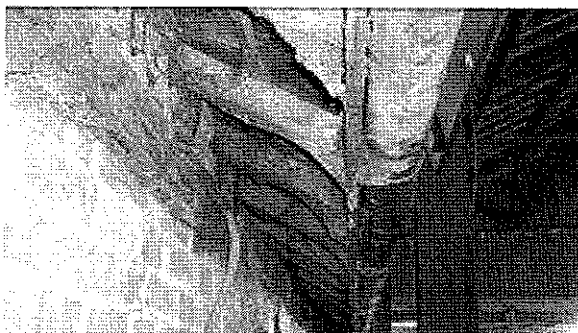
**Figure 4**

The eaves throughout the building are un-guarded and the wall tops accessible, although in many places these are well sealed tot the roof above with mortar, or (as in the covered sections adjoining buildings) are heavily cobwebbed.

Cobwebbed eaves found under the covered section to the north of the low barn

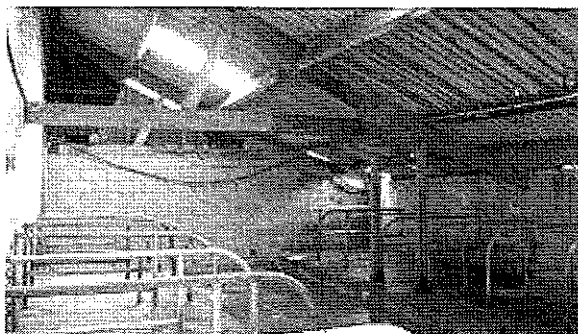
**Figure 8**

The western section contains cow stalls and roof lights and a large open door to the north make it light and airy inside.

Stalls in the western extension.
