## **Bat Survey of Franklin Hill Hall, Brockhall Village**

The site was at Franklin Hill Hall, Brockhall Village, BB6 8AY.

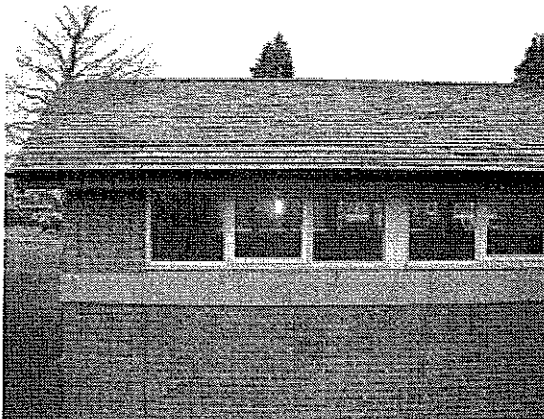
The main hall had a pitched slate roof in good condition (photo 1).

P1 slate roof in good condition

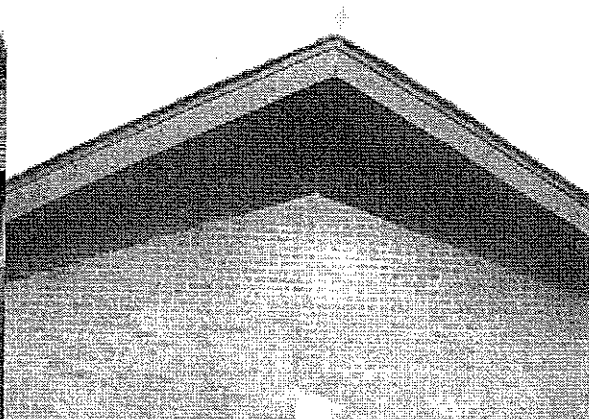
There was a gap, suitable for bat access, under the end ridge tile at the SE gable (photo 3).

The crevice under the ridge tile was suitable for non-breeding bats and the occasional roosting bat cannot be discounted.

P2 SE overhang, gap under ridge tile

5.1 No signs of roosting bats were found, but as there was a crevice with bat roosting potential in the building there is significant uncertainty due to the limitations of the season. It is therefore recommended that an evening emergence survey is carried out shortly before demolition. The survey must be carried out when bats are fully active, normally May-September, but weather dependent.

5.2 If no emergence is recorded, demolition should take place as soon as possible to minimise the risk of bat taking up occupation. If more than two weeks elapses after the survey and before demolition, removal of the roof tiles and hanging tiles must be done by hand under the supervision of a suitably qualified bat worker.
