Ditch issues from a surface water drain at the edge of Edisford Road Car Park.

| Rev | Date | Revision notes | By |
|---|---|---|---|
| HENTHORN ROAD CLITHEROE | | | |
| ANNOTATED EXISTING DITCH PLAN | | | |

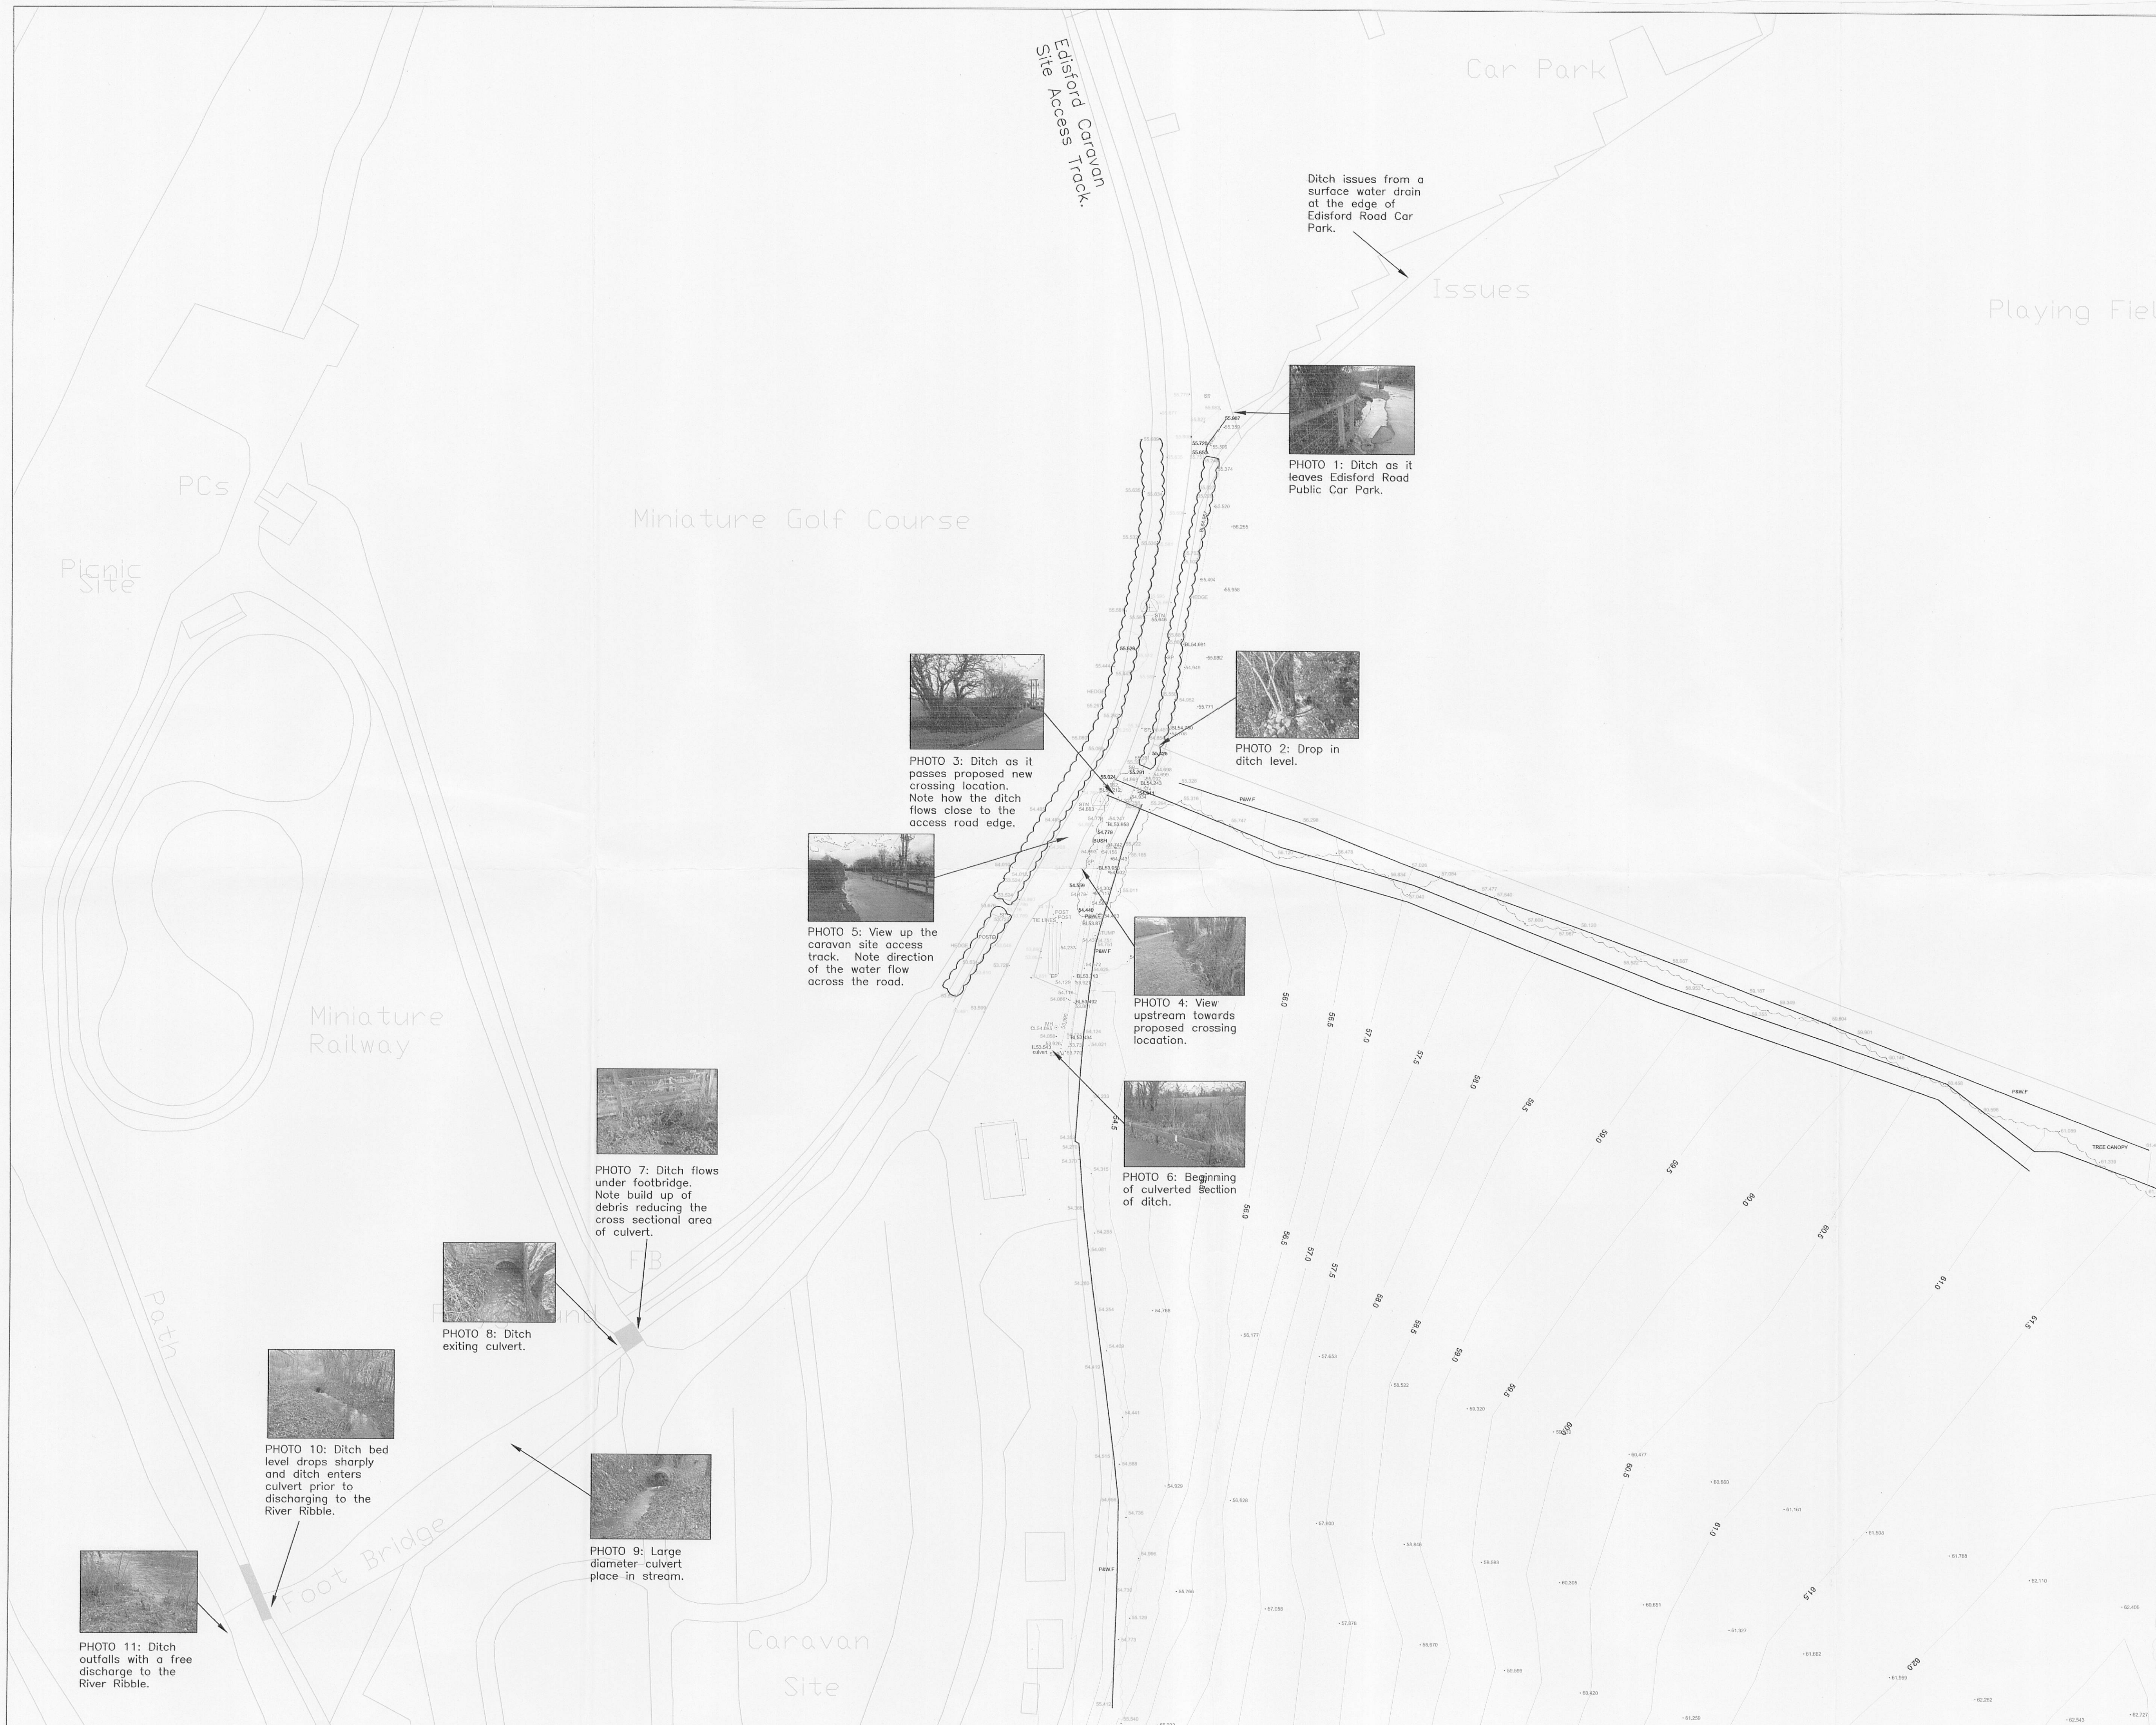
PHOTO 1: Ditch as it leaves Edisford Road Public Car Park.

PHOTO 2: Drop in ditch level.

PHOTO 3: Ditch as it passes proposed new crossing location. Note how the ditch flows close to the access road edge.

PHOTO 5: View up the caravan site access track. Note direction of the water flow across the road.

PHOTO 4: View upstream towards proposed crossing location.

PHOTO 6: Beginning of culverted section of ditch.

PHOTO 7: Ditch flows under footbridge. Note build up of debris reducing the cross sectional area of culvert.

PHOTO 8: Ditch exiting culvert.

PHOTO 10: Ditch bed level drops sharply and ditch enters culvert prior to discharging to the River Ribble.

PHOTO 9: Large diameter culvert place in stream.

PHOTO 11: Ditch outfalls with a free discharge to the River Ribble.
