BAT SURVEY

ASH LEA  
WHALLEY ROAD  
PENDLETON

320120055P

REFERENCE NO. AP/2011/BS

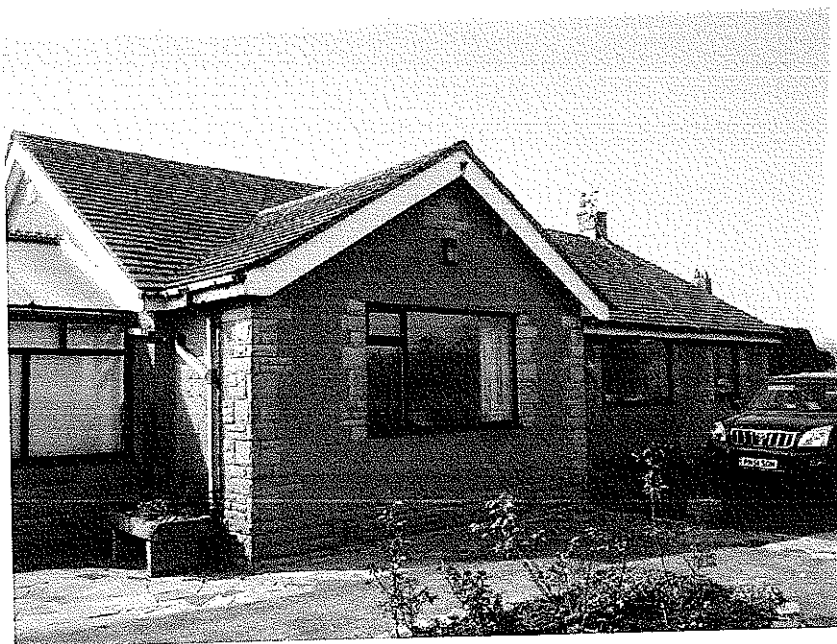
FRONT ELEVATION

COMMENTS: The walls are in good condition with no access points.

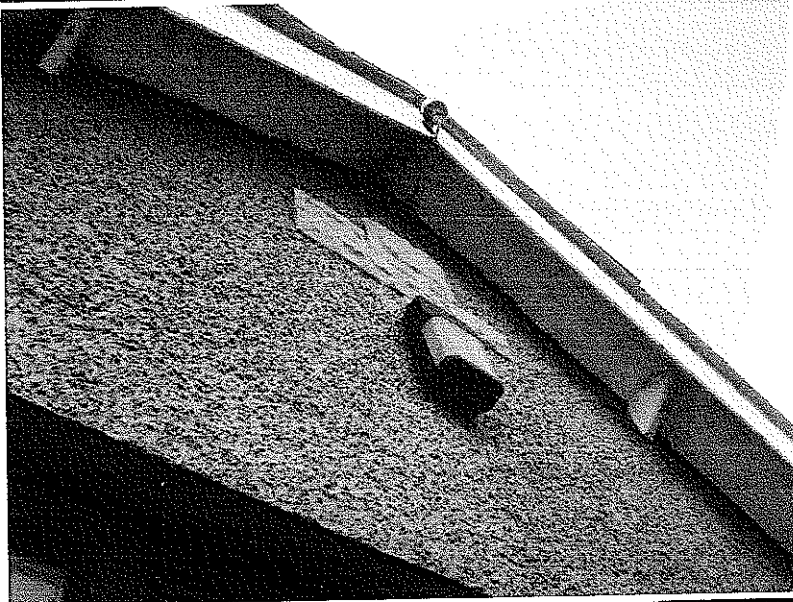
GABLE SOFFIT

COMMENTS: The roof was in good condition with no access points. The soffits are tight fitting with no gaps.
