**Backridge House, nr Waddington,  
Lancashire**

**Heritage Statement for the setting**

**Heritage Statement for the setting of  
Backridge House, Twitter Lane, nr Waddington, Lancashire**

**by  
The Architectural History Practice Limited**

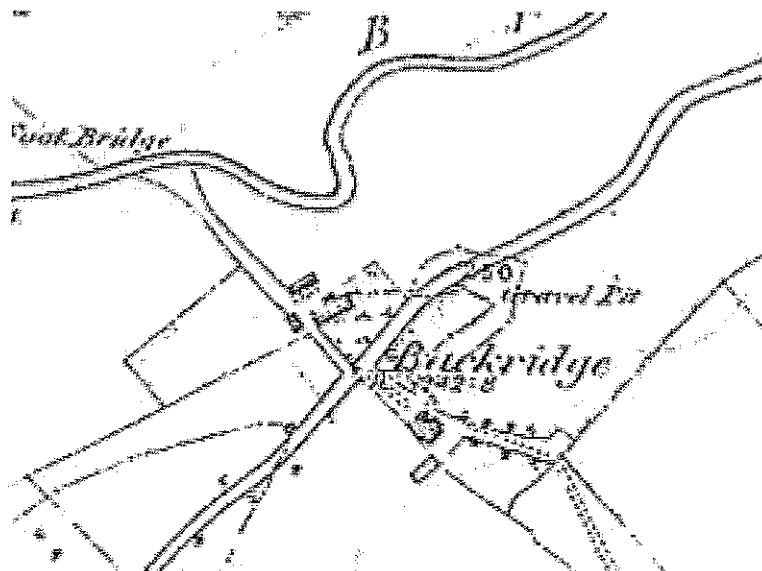
Fig. 1. Detail of 1<sup>st</sup> edition 1847 Ordnance Survey map (1:10560) (surveyed 1847) [Clitheroe Local Studies]

Backridge House is shown on the 1<sup>st</sup> edition Ordnance Survey map of 1847 (1:10560) set back from Twitter Lane with access via a short lane leading north to Bashall

Brook and a footbridge crossing. The house is shown sited in the north-west corner of an enclosed garden or orchard planted with fruit trees. This roughly rectangular enclosure is in the south-west corner of a large field, separated from it by boundaries and the north outbuilding. The map shows two associated small outbuildings, a long narrow structure with small yards on its south side, probably pig sties, to the north across a yard, and a smaller outbuilding across the access lane to the west. West of the latter a small field is marked. On the south side of Twitter Lane a track leads to a large building, probably a barn connected to Backridge Farm. To the north east of this building a gravel pit is marked, probably formed as part of the 'gravel digging' referred to in the 1878 book.

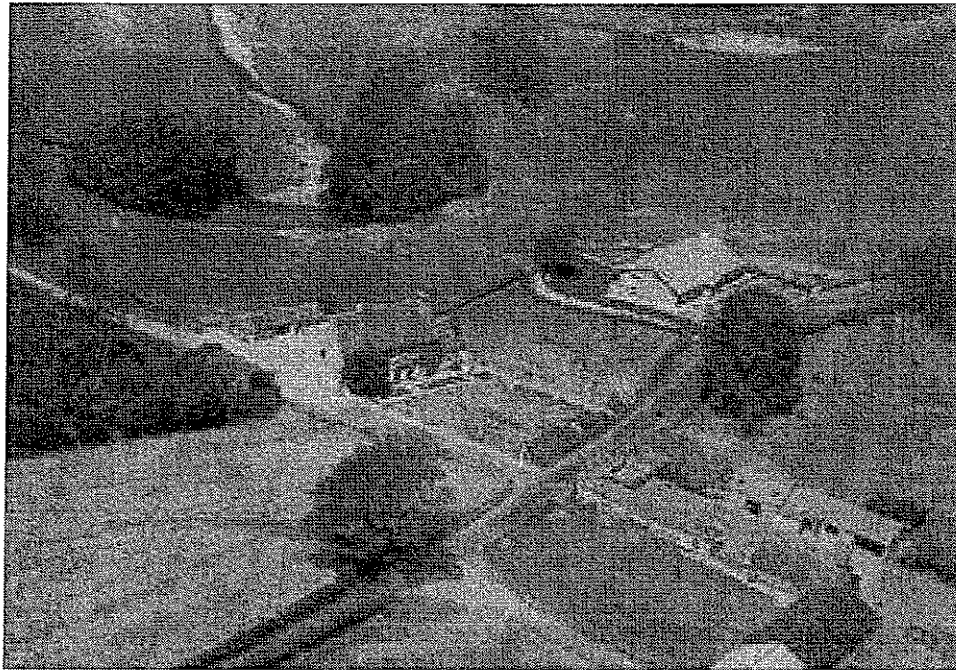
The garden to the south of the house appears mostly laid to lawn with perimeter beds in 1976, with one central planting bed and footpaths in front of the house. There is a large tree in front of the western bay of the house, and the west boundary to the access lane appears to be a stone wall. The area to the east is lawned, with a few small trees or shrubs; it is divided from the front garden by a wall and planting bed, with hedges to north, south and east.

*Fig. 6 1976 aerial photograph of Backridge House (client's collection)*

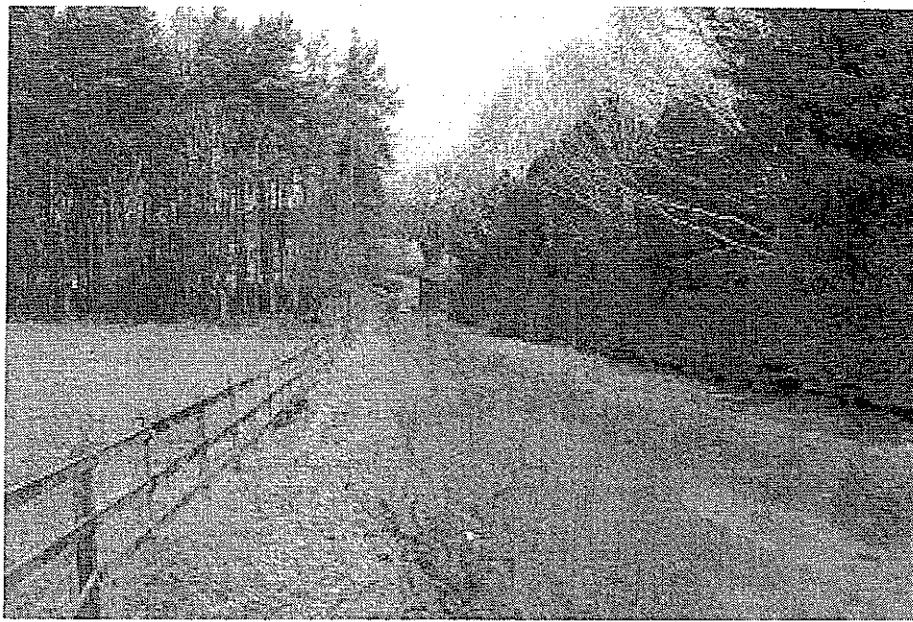
*Fig. 7: farm track laid out in 1990s, from the south (Ashworth Jackson Walker 2011)*

In the 1990s, the access to the surrounding farmland was separated from the drive to Backridge House, by creating a new farm track to the west of the west outbuilding (Fig.7). At the same time, the connection between the farm track to the north and the drive to the house was closed by building a boundary across it, to integrate the drive within the yard on the north side of the house. The new farm track was screened from Backridge House by tree planting; the current arrangement is clearly shown on satellite imagery from Google (Fig.10).

***The new drive and farm track.*** The new drive to the house will follow the line of the farm track laid out in the 1990s, with a new stone wall built along its west edge to separate it from the new farm track. This boundary line is defined by a timber post and rail fence at present. The new drive and track will be well screened from the house and garden by the retained tree and shrub belt. The new farm track will not detract from the setting of the house as it will be well-screened. Tightly aligning the two access routes close together minimises their combined impact on the setting of the house and on the landscape, compared with the present situation.

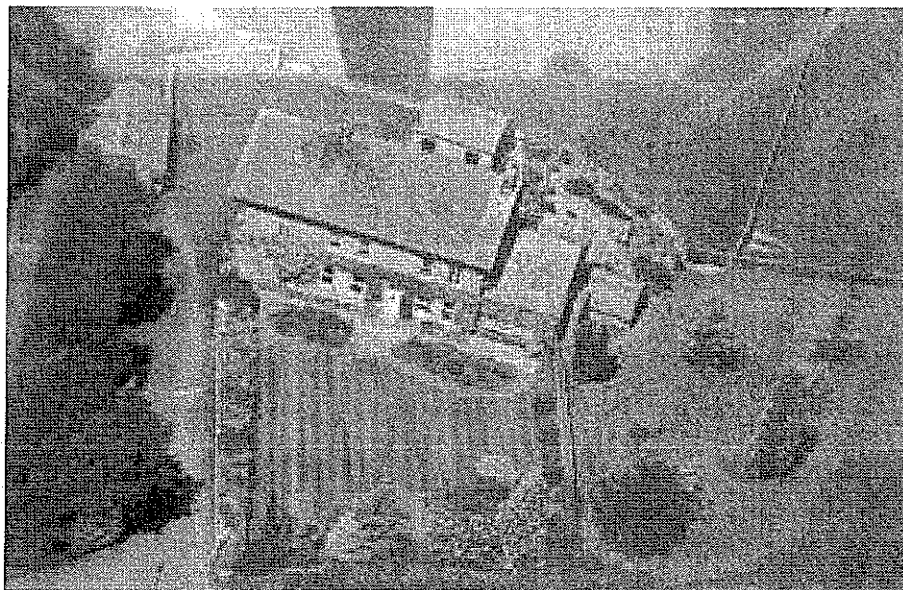
*Fig. 8: Aerial photograph of c. 2002 (client's collection)*

The air photograph from c. 2002 (Fig. 8) shows the two access drives and the garden to the south and east of the house, now bounded by stone walls.

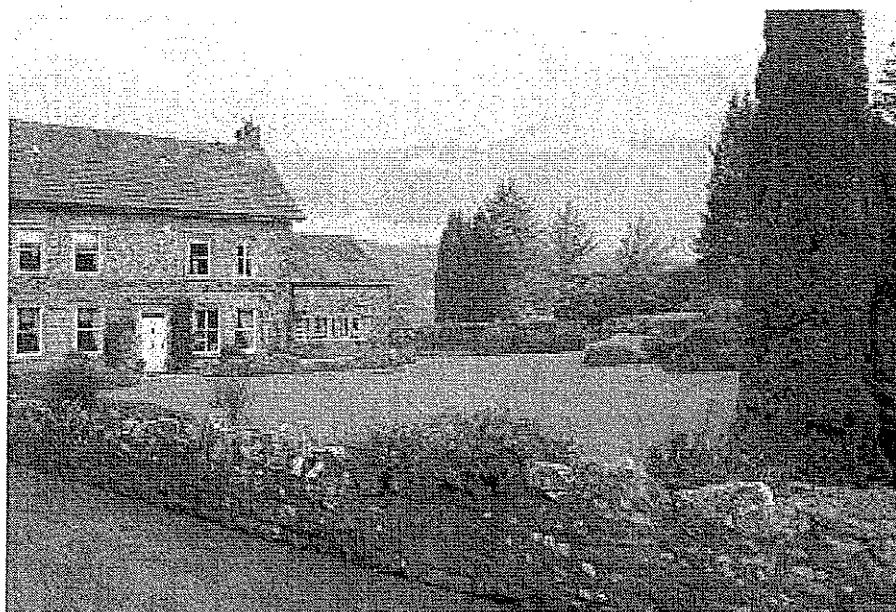
The drive to the house is bounded by a stone wall along its east side, separating the drive from the garden (Fig. 9). This wall is on the line of a boundary shown on historic mapping, but its irregular construction using cement-based mortar suggests it has been rebuilt on several occasions. The sandstone wall is topped with pieces of natural limestone, a feature popular in Victorian and early 20th century gardens.

*Fig. 9. stone wall along east side of the drive (Ashworth Jackson Walker 2011)*

The proposal entails incorporating the line of the existing drive to the house into the garden by taking down the stone boundary wall along its east side, and building a new wall across its south opening to Twitter Lane.

***The garden wall.*** Listed building consent is required for the removal of the wall, as it is a curtilage structure. In considering the application, the local authority has a duty to take account of the impact of the proposals on the setting and significance of the house. The removal of the wall affects a feature of indeterminate date; the line of this boundary appears on mid 19<sup>th</sup> century historic mapping, but the wall appears to have been rebuilt and has relatively low aesthetic value in relation to the significance of the house. The wall currently defines the west side of the garden; the western edge of the garden will be moved further west where it will be defined by the belt of tree and shrub planting along the west side of the present drive. This planting belt will continue to be maintained.

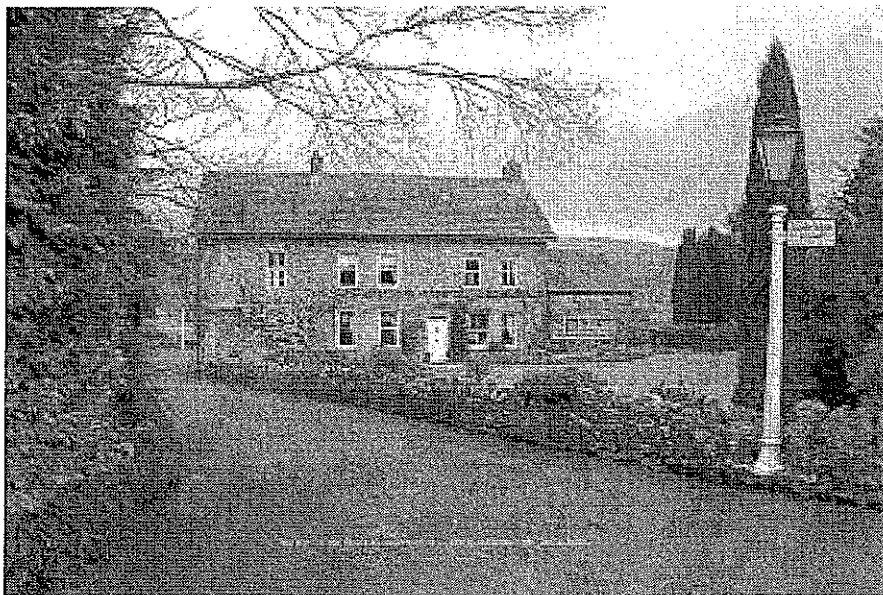
*Fig.11: Backridge House from Twitter Lane (Ashworth Jackson Walker 2011)*

The front of Backridge House is clearly seen from Twitter Lane along the drive; the south garden and drive are the most important elements of the frontage setting. The house is partly screened from the south-east by the hedge and high bank along the south boundary to the lane (Fig.12). The formal architecture of the south front of the house indicates that this was the elevation intended to be seen by the passing public.

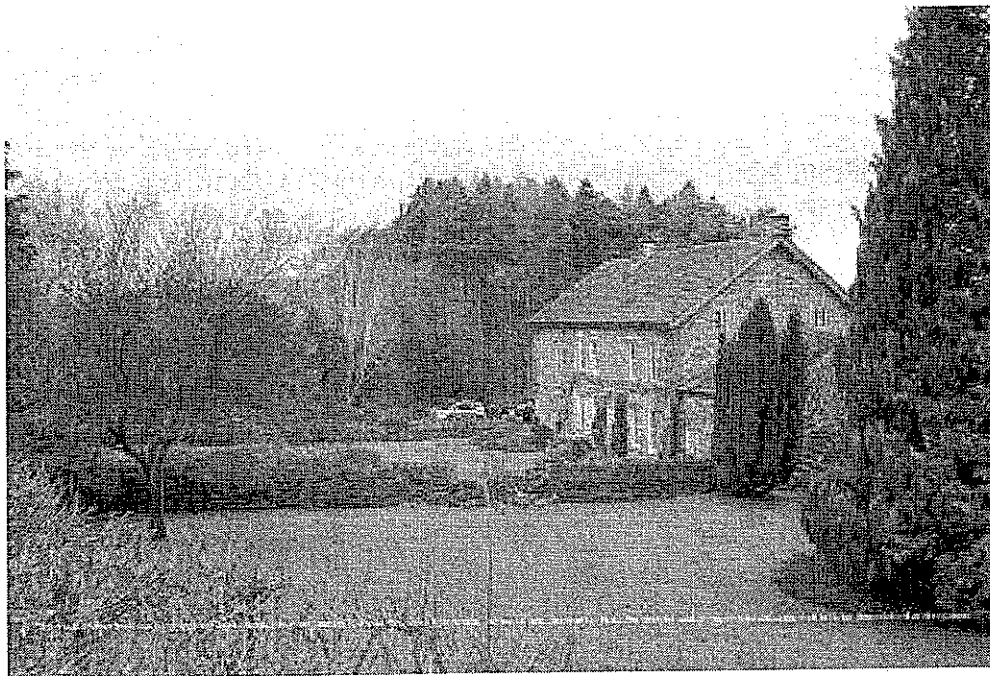
The existing drive to the house is on the line of the historic approach to the farmhouse, and the boundary walls and hedges that define the west and south side of the garden are also on historic lines and contribute to the setting of the house. The east side of the drive is defined by a low sandstone wall topped with limestone; the date of this is not known although it appears to have been repaired or rebuilt on several occasions.

*Fig 12: The house from the SE, screened by a hedge along the north side of the lane  
(Ashworth Jackson Walker Architects 2011)*

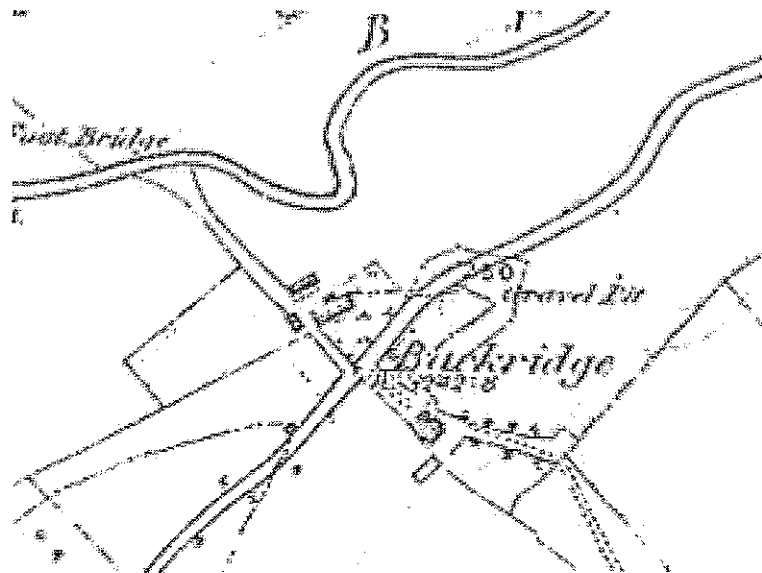
Fig.1: Detail of 1<sup>st</sup> edition 1847 Ordnance Survey map (1:10560) (surveyed 1847) [Clitheroe Local Studies]

Backridge House is shown on the 1<sup>st</sup> edition Ordnance Survey map of 1847 (1:10560) set back from Twitter Lane with access via a short lane leading north to Bashall

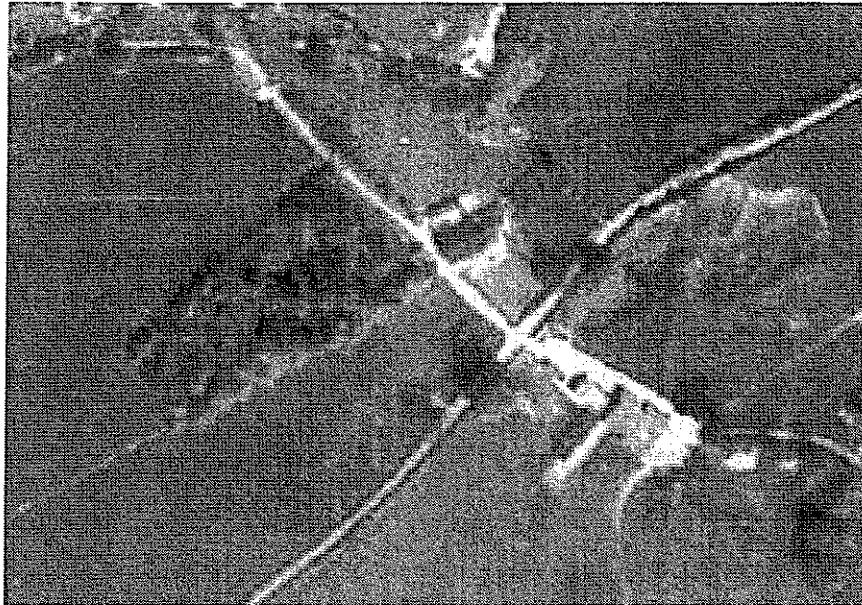
*Fig. 4: Detail of a 1940s aerial photograph of Backridge  
[Lancashire MARIO website]*

Little information is recorded about Backridge Farm in the first half of the 20<sup>th</sup> century. The house and outbuildings can clearly be seen on an aerial photograph (Fig.4) of the site from the 1940s on the Lancashire MARIO website, as can the mixed woodland to the west but not the smaller area of trees west of the lane. The garden/orchard is shown as two different areas, suggesting that the area south of the

house was differently managed to the area to the east. The boundaries of the garden appear to be hedges on this photograph, the traditional form of field boundary in the area. A large tree on the Twitter Lane boundary is shown.

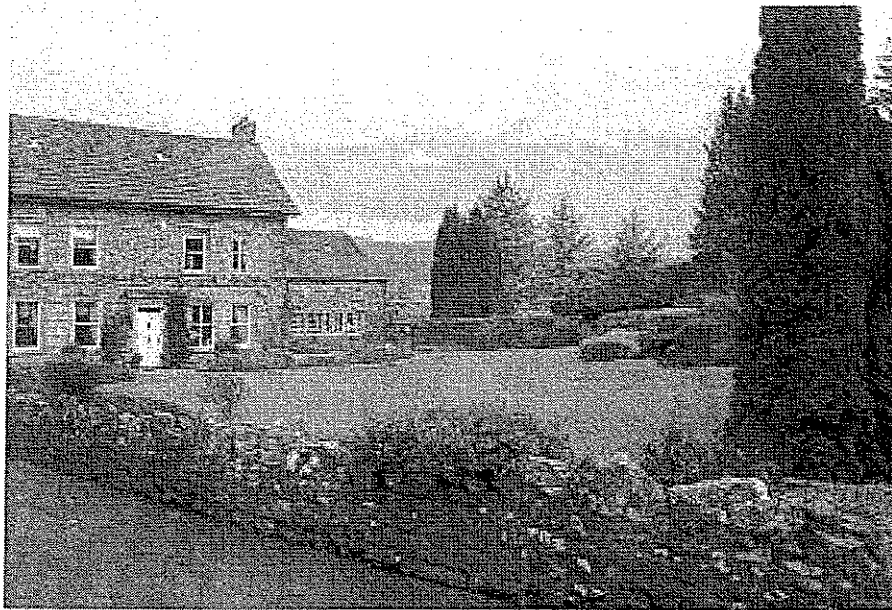
*Fig. 9: stone wall along east side of the drive (Ashworth Jackson Walker 2011)*

The drive to the house is bounded by a stone wall along its east side, separating the drive from the garden (Fig.9). This wall is on the line of a boundary shown on historic mapping, but its irregular construction using cement-based mortar suggests it has been rebuilt on several occasions. The sandstone wall is topped with pieces of natural limestone, a feature popular in Victorian and early 20th century gardens.

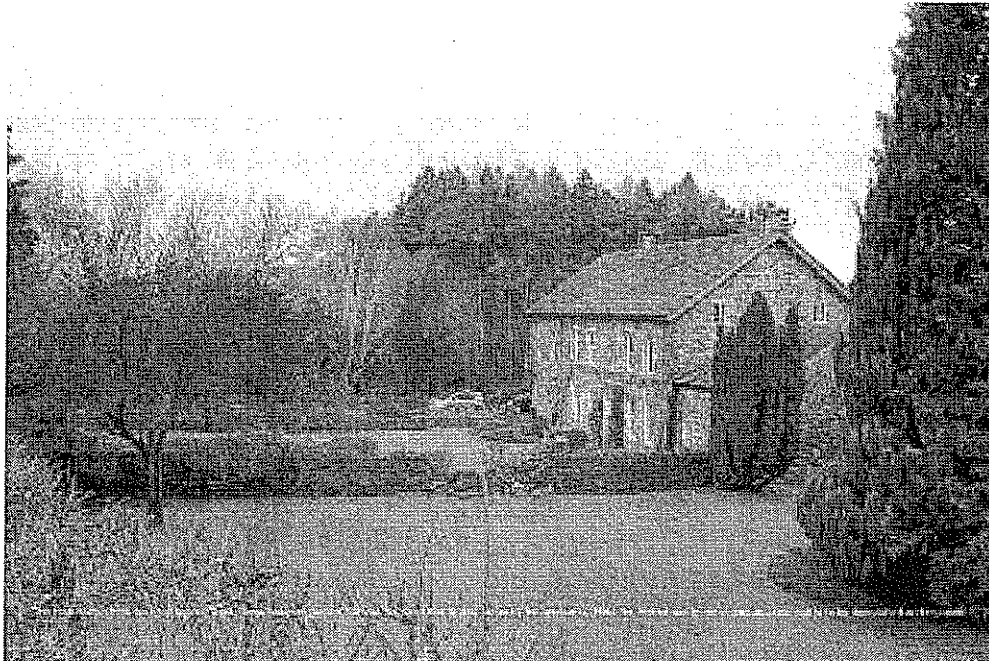
*Fig.12: The house from the SE, screened by a hedge along the north side of the lane  
(Ashworth Jackson Walker Architects 2011)*

The front of Backridge House is clearly seen from Twitter Lane along the drive; the south garden and drive are the most important elements of the frontage setting. The house is partly screened from the south-east by the hedge and high bank along the south boundary to the lane (Fig.12). The formal architecture of the south front of the house indicates that this was the elevation intended to be seen by the passing public

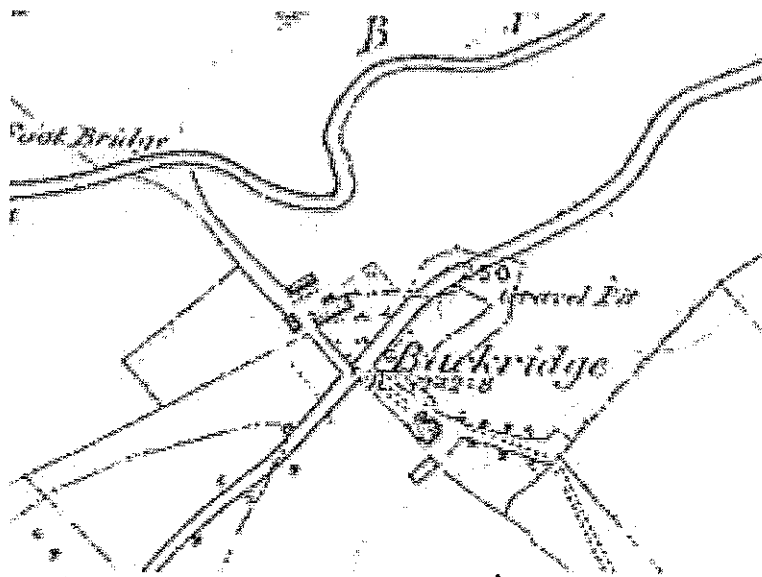
Fig. 1: Detail of 1<sup>st</sup> edition 1847 Ordnance Survey map (1:10560) (surveyed 1847) [Clitheroe Local Studies]

Backridge House is shown on the 1<sup>st</sup> edition Ordnance Survey map of 1847 (1:10560) set back from Twitter Lane with access via a short lane leading north to Bashall

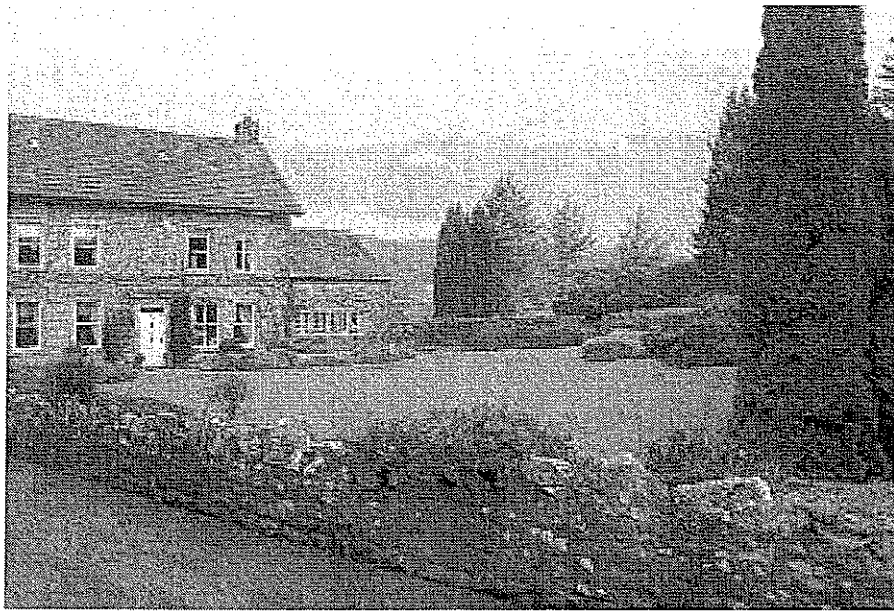
*Fig. 9: stone wall along east side of the drive (Ashworth Jackson Walker 2011)*

The drive to the house is bounded by a stone wall along its east side, separating the drive from the garden (Fig.9). This wall is on the line of a boundary shown on historic mapping, but its irregular construction using cement-based mortar suggests it has been rebuilt on several occasions. The sandstone wall is topped with pieces of natural limestone, a feature popular in Victorian and early 20th century gardens.

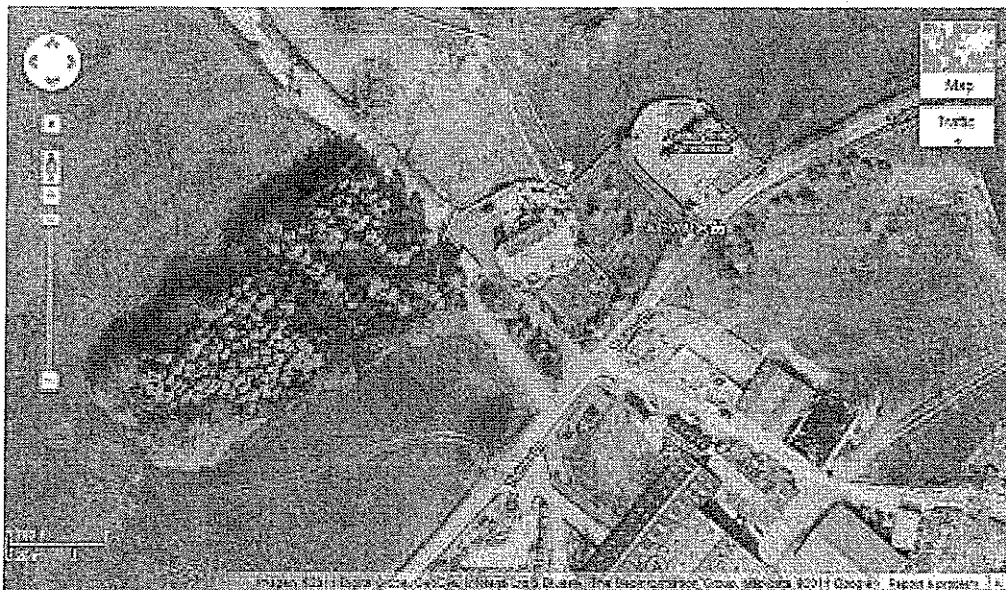
*Fig. 10: Backridge on Google Earth, 2011*

In the 1990s, the access to the surrounding farmland was separated from the drive to Backridge House, by creating a new farm track to the west of the west outbuilding (Fig.7). At the same time, the connection between the farm track to the north and the drive to the house was closed by building a boundary across it, to integrate the drive within the yard on the north side of the house. The new farm track was screened from Backridge House by tree planting; the current arrangement is clearly shown on satellite imagery from Google (Fig.10).

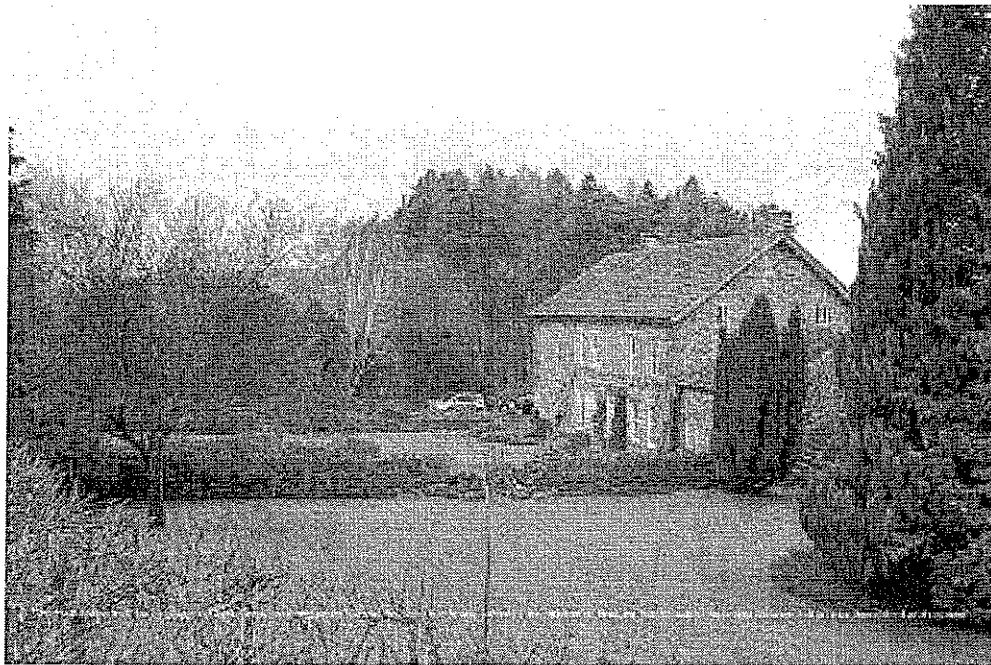
*Fig.12: The house from the SE, screened by a hedge along the north side of the lane  
(Ashworth Jackson Walker Architects 2011)*

The front of Backridge House is clearly seen from Twitter Lane along the drive; the south garden and drive are the most important elements of the frontage setting. The house is partly screened from the south-east by the hedge and high bank along the south boundary to the lane (Fig.12). The formal architecture of the south front of the house indicates that this was the elevation intended to be seen by the passing public
