## Heritage Statement

Altham Pumping Station

For Waterboy Ltd

Document Reference Number 2011/1034

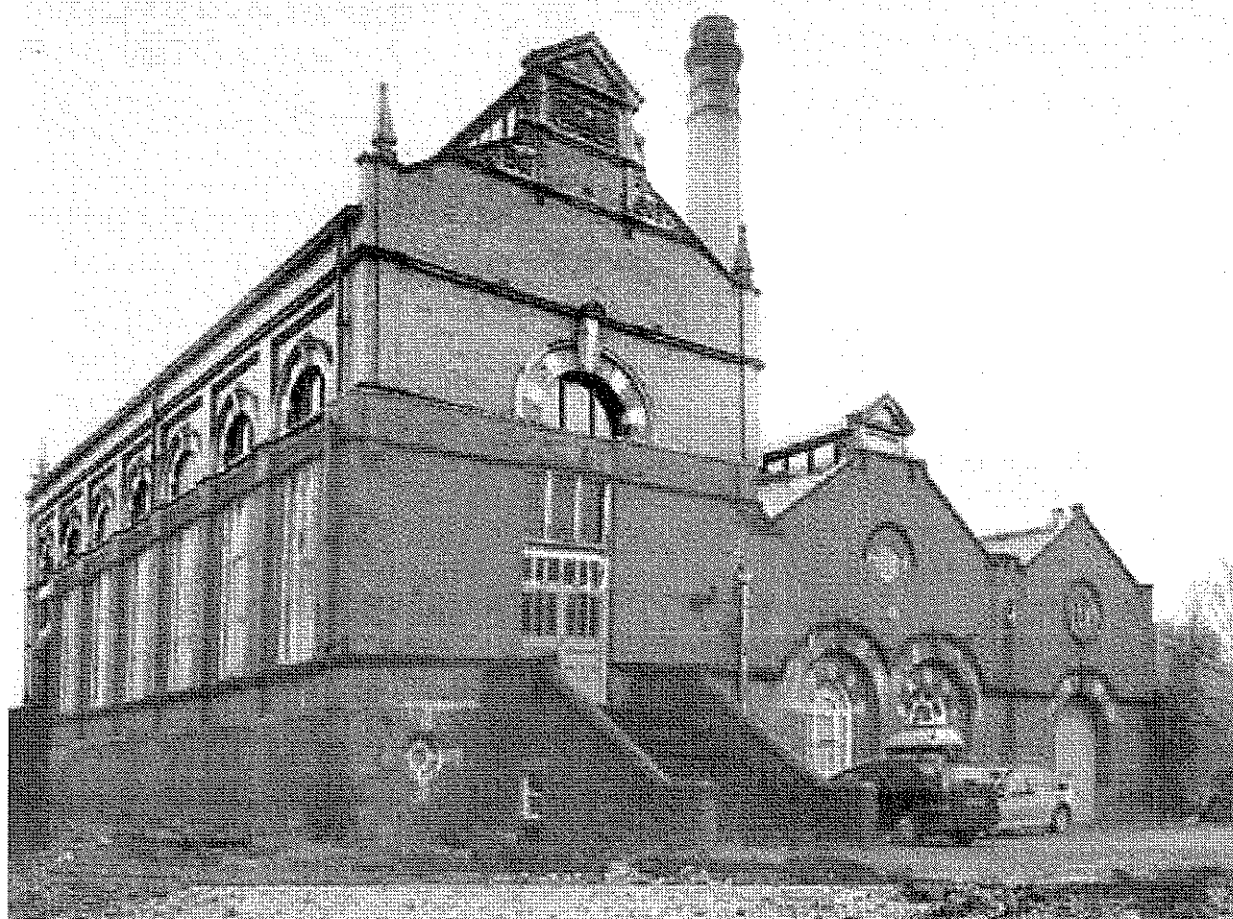
**Figure 4 Reconstruction of the pumping house with the demolished sections added**  
*The above image was supplied by Waterboy Ltd*

When the national grid was being established in Accrington & District in the 1930's, 40's and 50's, the main pumping house building was reduced in height by approximately 50%/roof and the middle building lost its skylight apex.

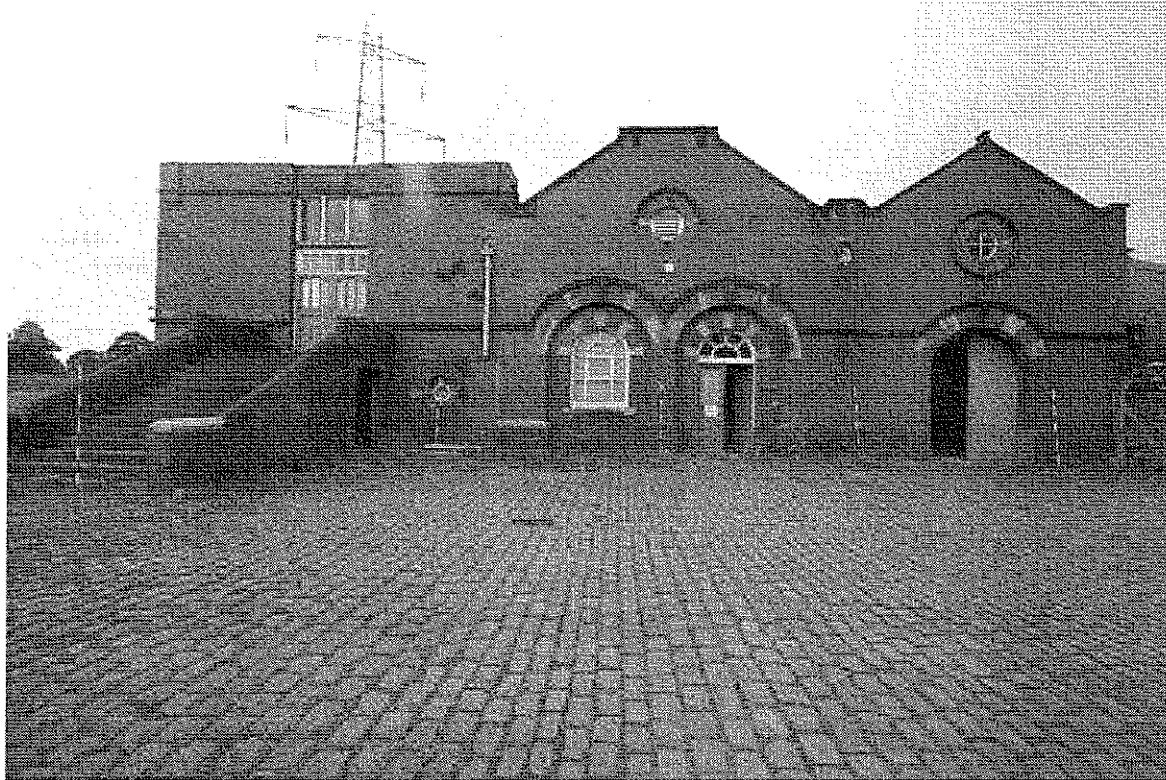
**Plate 1 The Front (East Elevation)**

To the left, the former engine / pump house, centrally, the boiler house and to the right, the coal store. The yard in the foreground is of brick cobbles.

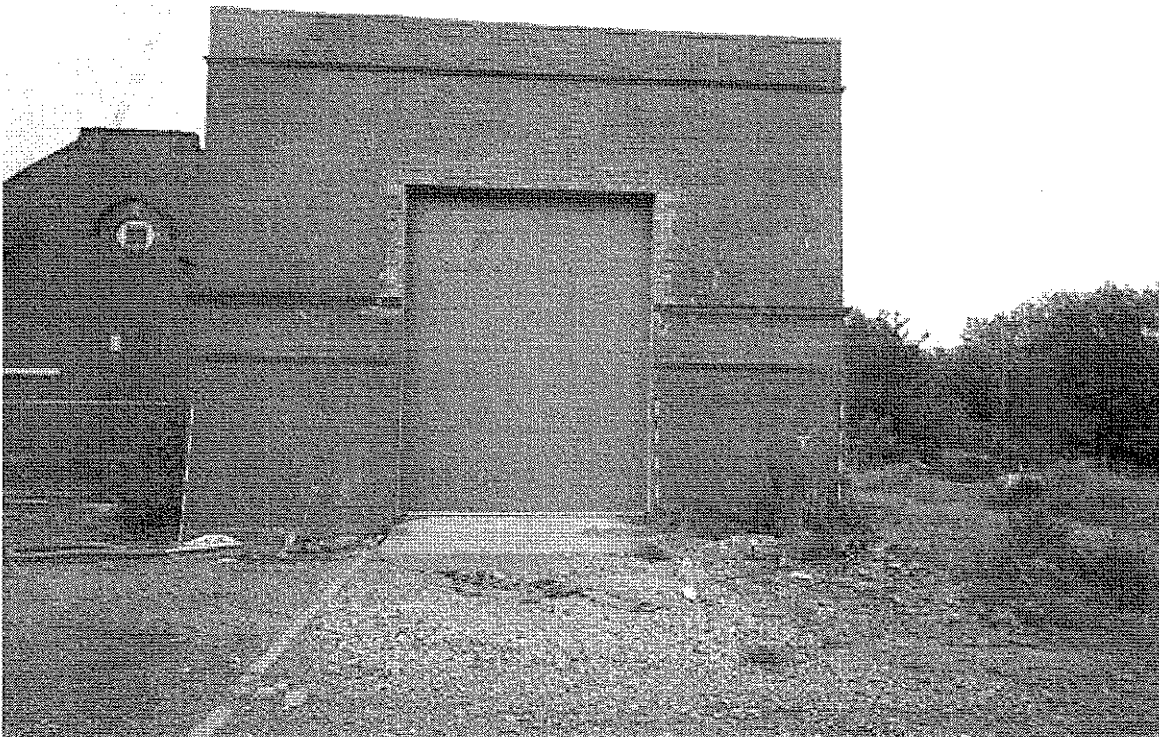
**Plate 8 The recent roller shutter door**

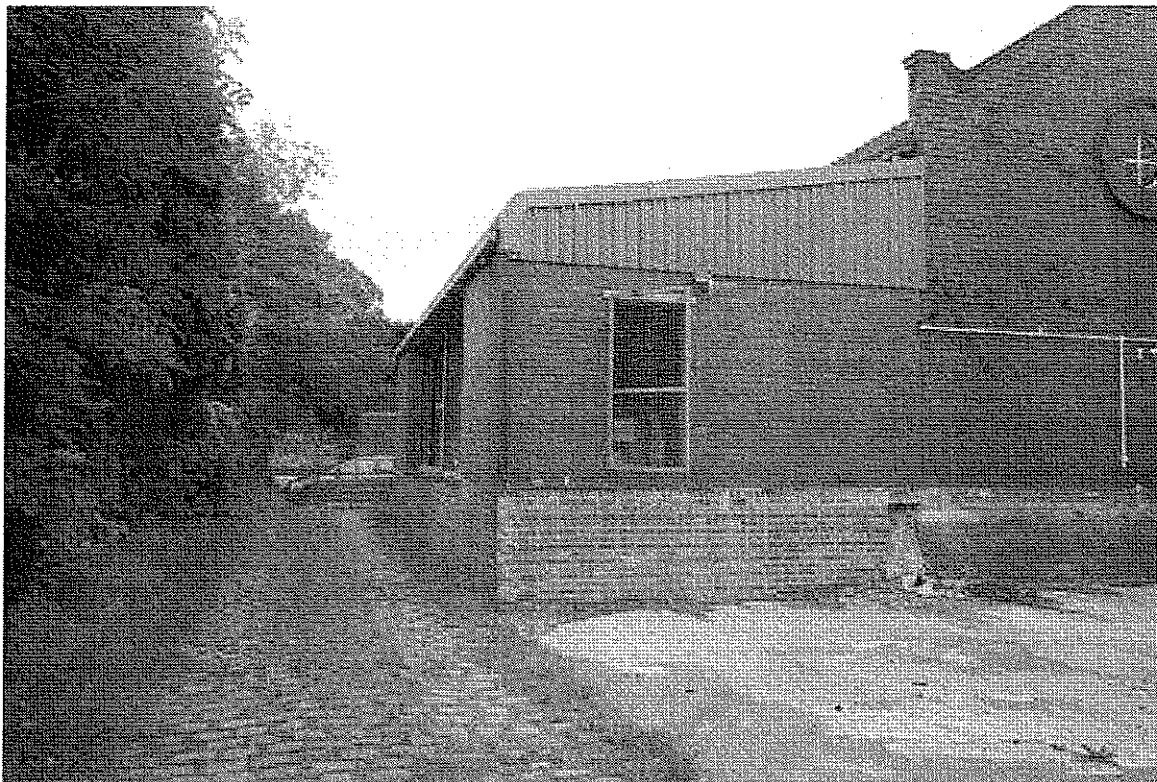
**Plate 9 Recent Extension**

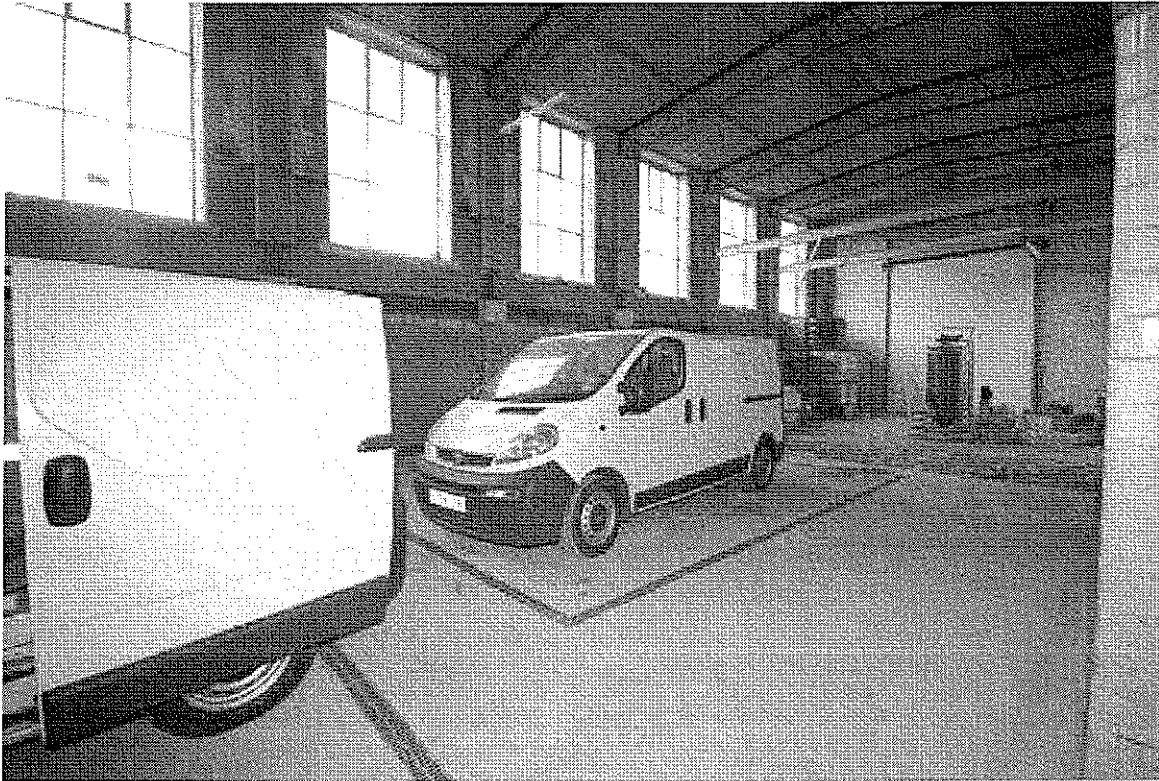
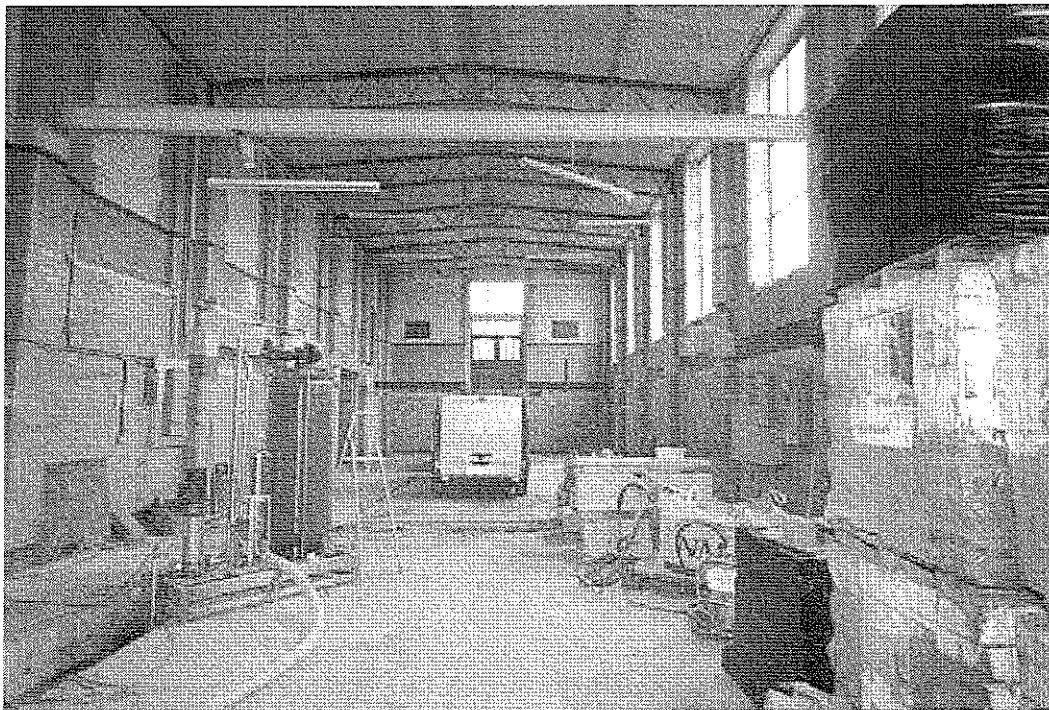
Plate 10 West Aspect

Plate 11 East Aspect

The roof structure of this part of the building is a variation on the Warren truss, with a slightly raised pitch. The trusses are constructed of rolled iron. The roof structure dates from the early 20<sup>th</sup> century when the building was reduced in height.

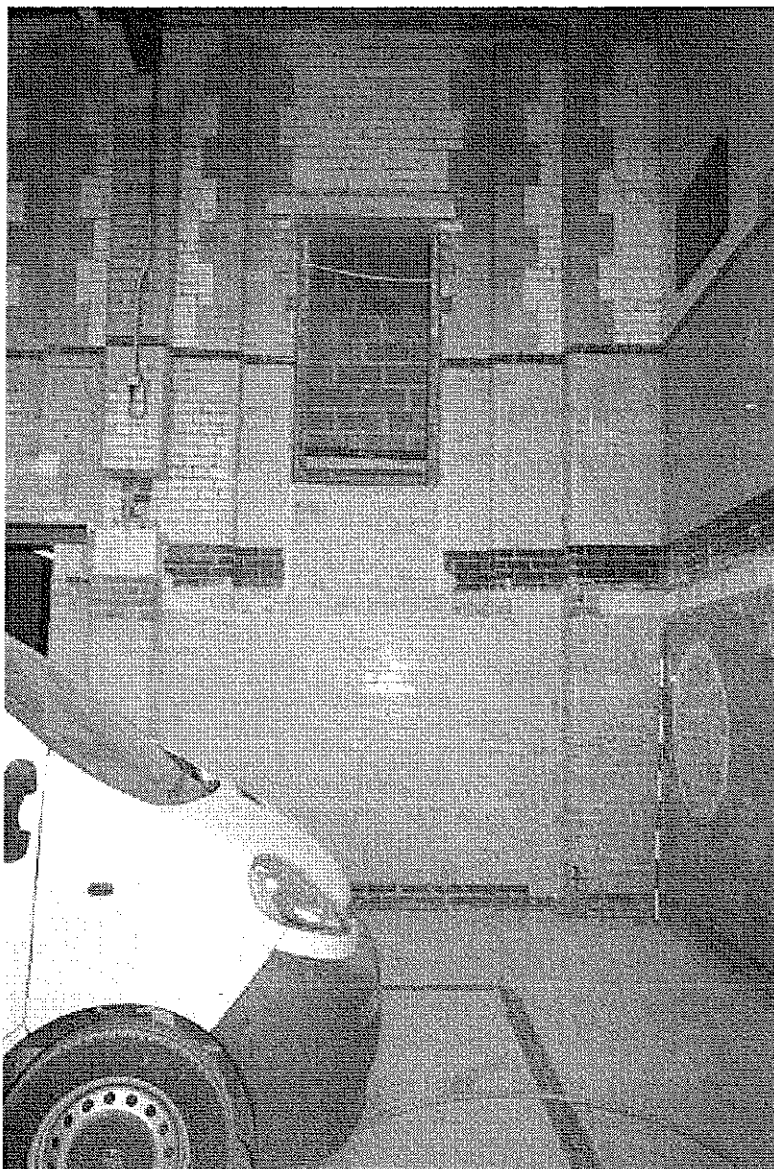
A mezzanine floor was once present in the engine house. This is apparent from the scars around the walls indicating the level of the previous ceiling. Doors are also present at the previous mezzanine level, now located high on the wall.

**Plate 12 Showing where mezzanine floor has been removed**

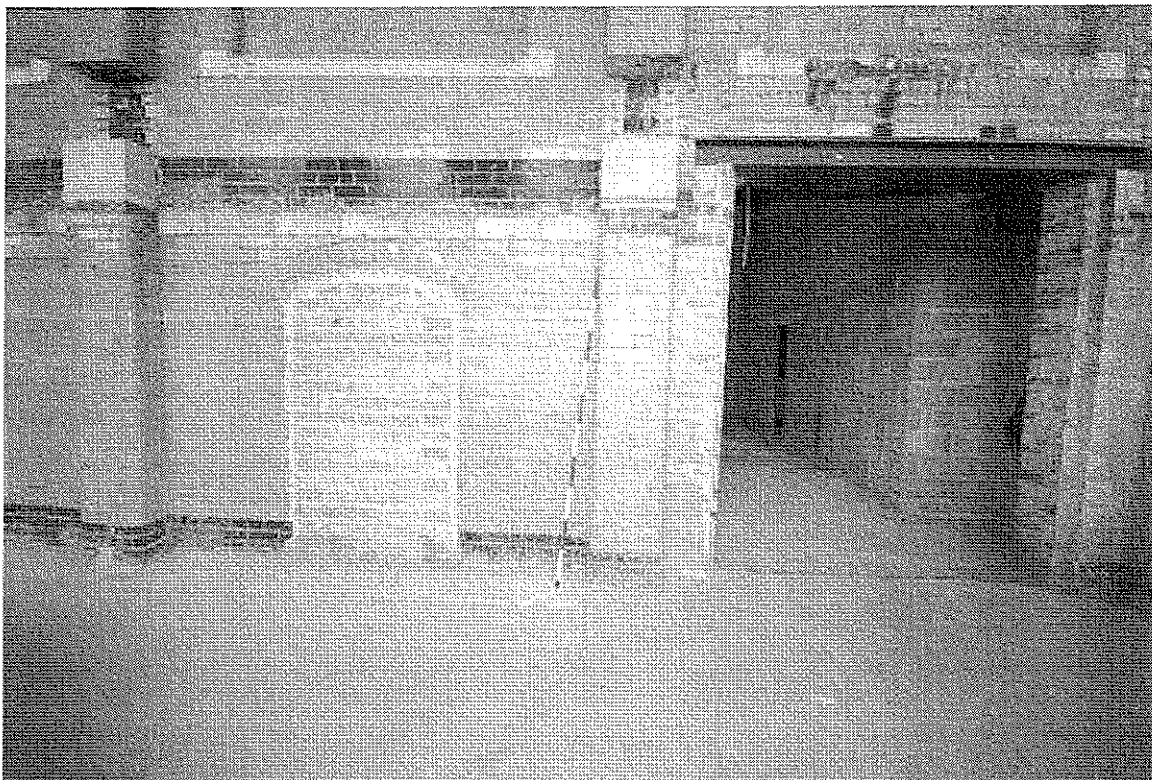
**Plate 13 Blocked door and new opening**

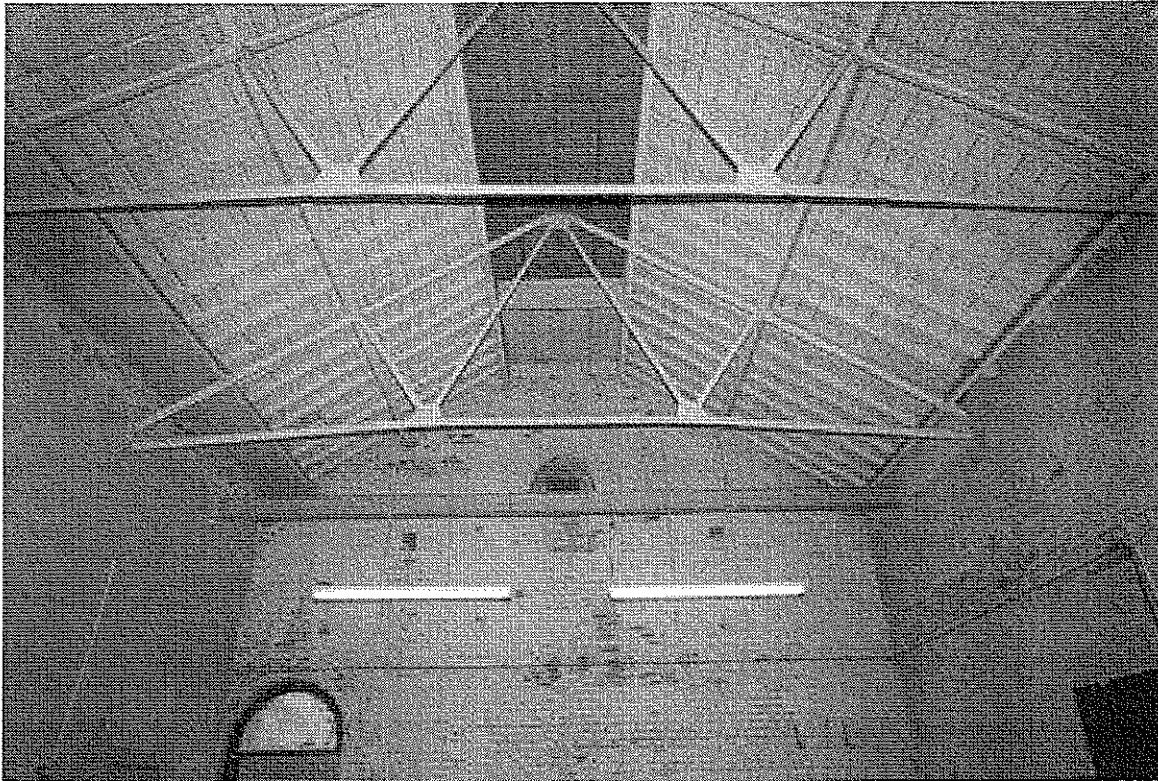
**Plate 17 Roof Structure North-West**

**Plate 18 Roof Structure – South East**

The roof trusses are of the triangular chord and strut form, fabricated from rolled angle steel joined with gusset plates.

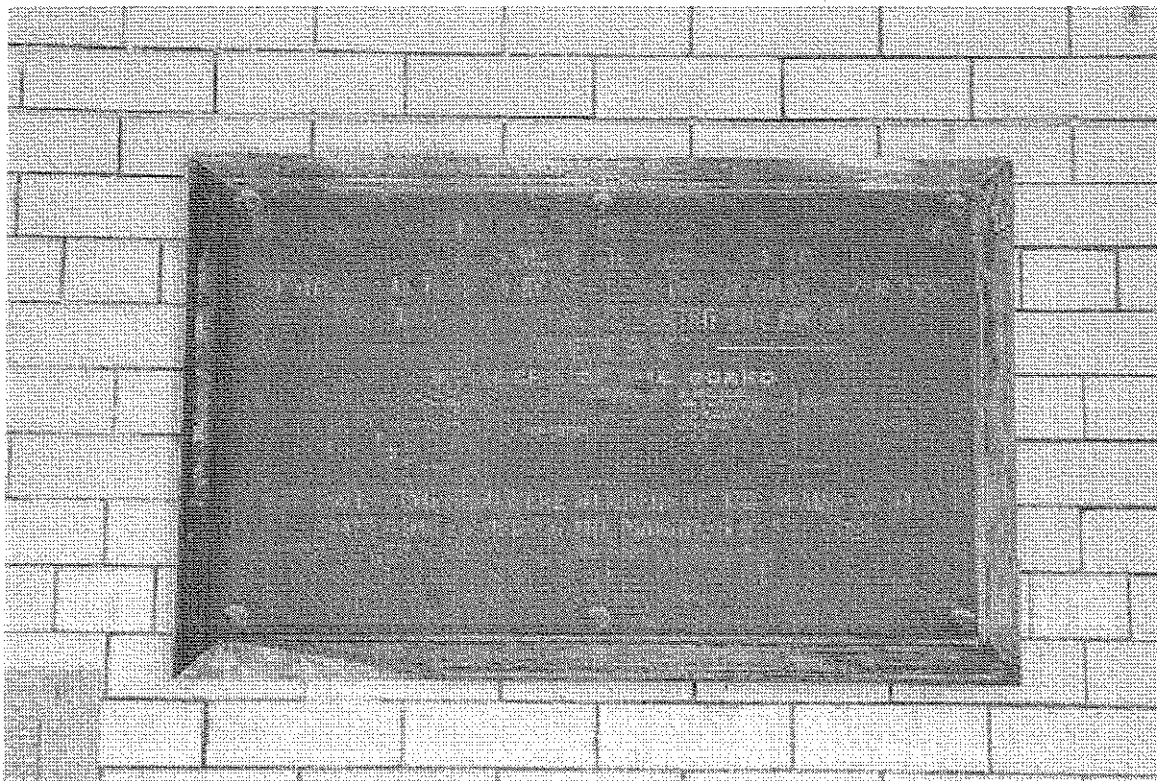
**Plate 28 The 1908 Dedication Plaque**

Two engine dedication plaques are present in the main engine/pumping room the first to the original beam engine and the second to the replacement electric pump.
