Application for Planning Permission and listed building consent for alterations,  
extension or demolition of a listed building.

Conversion of barn into 1 dwelling

House:  Suffix:   
House name: CHADWICKS FARM  
Street address: SETTLE ROAD  
BOLTON BY BOWLAND  
Town/City: CLITHEROE  
County:   
Postcode: BB7 4NT

## BAT, BARN OWL & NESTING BIRD SURVEY AT

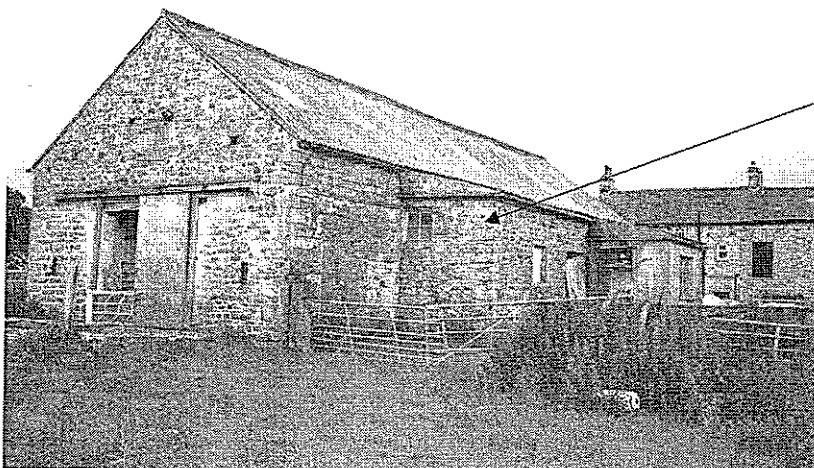
North and West elevation

Lean-to outbuilding offering poor roosting potential

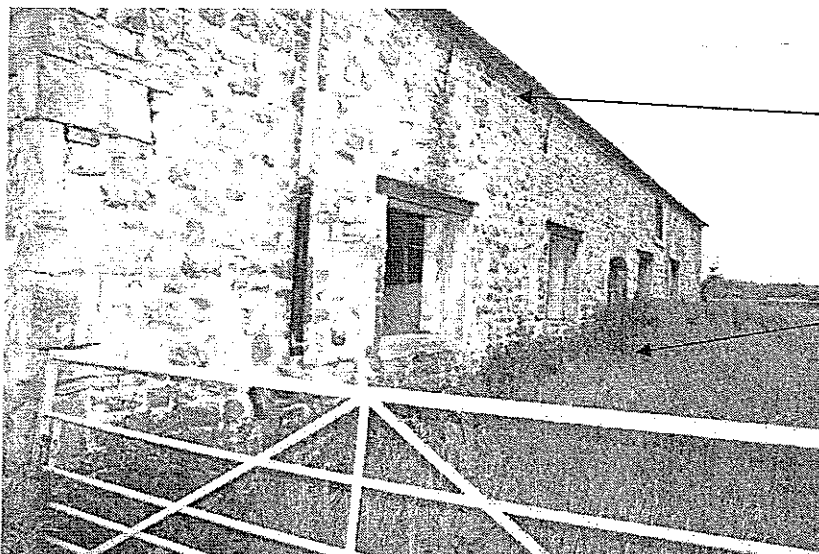
East elevation

Facia boards along the eaves offer some roosting potential, easy to inspect.

Area of long grass offering foraging potential.

There were occasional gaps noted along the roof line under the eaves along fascia boards and wall tops on the West and East elevations. The gaps were found to be potentially suitable although there was no evidence of past use such as droppings, grease or scratch marks, or urine staining on the walls themselves.

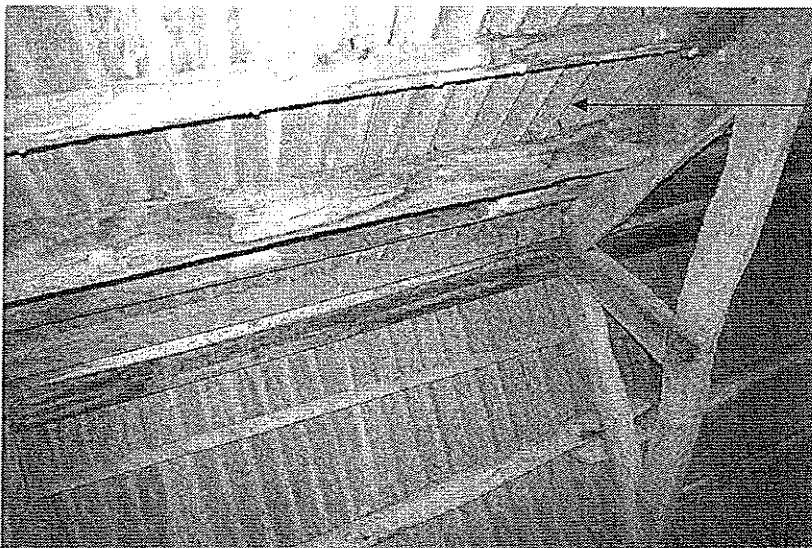
Asbestos roof offering negligible roosting potential.

The roof is made of asbestos and is unlined we consider that the potential for roosting bats in the roof is negligible. The entire roof could be easily inspected from the ground and the eaves line with close focus binoculars and a 1,000,000 candle power torch. No indication of use of the roof by bats such as lichen staining, grease or scratch marks could be found. The ridge line could also be fully inspected, and was found to be very well sealed, no indications of use could be found. The roof structure generally appears of low quality for use by bats.
