Barn at Chadwick's Farm
Settle Road, Bolton-by-Bowland, Lancashire:
Historic Building Record

January 2012

STEPHEN HAIGH

Historic Building Record

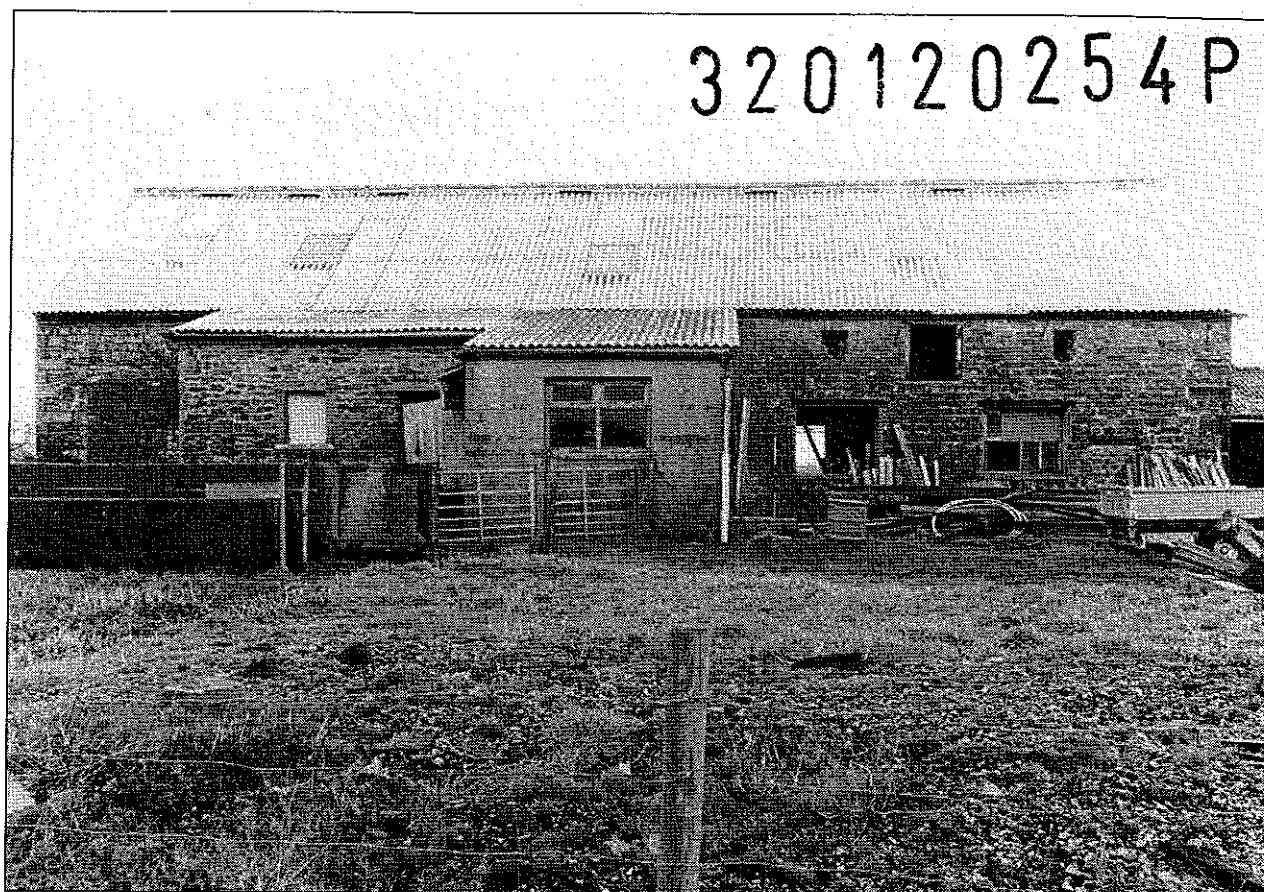
Photo 3: West elevation

- 6.2 The west front is much altered (3), and its principal feature, a wide, central cart entrance with segmental, chamfered stone arch, is now blocked with brickwork and mostly hidden by the modern render and ceiling within the former porch (4), but this would have formed the main entrance to the threshing bay within the middle of the barn. It is flanked by a pair of rubble "cheek" walls which form an external porch, and it is likely but not certain that these are contemporaneous with the main building. The south cheek wall has a modern window inserted through it, and the north wall a doorway (5,6), and the interior of the former porch is rendered entirely.

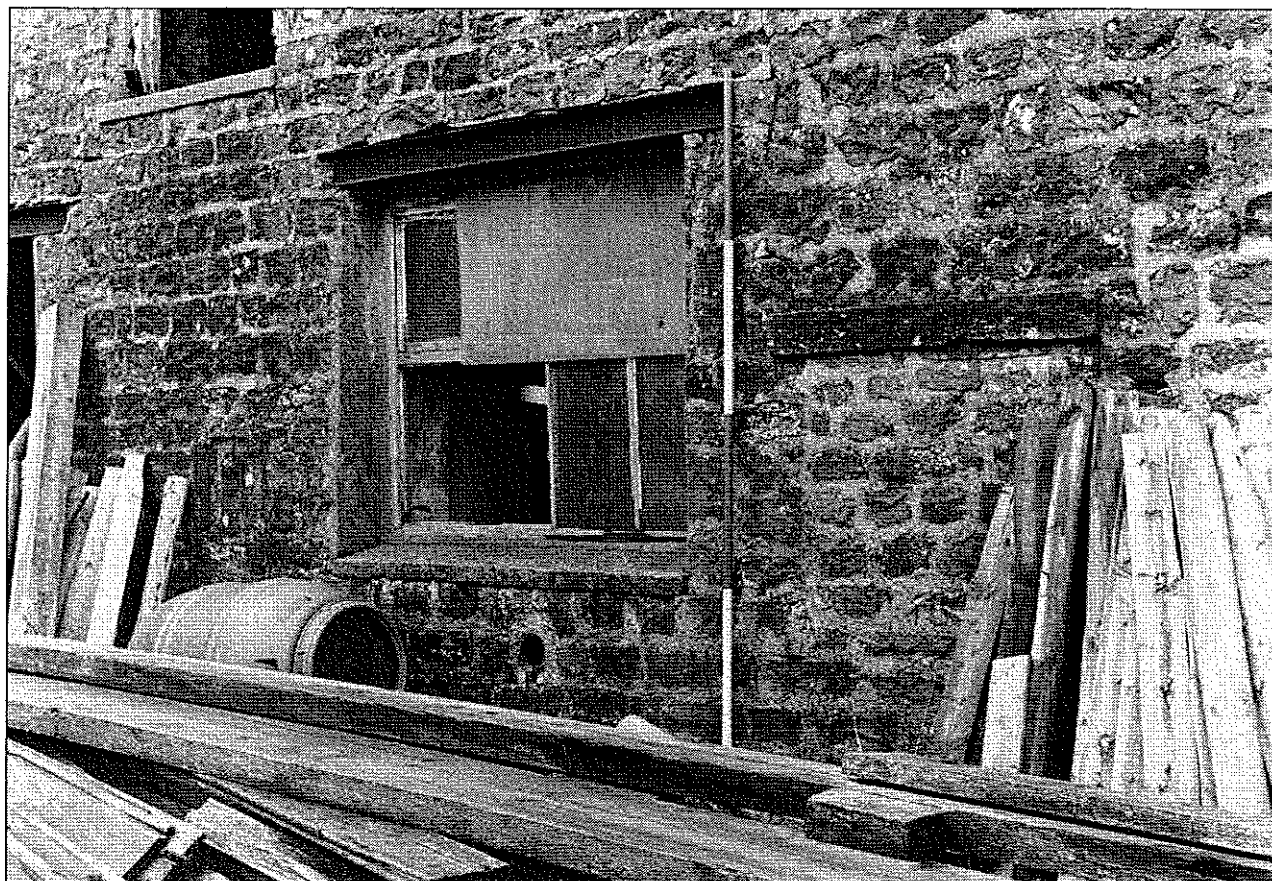
Photo 7: Inserted 20th century window and former openings including blocked breather (type A), west elevation

- 6.3 To the south of the cart entrance are two large, mid 20th century ground floor window openings with steel lintels, as well as various other openings of different dates. Three of these latter are small breathers, here termed "type A", because of their chamfered stone dressings, although the two such breathers on the first floor have had their surrounds removed. There is also a larger, blocked opening with projecting lintel near the south end, most likely a window created in the late 19th or early 20th century (7).

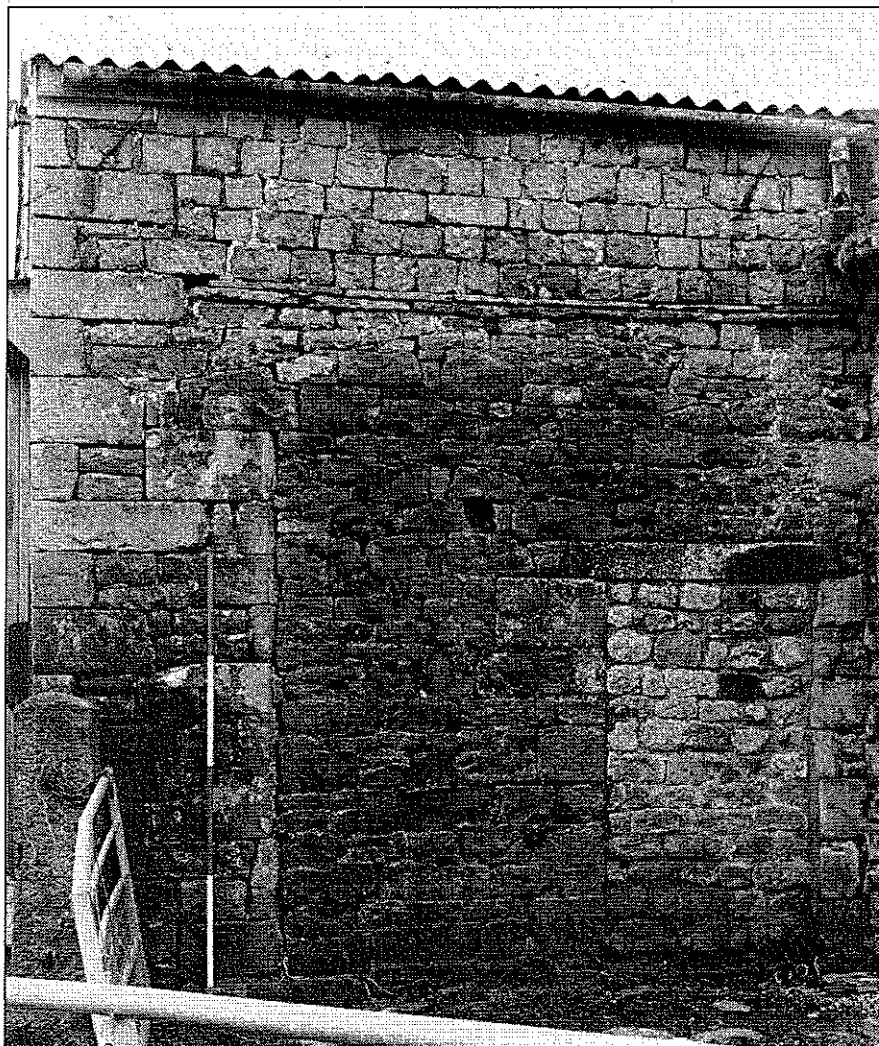
Photo 9: Blocked cart entrance in west elevation (with second blocked doorway within infill)

- 6.4 To the north of the cart entrance, there are three "type A" breathers presently visible within the lean-to, one at ground floor level and two at first floor, but there may be more, hidden by boarding; these indicate that the lean-to is secondary (8). Beyond the lean-to is a second cart entrance with drip band of flagstones above (9), thought to be a 19th century insertion, as the lintel to the inside of the building is of square-cut softwood (in contrast to the oak lintel of the central doorway), and it is associated with a later cross wall which separates this end from the remainder of the barn, forming a cart bay. However, it is worth noting

that the cart entrance has chamfered jambs, raising the possibility that it is actually an original entrance. The doorway was first infilled to leave a pedestrian doorway, which was in its turn blocked too.

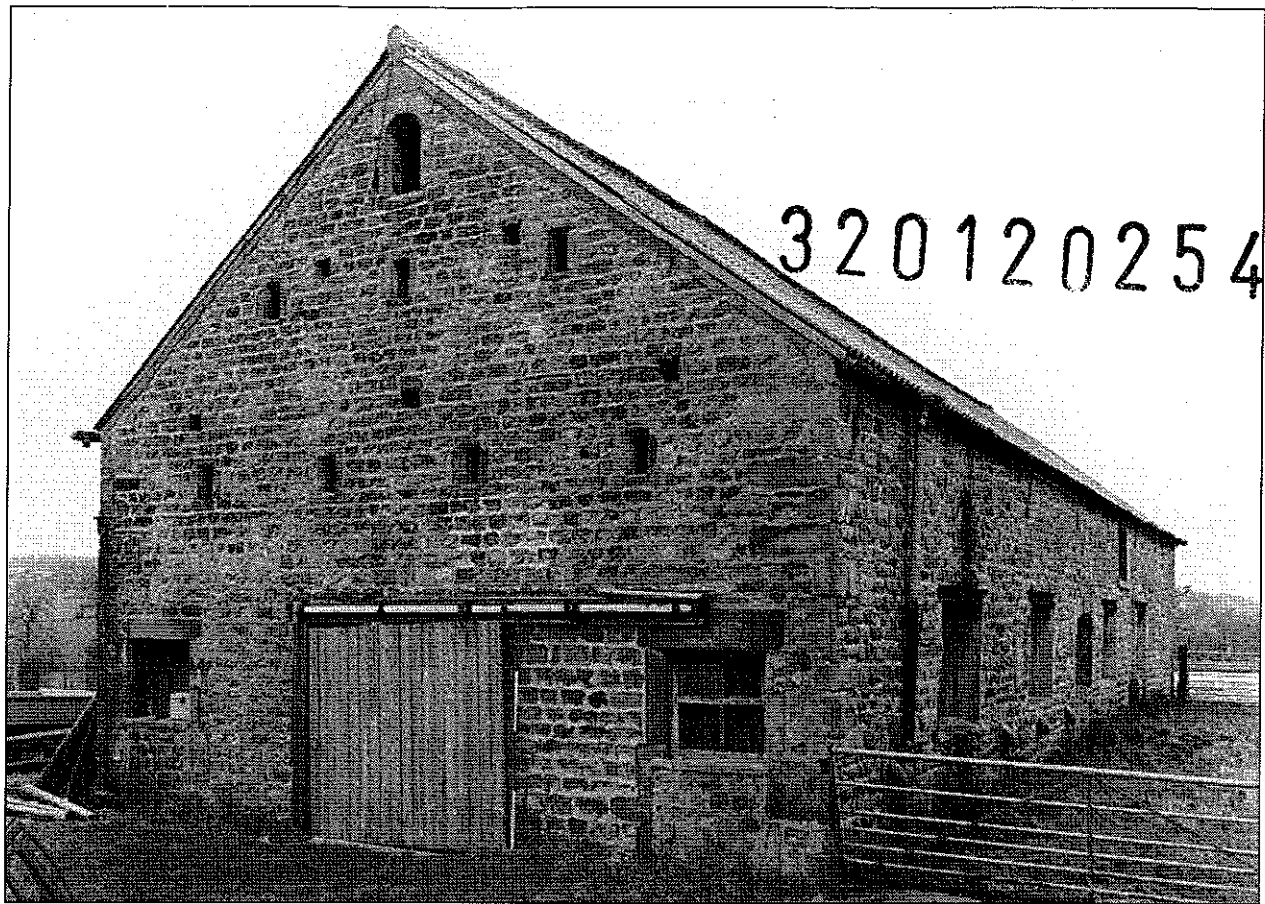
Photo 12: View of the barn, from the south-east

- 6.6 The south gable is the building's finest and least altered elevation, although the present openings at ground floor level are not in their original forms (12,13). At each end is a doorway with chamfered and stopped jambs, now reduced to a window (14,15). It is notable that the quoins run through to form some of the jamb stones, but that the lintels are not chamfered, and the left-hand lintel has a distinct tooled finish which suggests it has been replaced. This pair of doorways is a characteristic arrangement in barns such as these, and typically served as entrances to rows of cattle stalls aligned along the building's long axis, facing onto a central feeding passage, sometimes but not always provided with its own entrance in the centre of the gable. However, the central doorway at this barn is a wide 20th century opening, so whether it had a predecessor cannot now be determined.

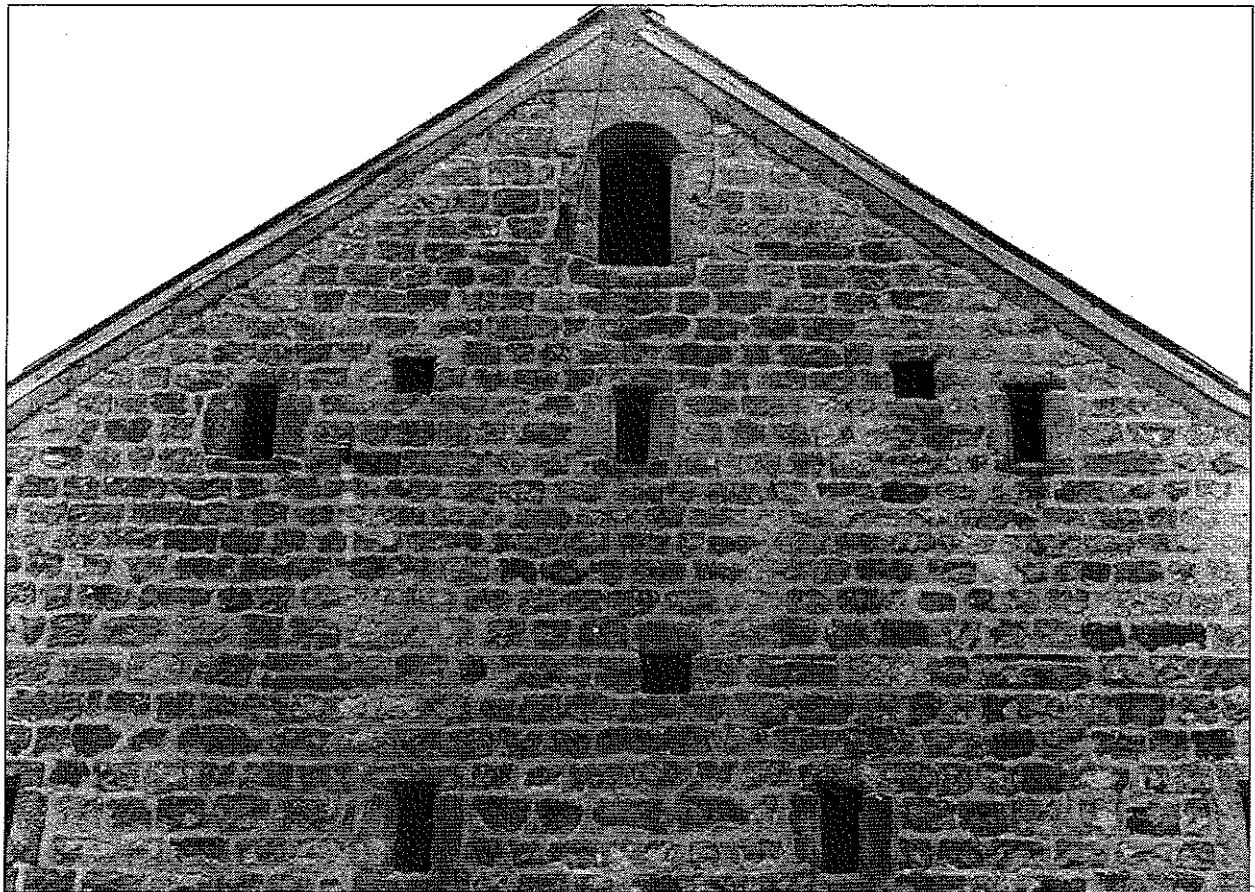
Photo 16: Detail of breathers (type A), putlog holes and owl hole in south gable

- 6.7 Above these ground floor openings are two rows of type A breathers, interspersed with plain putlog holes (for scaffolding) which also pass through the wall thickness and no doubt could have provided adequate ventilation, so the breathers are decorative rather than purely functional. The tall owl hole at the ridge has a chamfer to its surround of the same form as the breathers (16).

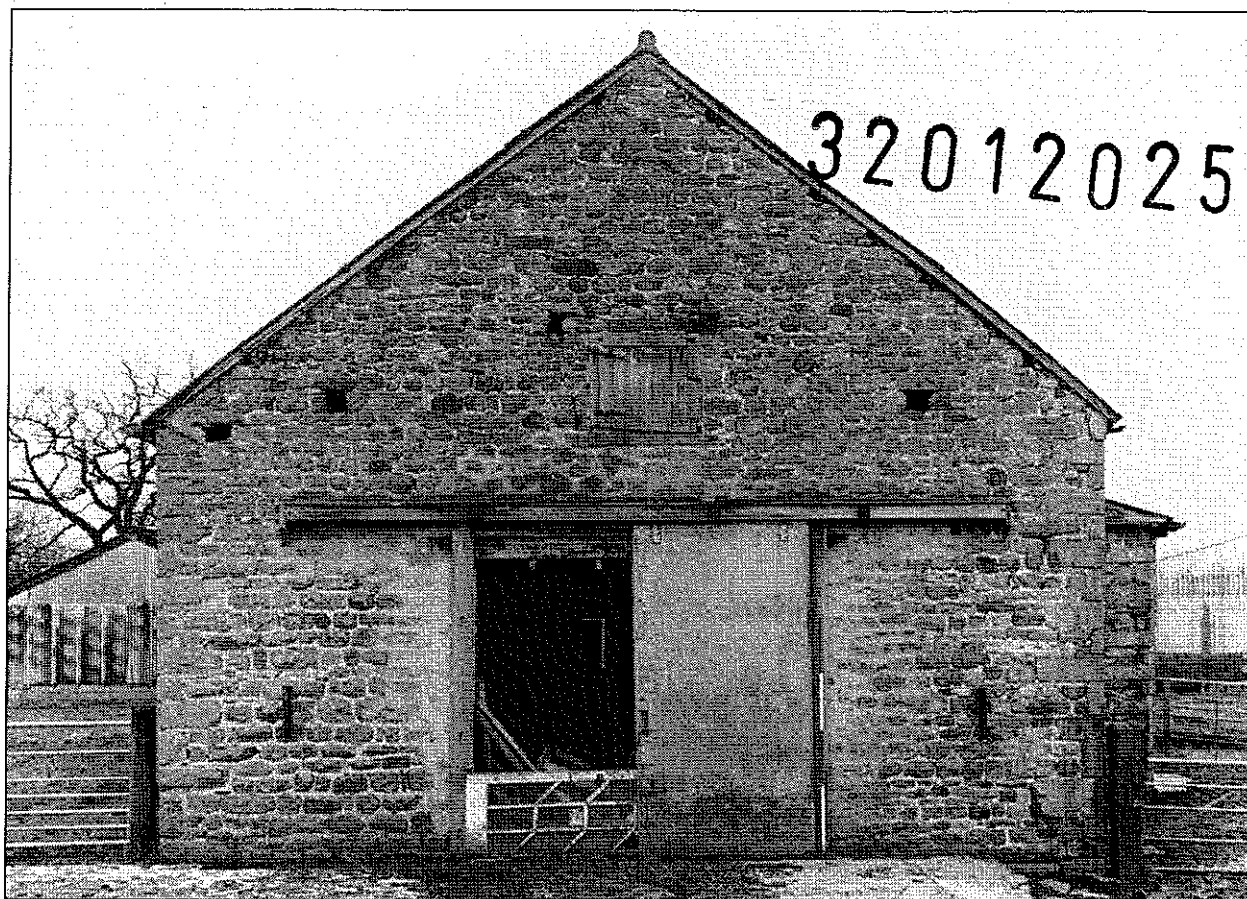
Photo 17: North gable

- 6.8 In contrast, the north gable lacks any decoration, with the few putlog holes seeming to be the only original openings. Comparison with other barns in the area suggests that the present wide, ground floor doorway is entirely modern, but the plain forking hole above it is thought to be 19th century rather than original (17), on the basis of its appearance from the interior.

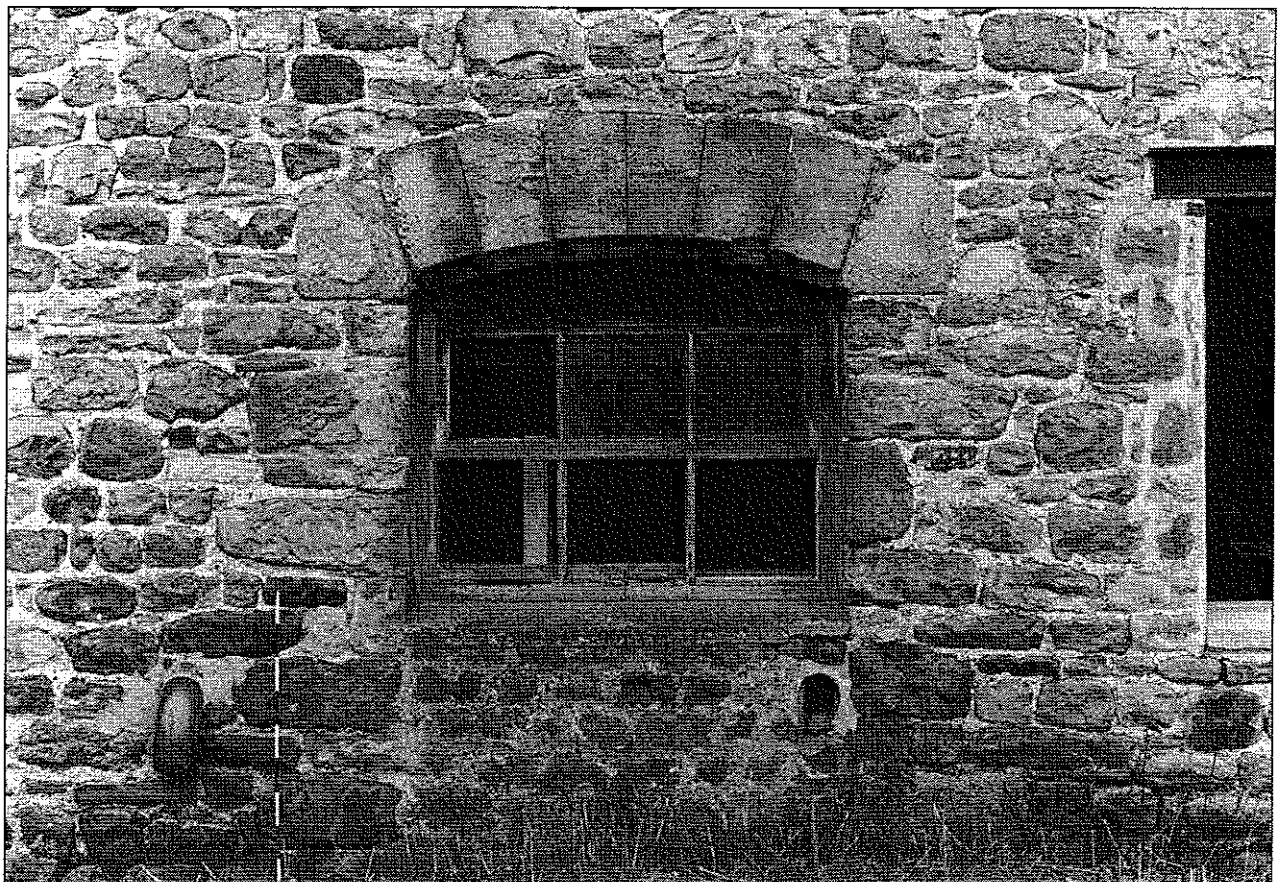
Photo 20: Former threshing doorway in east elevation

- 6.9 Four large, mid 20th century window openings have drastically altered the rear, east elevation, and the forking hole here also has concrete and brick around it, so is probably of the same period, but a number of earlier features do survive in altered form (18,19). The most obvious is the former threshing doorway with chamfered segmental stone arch (20), positioned approximately, but not exactly,

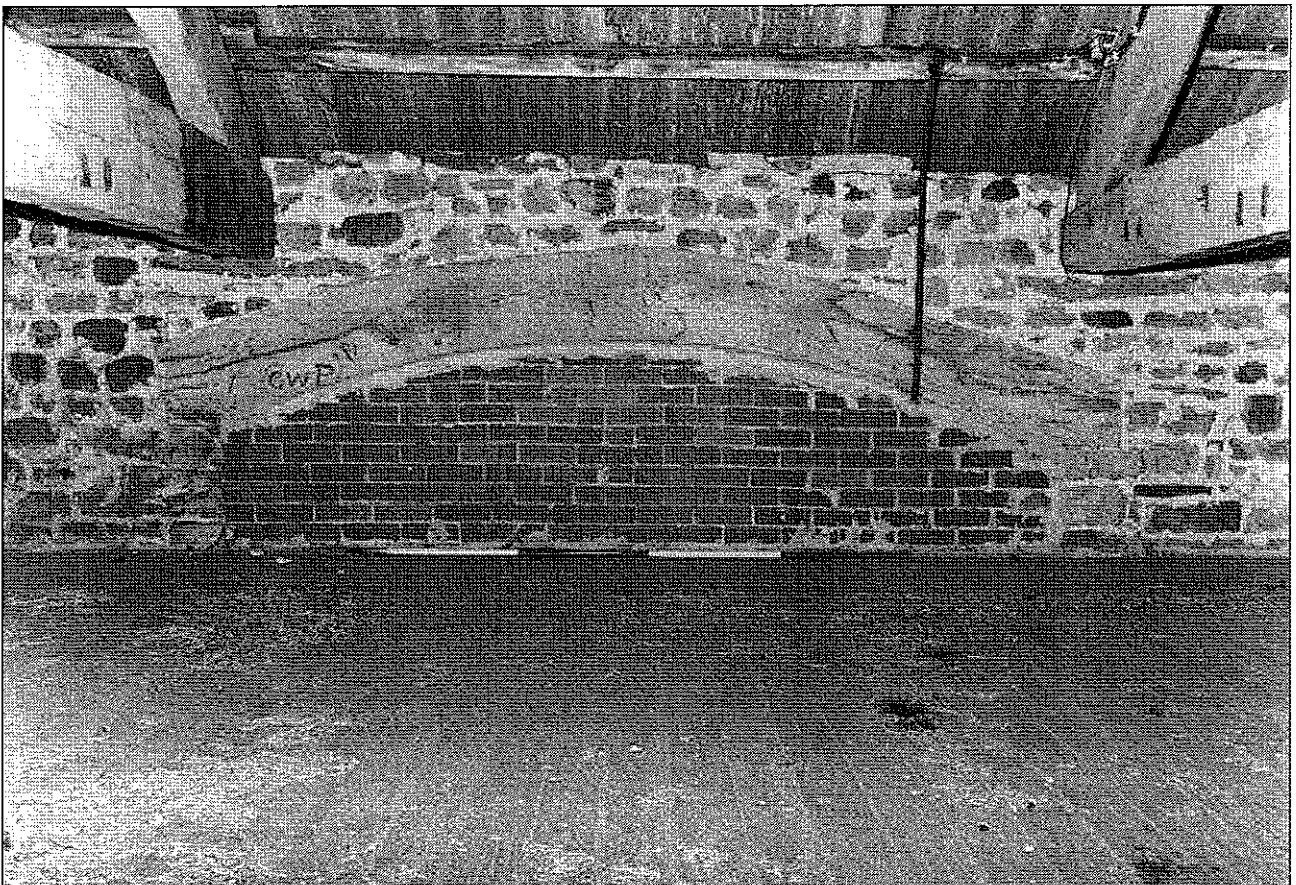
Photo 29: Internal, timber lintel of arched cart entrance in west elevation

- 6.11 The present loft is continuous throughout the other six bays, cutting across the infilled central cart entrance in the west elevation with its bowed oak lintel, painted with the initials "CWP", not identified but most likely a Parkinson (28-30). Previously, it is likely that there was a loft to the south of this doorway, and perhaps to the north, but the alterations to the ground floor mean that there is no clear evidence of their former extents.

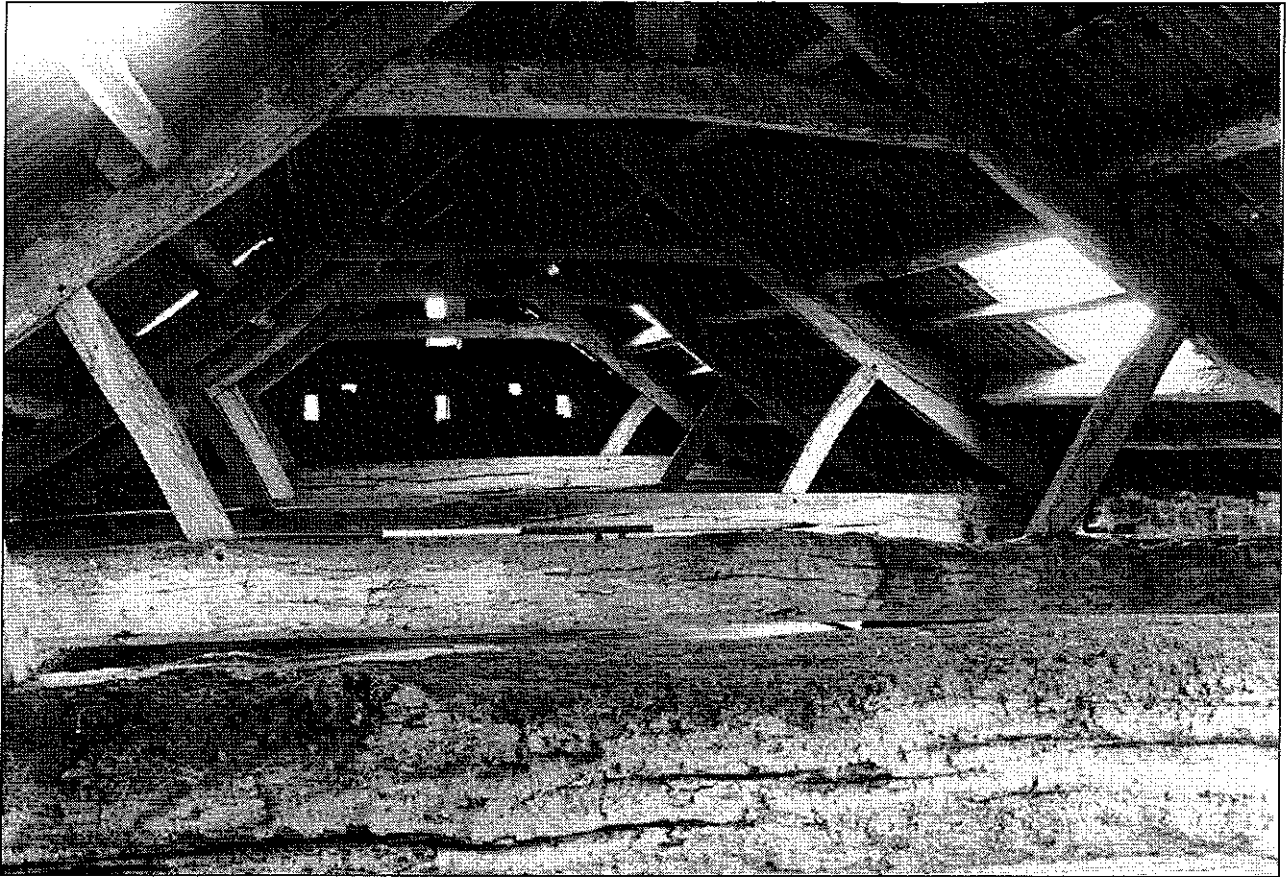
Photo 32: Roof trusses, from the north-east

- 6.12 The roof trusses are a very significant part of the building, all six being of the same design, remaining unaltered and in relatively good repair (31,32). They are constructed from oak, with the tie beams of heavy scantling in most cases, each formed from a single trunk. They carry principal rafters supported by raking "V" struts (some slightly curved), and each has a collar with king post, supporting the diamond-set ridge (33-38). All joints are pegged, and a few have assembly numbers in the form of notches, either I or II (39), all on the south faces: these appear to have been used to distinguish the right and left hand components of the trusses, and there is no sequential truss numbering as is often found in roofs such as this. There are three pairs of side purlins laid in trenches cut into the principal rafters (as well as later softwood ones associated with the asbestos roof), and these are only one bay long, laid in an overlapping series, from the
