320120255P

Application for Planning Permission and listed building consent for alterations,
extension or demolition of a listed building.

Conversion of barn into 1 dwelling

House: Suffix:
House name: CHADWICKS FARM
Street address: SETTLE ROAD
BOLTON BY BOWLAND
Town/City: CLITHEROE
County:
Postcode: BB7 4NT

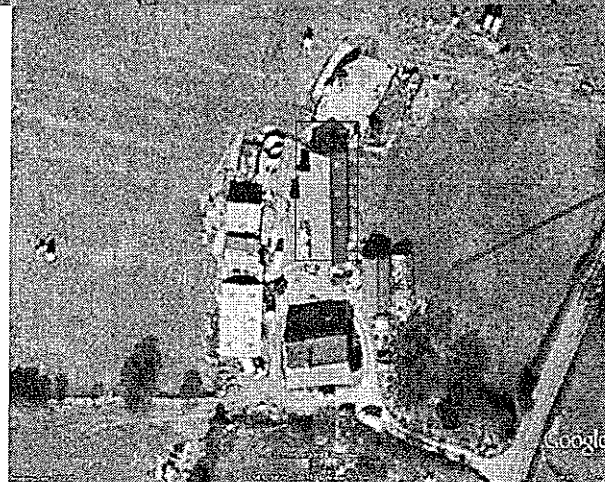
Figure 2

The trees to immediately adjacent to the site to the Southeast and the area of long grass to the east are judged to be the primary foraging areas for bats around the site.

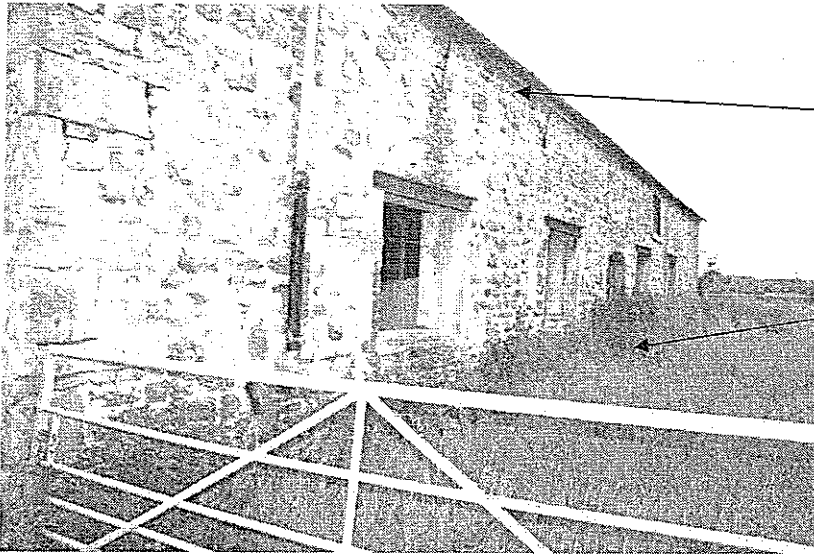
East elevation

Facia boards along the eaves offer some roosting potential, easy to inspect.

Area of long grass offering foraging potential.

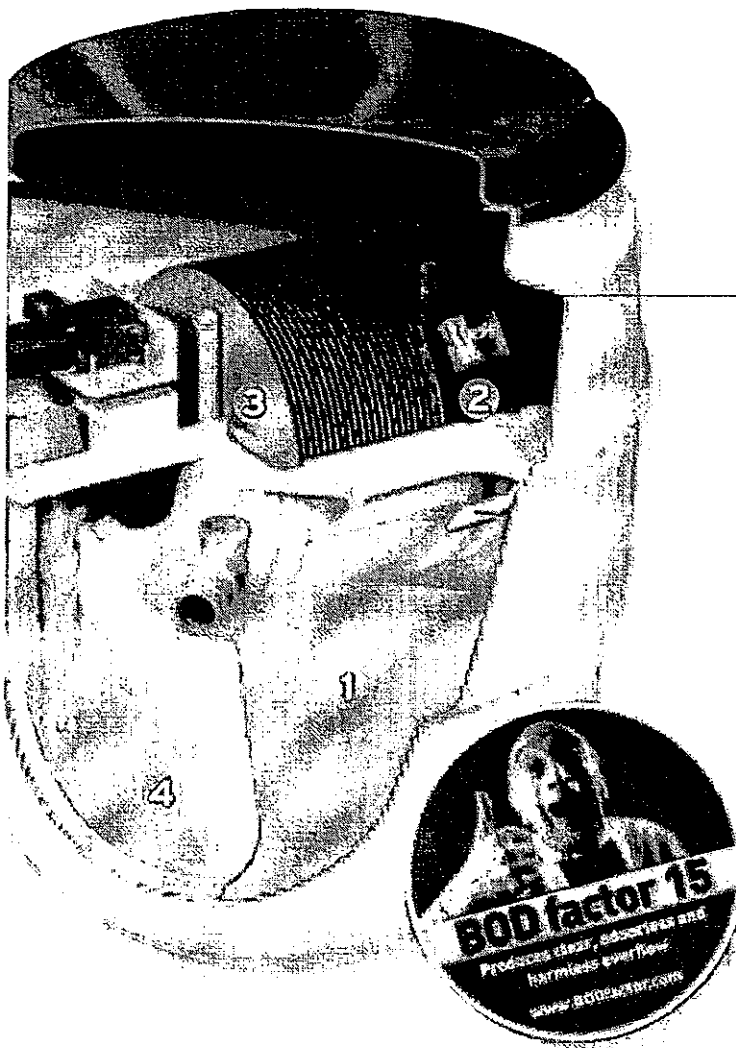
How the Klargestar BioDisc® Works

Central to the operation of each Klargestar BioDisc® is the Rotating Biological Contactor (RBC), which supports a biologically active film or biomass on to which aerobic micro-organisms, naturally found in sewage, become established. Natural breakdown of sewage can then occur as described below.

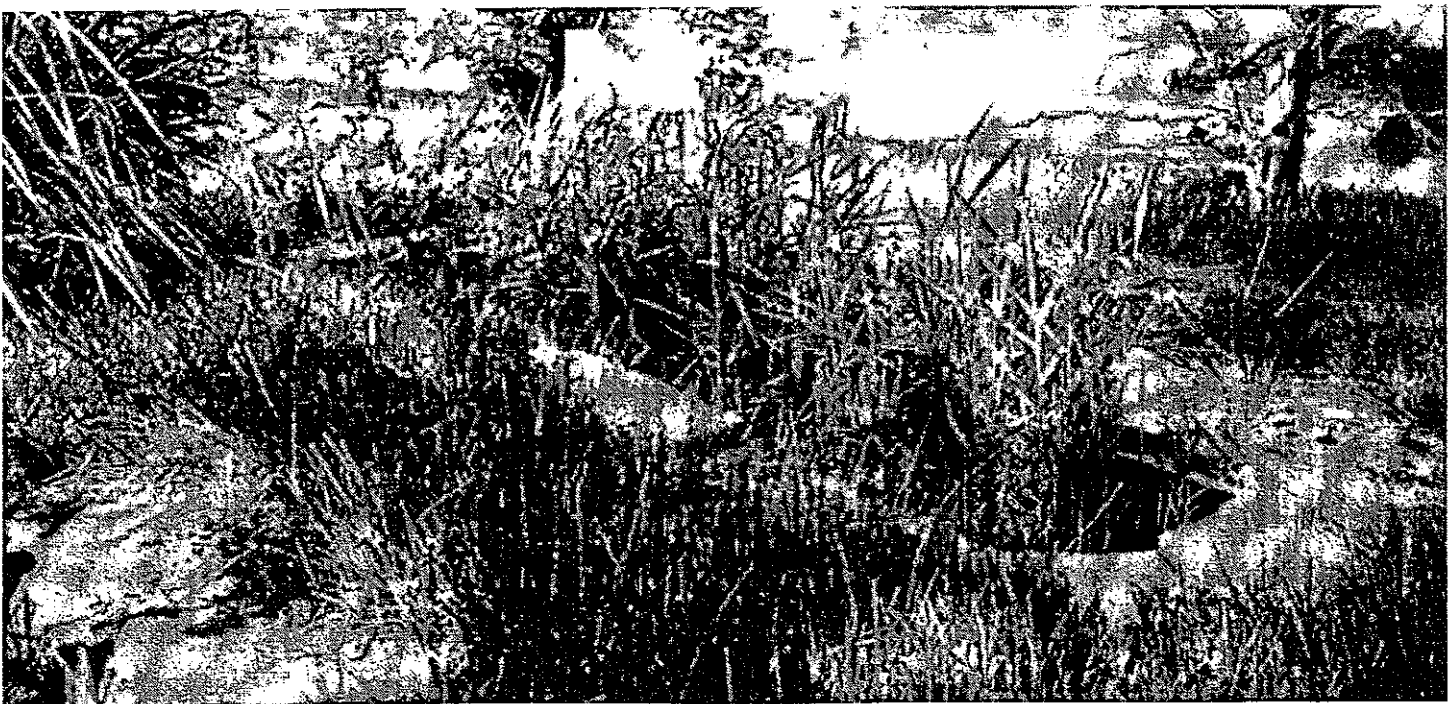
Design

- Advanced Patented design delivers superior performance
- Pre-fabricated to ensure correct sizing
- Modules designed with a hydraulic gradient across the length of the units
- Performance tested in Germany to EN12566-3 in combination with a Part 3 plant
- Adjustable outlet weir allows water level control
- Modular system comprising of:
 - 2 individual reed beds = Single house application**
 - 4 individual reed beds = Two house application**
- One piece GRP moulding installed flush to the ground
- Reeds and GRP beds supplied. Washed pea gravel, 'growing' media by others (not included)
- Effluent discharge is typically improved by at least 50%, providing reduced BOD and suspended solids
- Provides rooting zone depth of 600mm (required by Phragmites Australis)

Specification

Reed Bed	HRB006	HRB012
Population Equivalent	6	12*
Length (mm)	2500	2500
Width (mm)	800	800
Depth (mm)	800	800
No. Required	2	4
Outlet Size (mm)	110	110
