**ERECTION OF SPORTS HALL FACILITY AND  
RE - ARRANGEMENT OF TENNIS COURTS AT  
CLITHEROE ROYAL GRAMMAR SCHOOL**

**PLANNING, DESIGN AND ACCESS STATEMENT**

**Clitheroe Royal Grammar School**

**March 2012**

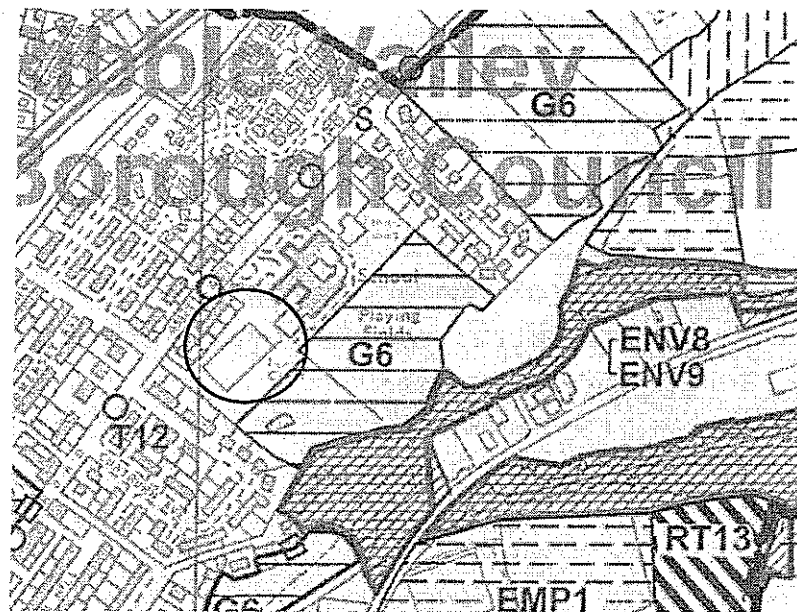
Extract from Ribble Valley Local Plan Proposals Map (Application site marked in red)

3.2.1 An extract from the Ribble Valley Districtwide Local Plan Proposals map is included below. The site lies within the development boundary of Clitheroe. However, there are no specific designations applicable to it. The schools open plays fields to the east are covered by Policy G6. However the application site does not intrude into this area.

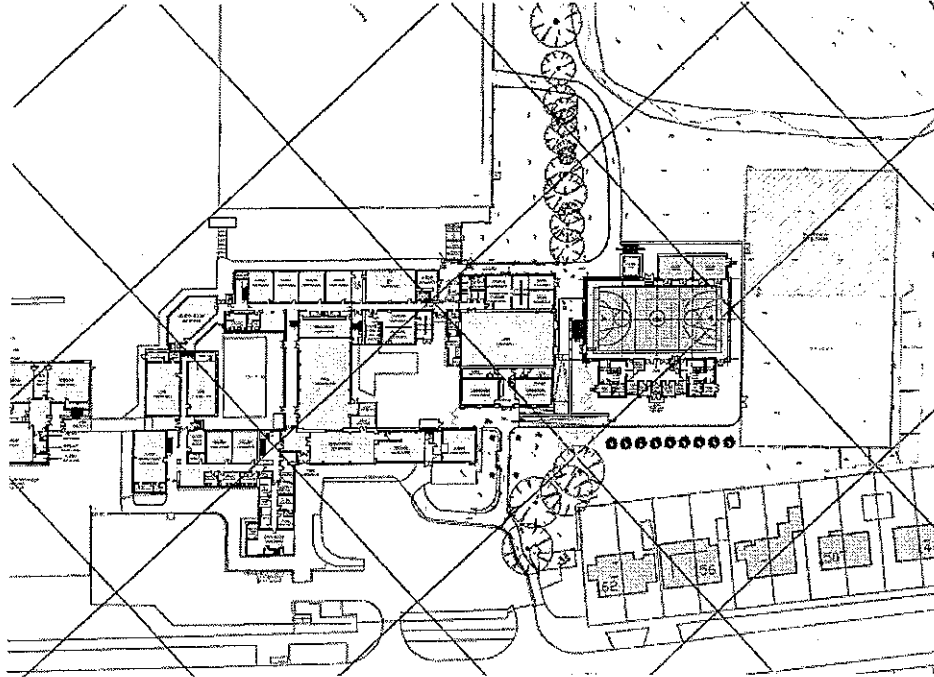
**Proposed site layout**

5.3.2 The sports hall has been set out on a general north east to south west axis, with the main double height gymnasium space occupying the majority of the floorspace. To the front elevation a foyer, small office and changing areas are located. Two storage rooms are located to the rear of the building.

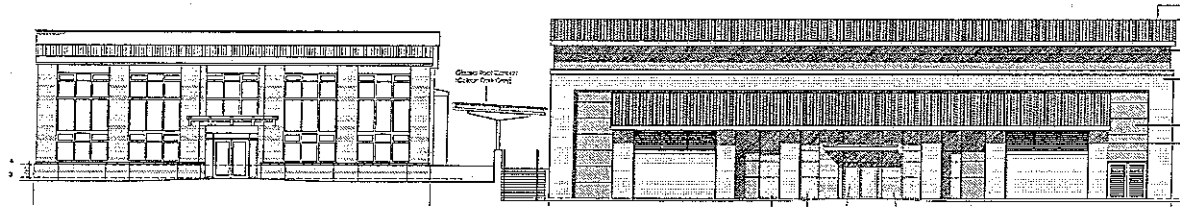
**Proposed North West Elevation (existing building to right)**

- 5.4.5 The scale of the development has been determined by the uses required to be accommodated within the scheme, together with the size of the plot and the nature of the surrounding built development.
- 5.4.6 The sports hall will rise to a maximum of 12.53 metres in height and is designed with a double height space to enable it to be utilised for a wide range of indoor sporting activities. The height of the building is somewhat offset by the fact that (due to the topography of the land) it shall sit lower than those existing school buildings to the north. Therefore (and as shown in the proposed North West elevation of drawing no. 7999 L116) the building will only appear marginally taller than that adjacent.

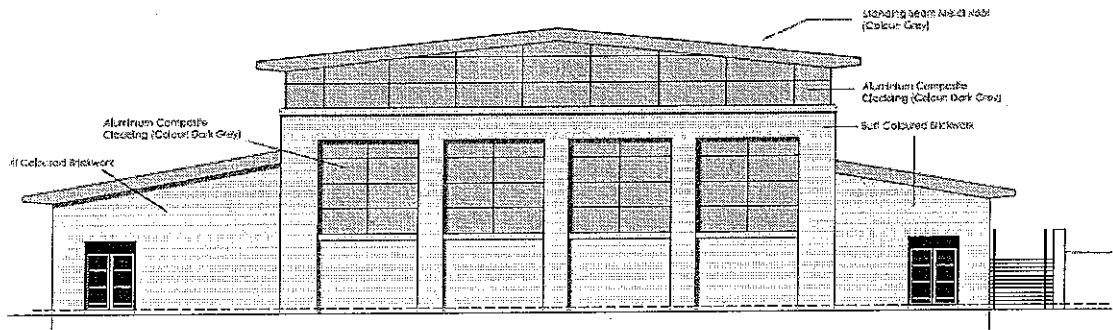
**Proposed South West Elevation**

- 5.6.1 The design of the sports hall incorporates a range of materials and finishes which allow it to sit comfortably in this location. A mix of buff coloured brickwork, aluminum cladding and glazing form the majority of external wall space. This compliments both the existing school buildings whilst providing a modern building which is fit for use.
- 5.6.2 The principle elevation of the sports hall will face North West towards Chatburn Road and will sit alongside the existing languages building to the north. The entrance incorporates some glazing in order to maximise natural light levels.
- 5.6.3 Two small single storey stores / equipment rooms form part of the rear of the building and are shown in the south east elevation.
- 5.6.4 Access between the purposed building and the existing school site made possible though a combination of steps, ramps and a covered canopy area.

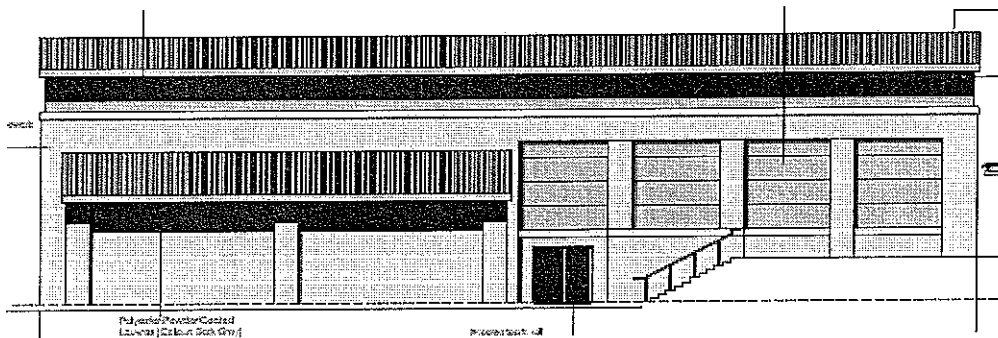
**Proposed South East Elevation**

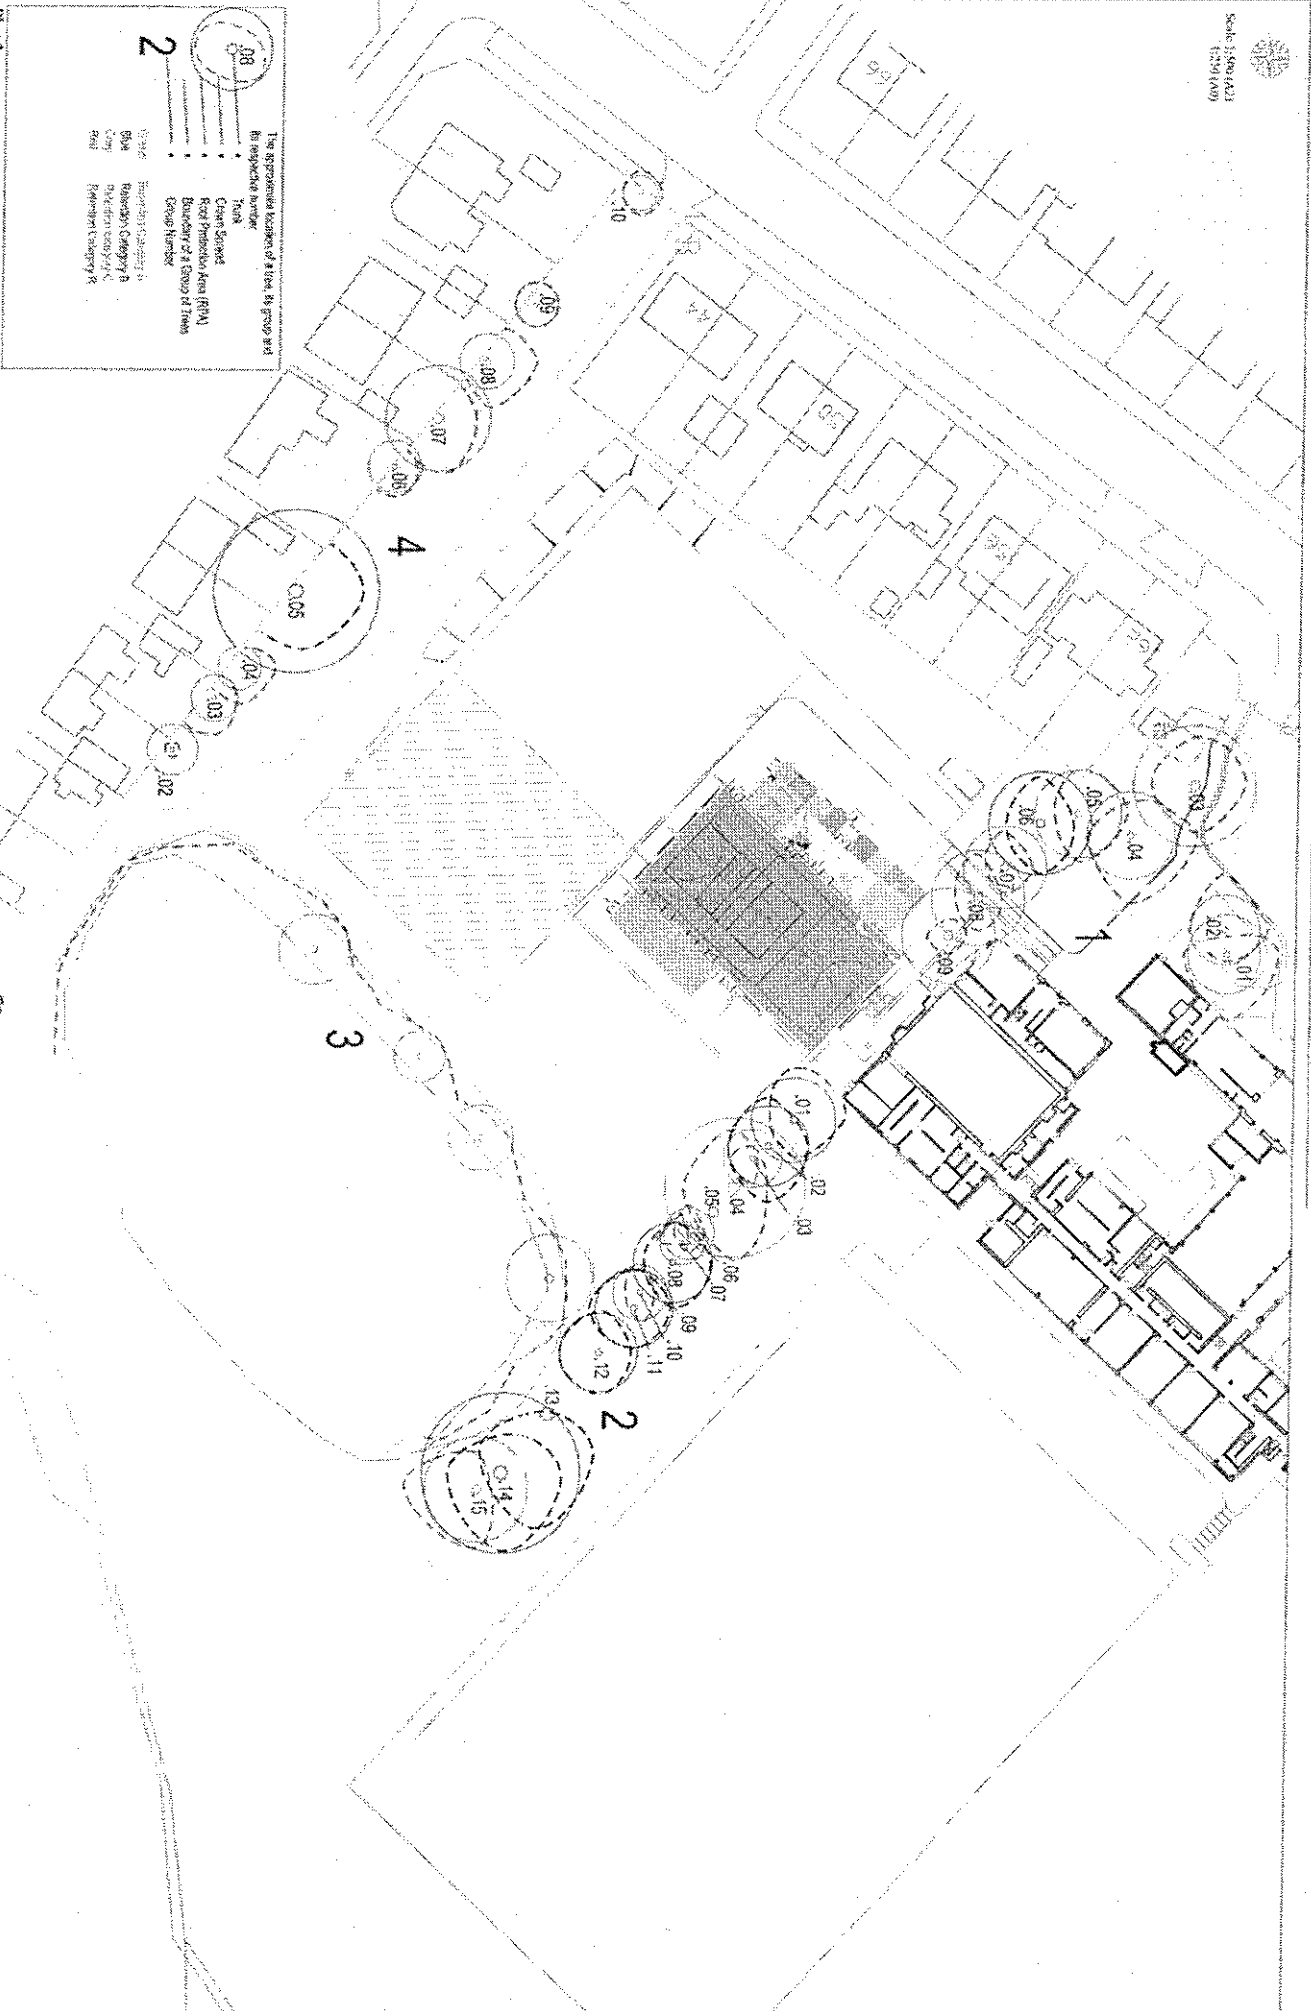
Plan 2  
 Tree constraints plan of the  
 proposed site layout

The species, size and condition of the trees, and my tree management recommendations, are listed in the schedule included as Appendix 6. Plan 1 shows the existing site layout, the locations of the trees, their canopies and root protection areas (RPAs) calculated using the guidance contained in the British Standard: *Trees in relation to construction – Recommendations* (BS 5837, 2005). Plan 2 shows the footprint of the proposed Sports Hall as well as the tree information.
