**Householder Application for Planning Permission for works or extension to a dwelling.  
Town and Country Planning Act 1990**

AMENDED ROOF DESIGN TO REAR OF EXISTING APPROVAL OF GARAGE & SUN LOUNGE TO THE REAR OF THE DWELLING.

Protected Species survey: 'Glenbrook' Talbot Street, Chipping.

# PROTECTED SPECIES (BATS) SURVEY

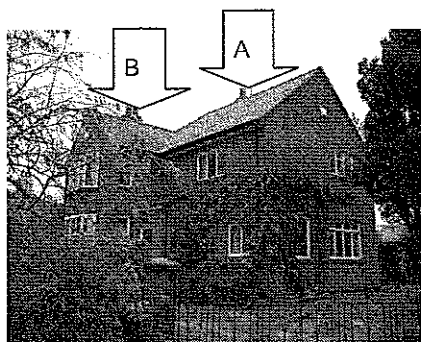
Fig 1.

The property is a detached two storey house with brick cavity wall construction and pitched timber-framed roofs with enclosed voids. The house also has a single storey brick-built garage with flat roof (figures 1/2).
