## **HERITAGE STATEMENT**

**IN SUPPORT OF A PLANNING APPLICATION TO  
CONVERT A BARN TO A DWELLING**

**WITTONS FARM,  
BOLTON BY BOWLAND,  
CLITHEROE,  
LANCS, BB7 4NZ**

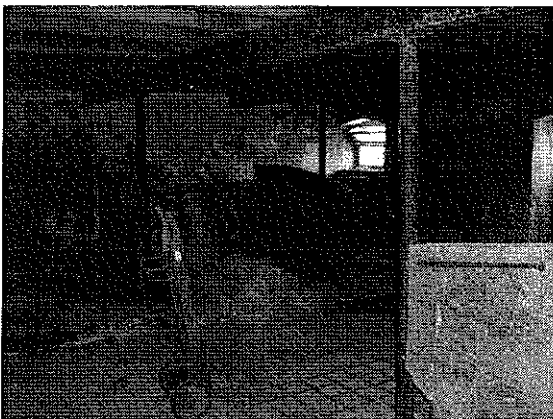
The main part of the barn is two storeys high and rectangular in plan, but the floor level is split. The upper section is the full height of the building. The lower section on the east side appears to have originally been a shippon with two entrance doors (now made into windows) in the east gable. This arrangement has been altered at a later date with a new entrance for cattle through a sliding door in the centre of the gable giving access to stalls with concrete partitions. The hay loft above is carried on metal columns and beams.

Shippon with hay loft on metal columns

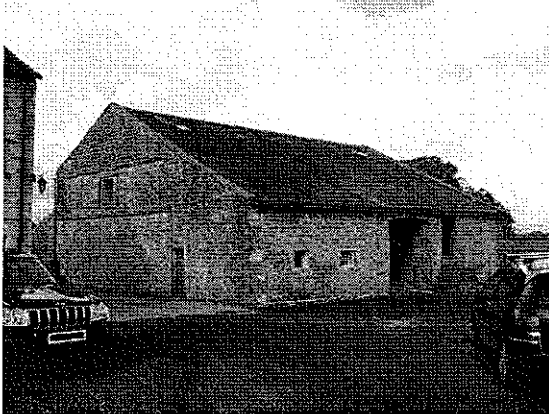
The existing plans section and elevation drawing 1822.E.002, show the large wagon entrance on the south side of the barn with the archway with the date stone on the outer

South elevation with wagon entrance

The retention and reuse of all the existing openings in the barn, including the wagon entrance, has been the guiding factor in the design of the conversion of the barn using these openings for windows and doors where possible and keeping the introduction of new window openings to a minimum. In additional alterations by the inclusion of new openings has been restricted to the least sensitive elevations of the building. We have identified the southern elevation with the wagon entrance as being the most significant and we have avoided alterations to this elevation.
