Application for listed building consent for alterations,  
extension or demolition of a listed building.  
Planning (Listed Buildings and Conservation Areas) Act 1990

Alterations to a Grade II Listed Building Internally and to rear elevation

*Design & Access Heritage Statement to support a Listed Building Application  
To carry out internal and external alterations to a Grade II Listed Building  
No 2. Abbeycroft. The Sands. Whalley. BB7 9TN.  
Whalley BB7 9JD*

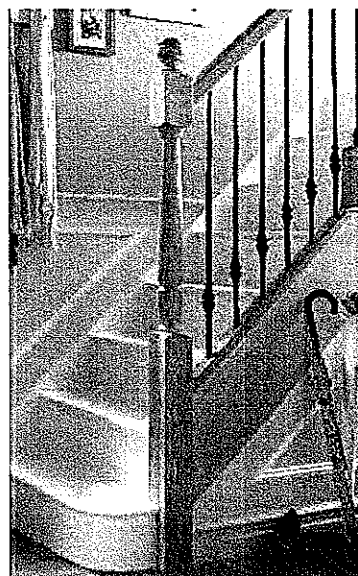
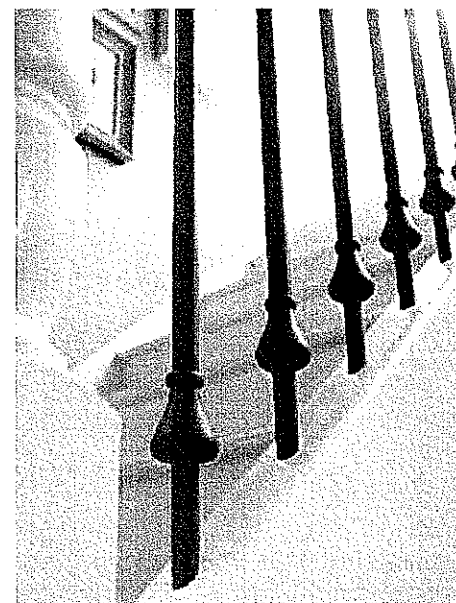
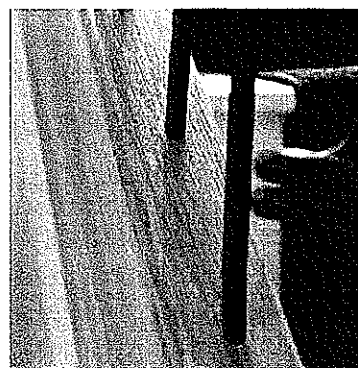
Top: NEW – Elements hybrid double baluster. Elements hand and baserail with Classic newel all White Oak

Bottom: NEW – Elements spiral baluster with Elements baserail in White Oak
