Application for Planning Permission.  
Town and Country Planning Act 1990

Bank Protection / Stabilisation Works consisting of Rock Armor Wall, Rip Rap and Regraded Bank and improved temporary construction access junction.

**HOLDEN BANK WTW RIVER BANK REPAIRS**

**PROPOSED REPAIRS SITE PLAN & DETAILS**

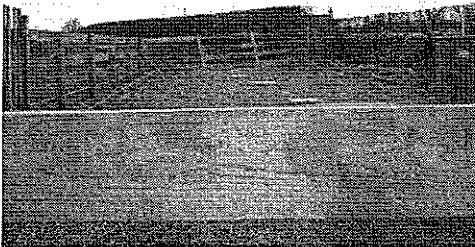
| Target Note | Description | Photograph |
|---|---|---|
| 1 | The existing underground treatment works is situated within a section of intensively grazed pasture approximately 5m from the top of the east bank of Holden Beck. The treatment works is fenced with timber rail and post fencing with a gravel compound and two metal kiosks. | |

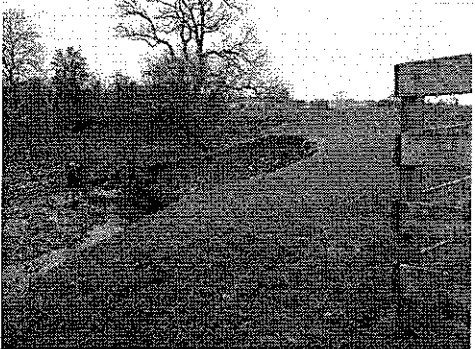
| Target Note | Description | Photograph |
|---|---|---|
| 2 | The proposed works location and the surrounding land consists of intensively grazed generally species poor pasture. The dominant species present include; creeping buttercup ( <i>Ranunculus repens</i> ), abundant perennial rye grass ( <i>Lolium perenne</i> ), cock's foot ( <i>Dactylis glomerata</i> ), dandelion ( <i>Taraxacum officinale</i> agg) and the moss <i>Brachythecium rutabulum</i> . | |

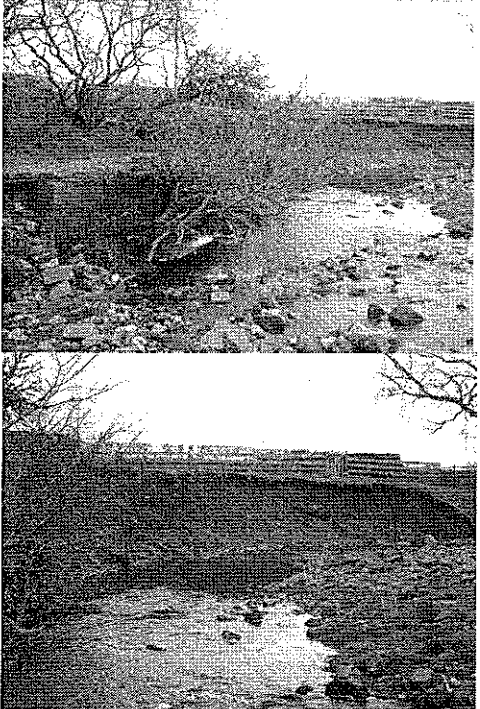
| Target Note | Description | Photograph |
|---|---|---|
| 3 | Holden Beck flows from north to south through the proposed working area. Significant slippage/erosion of a section of the eastern bank of the watercourse has occurred in recent years, comprising the adjacent WWTW building. This section of the bank will be subject to proposed bank reinforcement. The section of the watercourse within the proposed working area consists of heavily eroded banks with exposed shingle berms, with embankments set back from the watercourse itself. The watercourse was observed to be fast flowing at the time of survey with a substrate consisting of shingle with occasional boulders. The depth/width of the beck is variable in nature, although was noted to be approximately 3-4m width and 1m depth in the proposed working area.<br><br>A water vole and otter survey was undertaken of the watercourse approximately 50m either side of the | |

| | proposed works location by Bowland Ecology at the time of the Phase 1 Survey. No evidence of water vole or otter was found at the time of survey. | 320120524P |

- 3.8 Holden Beck flows from north to south through the proposed works location at Target note 3. The watercourse was observed to be fast flowing at the time of survey with a shingle substrate with occasional boulders. The banks of the watercourse have been heavily eroded over time leaving areas of exposed shingle bed with the existing embankments set back from the edge of the watercourse. Areas of marsh vegetation have colonised damp depressions within these shingle beds where the water level appears to fluctuate at times. The section of bank subject to the proposed works has been subject to significant erosion/bank slippage in recent years. The approximate depth of the beck is variable in nature, but was noted to be approximately 3-4m in width and 1m depth adjacent to the proposed works location.

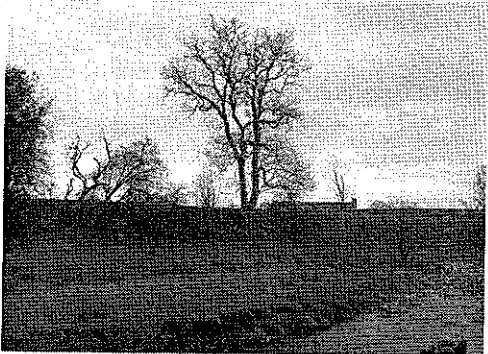
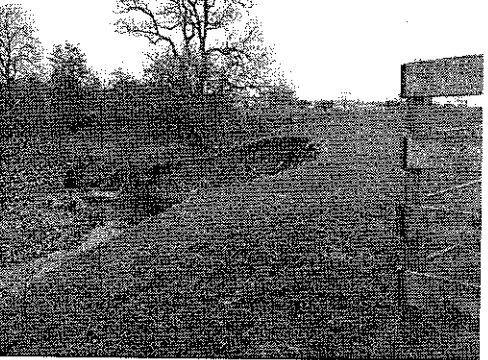
| 5 | <p>A row of mature trees and scattered scrub along the top of a raised embankment with areas of exposed rock, adjacent to the eastern margin of Holden Beck. The embankment itself was noted to have acidic tendencies represented by the floristic composition, which included; foxglove (<i>Digitalis purpurea</i>), mouse-ear hawkweed (<i>Hieracium pilosella</i>), lesser celandine (<i>Ranunculus ficaria</i>), brooklime (<i>Veronica beccabunga</i>), willowherb species (<i>Epilobium</i> species), <i>Geranium</i> species, perennial rye grass, Yorkshire fog (<i>Holcus lanatus</i>) and the moss <i>Brachythecium rutabulum</i>. The tree/scrub species include; ash, hawthorn, elder and holly (<i>Ilex aquifolium</i>). Two mature ash trees are present within close proximity of the proposed working area and were observed to have features such as cavities and splits in branches which could potentially be used by roosting bats. The trees/scrub also provide suitable habitat for a range of tree/shrub nesting birds.</p> | |

- 3.18 Two mature ash trees upon the eastern embankment of the watercourse within close proximity of the proposed works location at Target note 5. The individual trees were observed to have features such as cavities and splits in branches providing suitable roosting habitat for bats. The watercourse and hedgerow habitats are considered to provide suitable foraging habitat for a range of bat species.
- 3.19 Ouzel Hall Bridge situated approximately 30m to the south of the proposed works location was inspected for its potential to provide suitable habitat for roosting bats. The underneath and sides of the bridge were observed thoroughly and were noted to be in good condition and well pointed with few opportunities for roosting bats. A single, shallow crevice on the north side of the bridge was observed to be present. No evidence of bats was found at the time of survey.

- 4.7 Two mature ash trees adjacent to the proposed works location were observed to have cavities and splits in branches providing suitable roosting opportunities for bats. No tree pruning/removal is considered necessary in order to facilitate the works. However, if this is not the case a bat tree inspection of the aforementioned trees will be required by a suitably experienced ecologist prior to any works commencing on site. If evidence of bats is identified; dusk emergence or dawn re-entry surveys or a climb and inspect survey may be required. If bats are found to be roosting within any of the trees a licence from Natural England may be required in order to proceed with the required works.

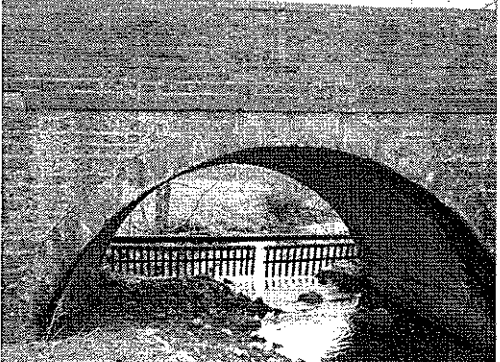
| 8 | <p>Ouzel Hall Bridge is located to the south of the proposed works location. The bridge was considered to be well pointed with a single crevice identified on the north side of the bridge. No evidence of bats was identified at the time of survey. The bridge will not be directly impacted by the proposed works.</p> | |

- 3.13 Ouzel Hall Bridge is situated over Holden Beck approximately 30m to the south of the proposed works location at Target note 8. The bridge was observed to be in good condition and well pointed.

- 4.8 Ouzel Hall Bridge situated within close proximity of the works was considered to provide low risk potential habitat for bats. The inspection of the bridge revealed only a single, small, shallow crevice on the north facing side of the bridge. The remainder of the bridge was observed to be in good condition, well pointed with no obvious gaps/crevices where bats could roost. No evidence of bats was found at the time of survey. The bridge will not be directly impacted as a result of the proposed works.

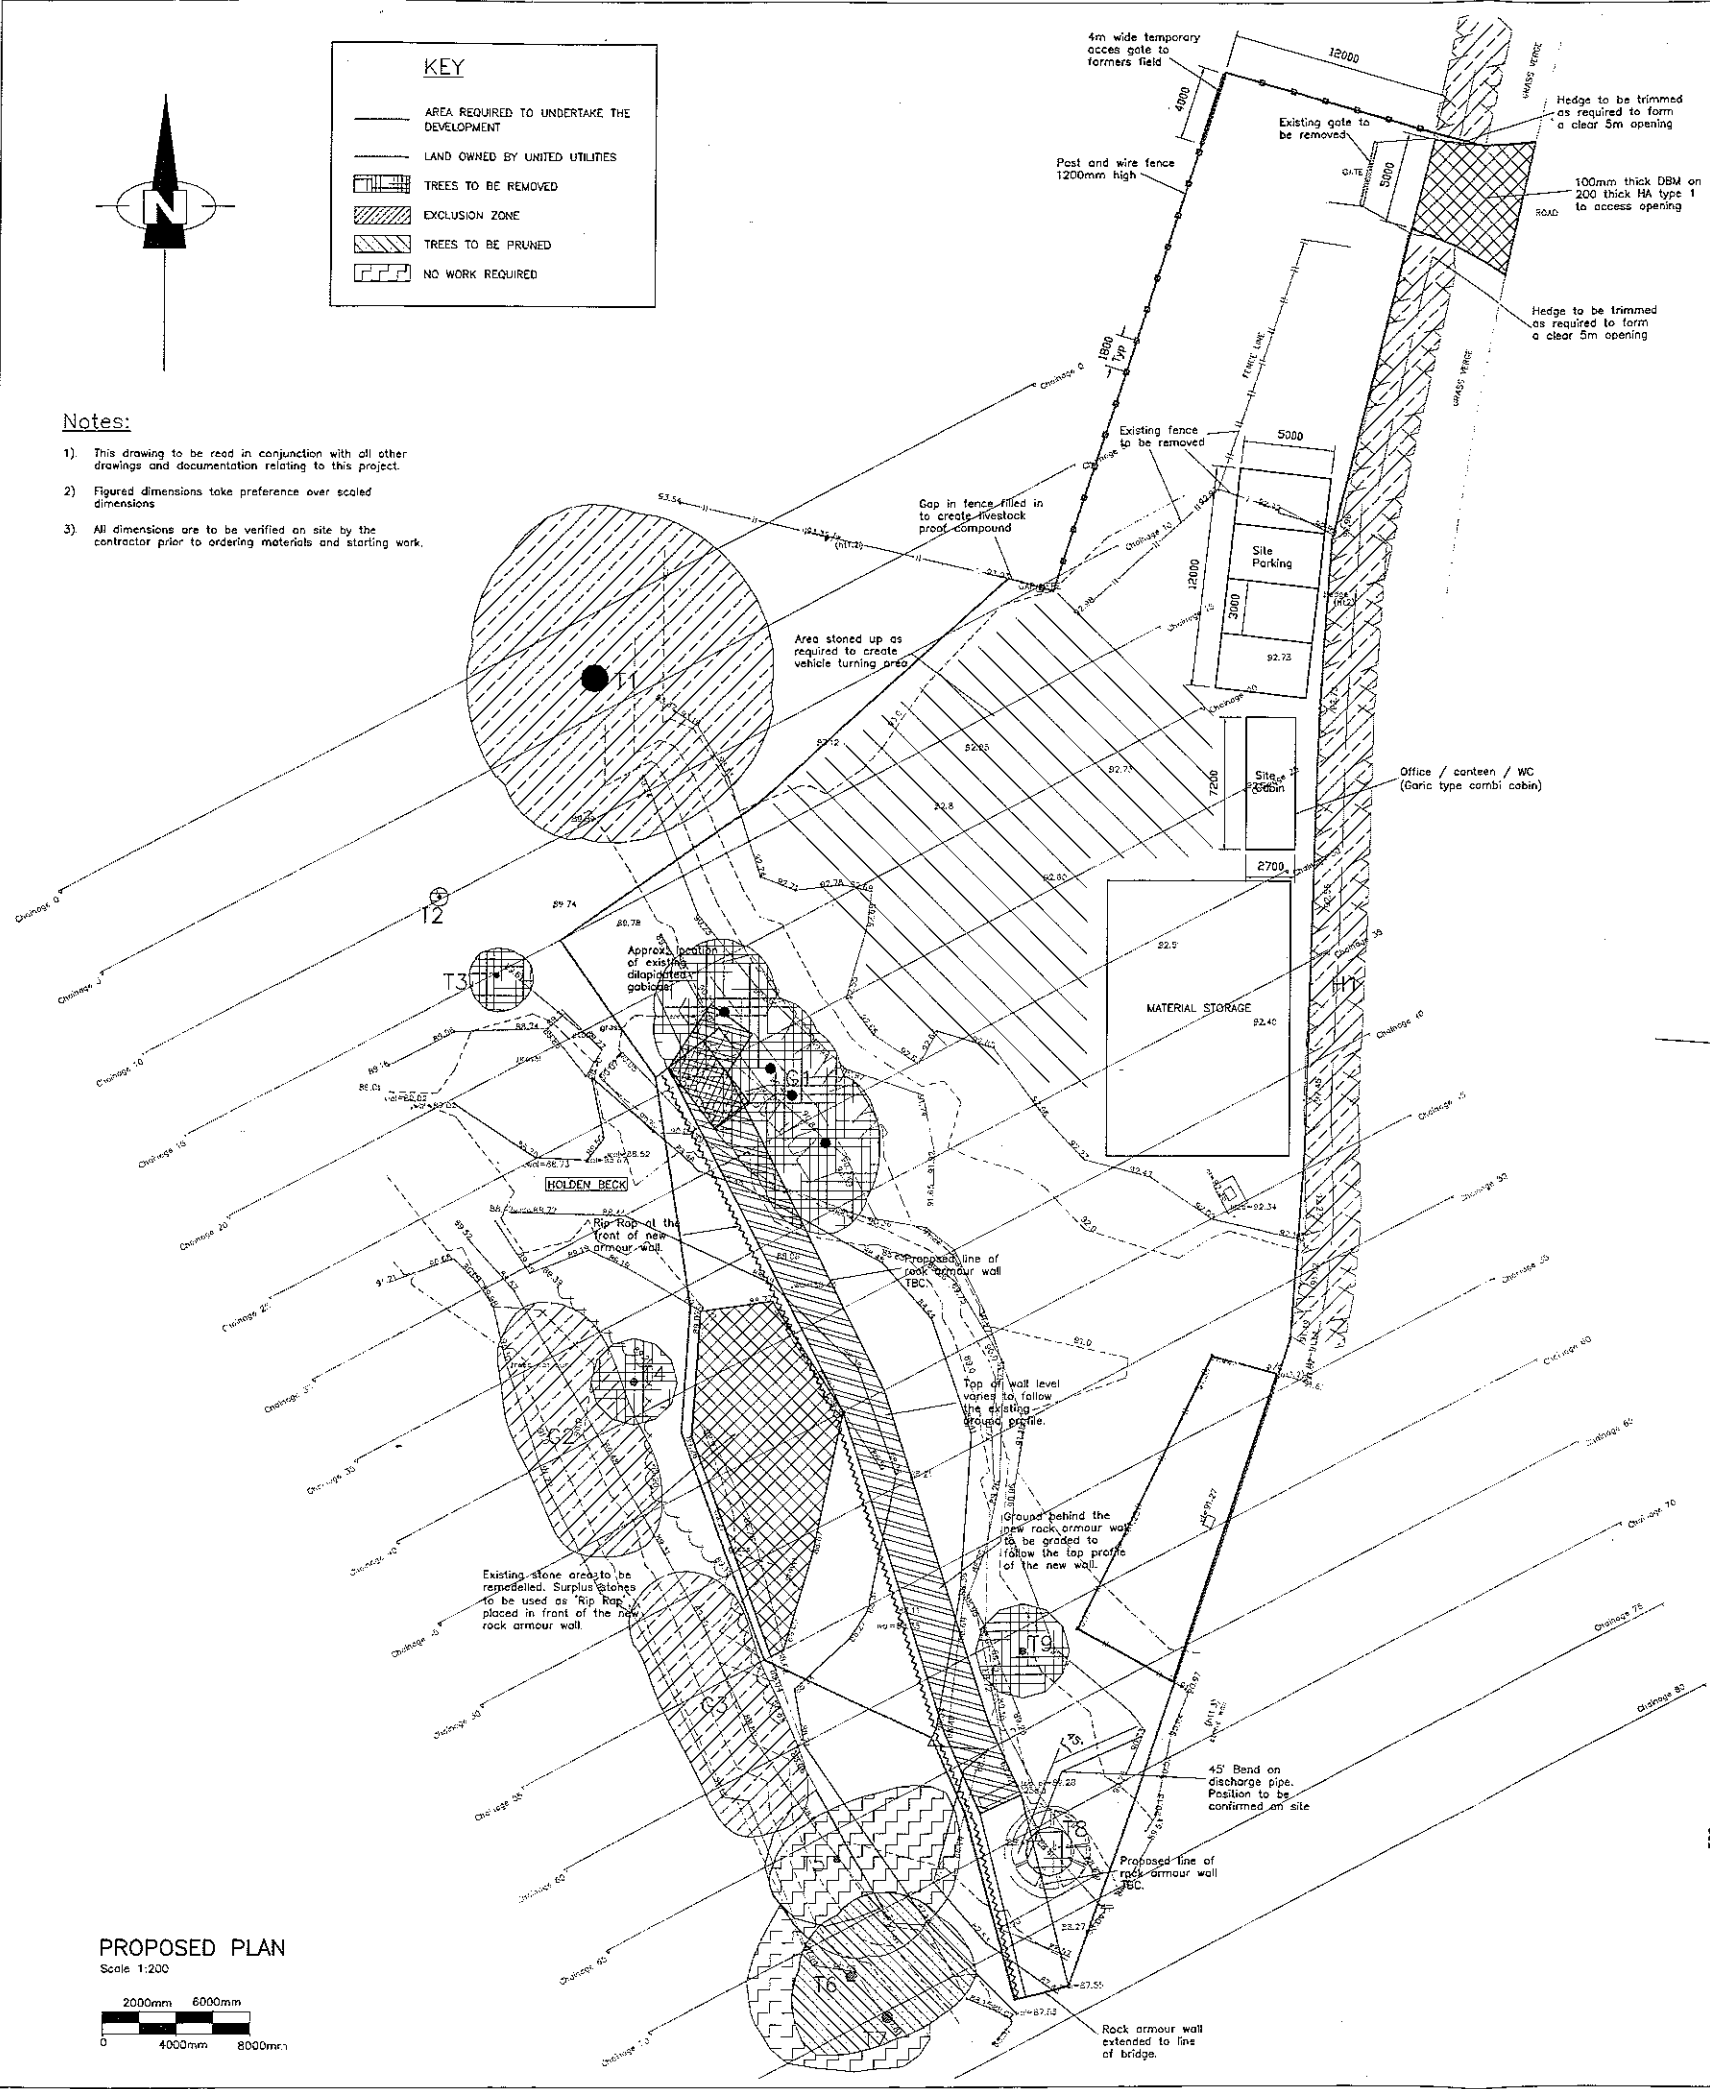
**PROPOSED PLAN**  
Scale 1:200

To provide the necessary improvements UU are proposing to construct to construct a Rock Armour Wall along the previous line of the beck with Rip Rap and re grade the bank with soil to tie back into the existing levels. Cross sections showing the existing and proposed profile of the bank and scope of the proposed works can be found on drawing TS 928 03 D.
