OUTBUILDINGS AT GREENGORE

HURST GREEN, BOROUGH OF RIBBLE VALLEY, LANCASHIRE

HERITAGE ASSESSMENT

GARRY MILLER
HISTORIC BUILDING CONSULTANCY

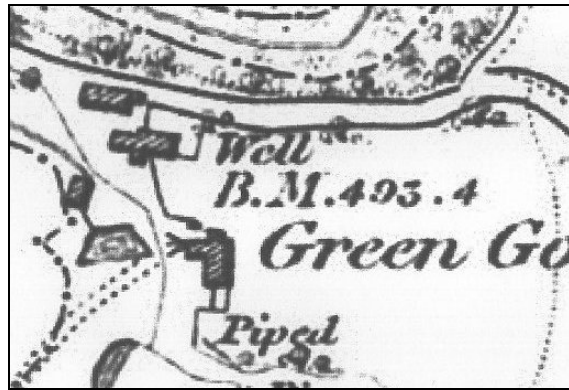
The 1844 six-inch OS map shows the arrangement of the farmstead was broadly similar to the present, with the principal exception of the garage and store. A small projection appears on the east side of the shippon; the barn is shown in its present form apart from the modern store. However the house is larger, with a now-vanished wing to the west and possibly a small porch. A separate structure lies to the southwest of it.

Map 3.
Enlargement of 1844 six-inch OS
map (Digital Archives; author's
library)

While the barn appears principally of 1818, the cart shed and the store may be early additions on evidence of the breathers in the barn walls. Both existed by 1844 as Map 3 shows. The store may have been rebuilt or reduced as the crude water tabling stands some distance above the present roof level.

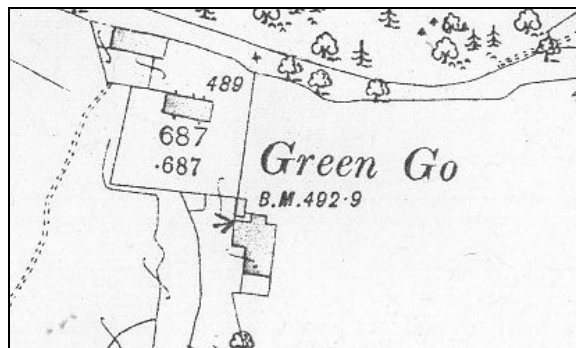
Changes in the interim are revealed by the 1891 25-inch mapping; the projection on the shippon has gone, along with the building southwest of the house; the latter had acquired its present form.

Map 4.
Enlargement of 25-inch OS
mapping surveyed 1891

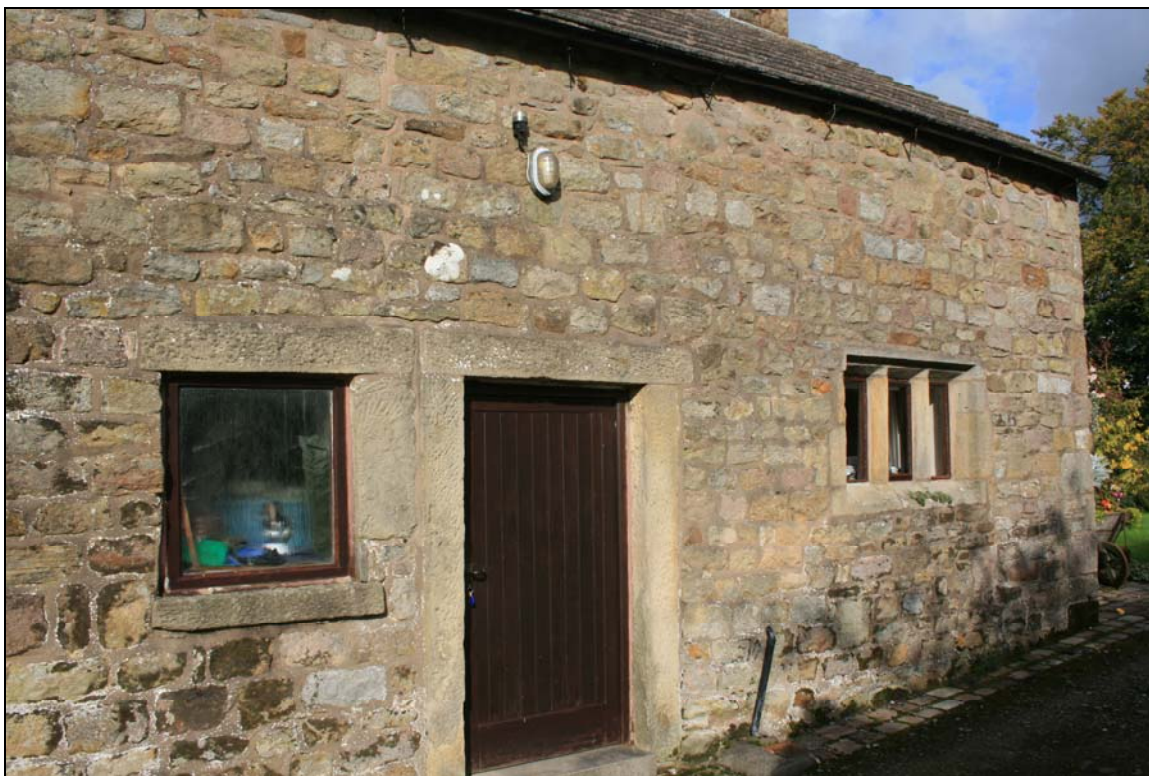
11. 19th century door and window and 17th century window and mullioned window of cottage

The building is probably early 17th century, with alterations of the 19th century. Evidence of the earlier phase is the three-light window of the third bay along with the trusses; evidence of the latter the doorways and windows with plain rusticated surrounds on the same elevation (although the jambs of the window in the first bay appear to belong to an earlier mullioned window). Various blocked slit breathers suggest the building's original agricultural role, but windows to the second and third bays on the rear (north) elevation appear to belong to the conversion. This elevation

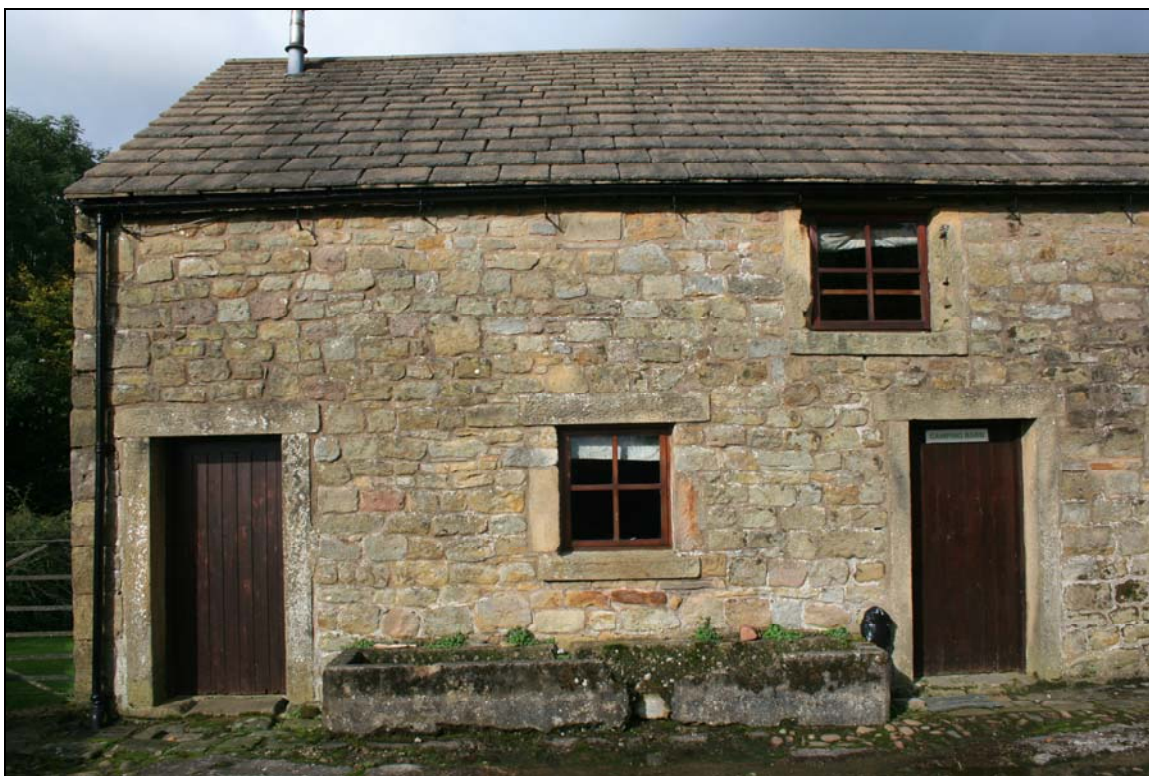
12. Detail of camping barn showing 19th century window and door surrounds with exception of ground floor window whose jambs seem earlier, probably from two-light mullioned window

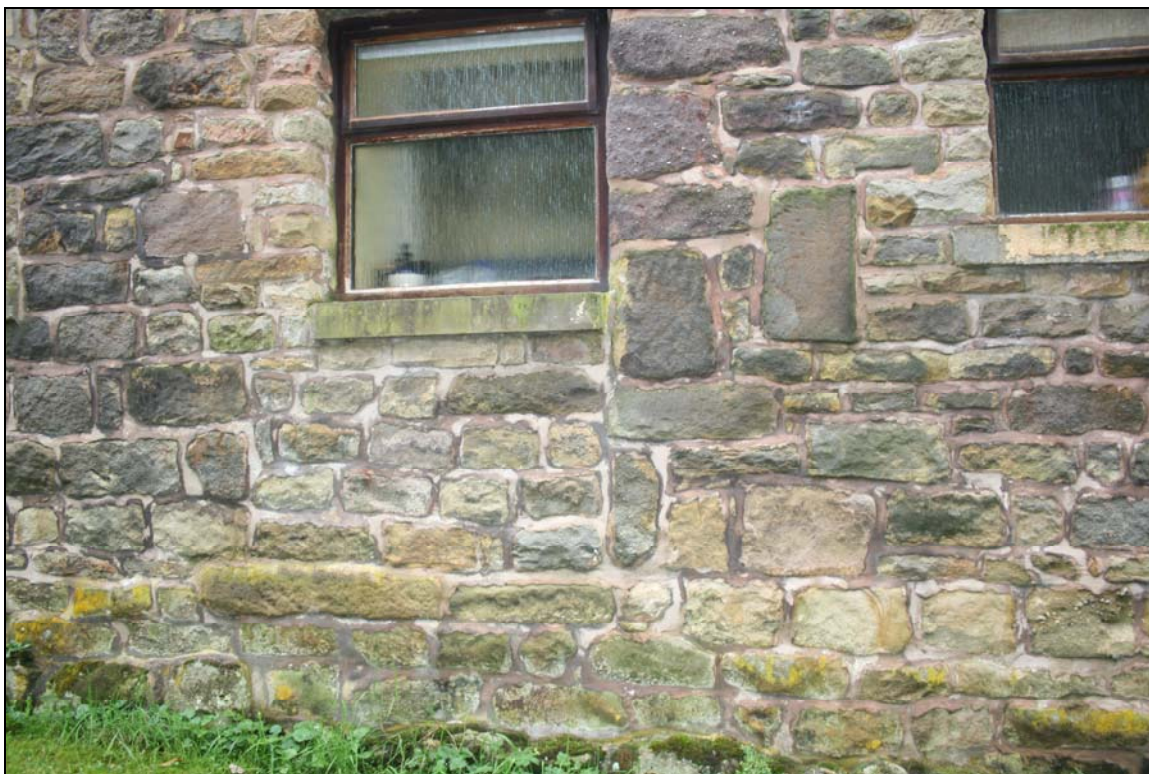
15. Evidence of rebuilding or blocked opening on rear wall between second and third bays

also shows indeterminate signs of early rebuilding, or a blocked opening, around the second/third bay junction.

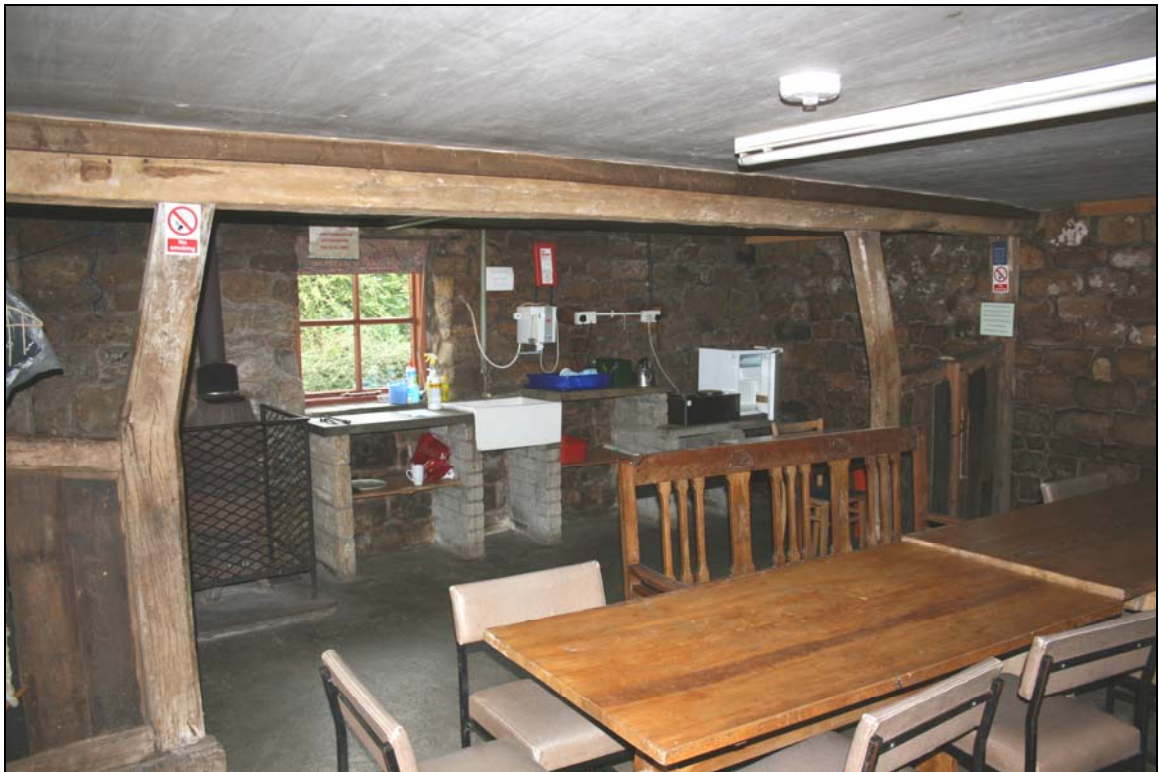
16. Interior of camping barn showing stall posts relocated beneath beam

- **Former stalls structure in camping barn**
Reason: evidence illustrating earlier phase of building, but now ex-situ and significance thus compromised

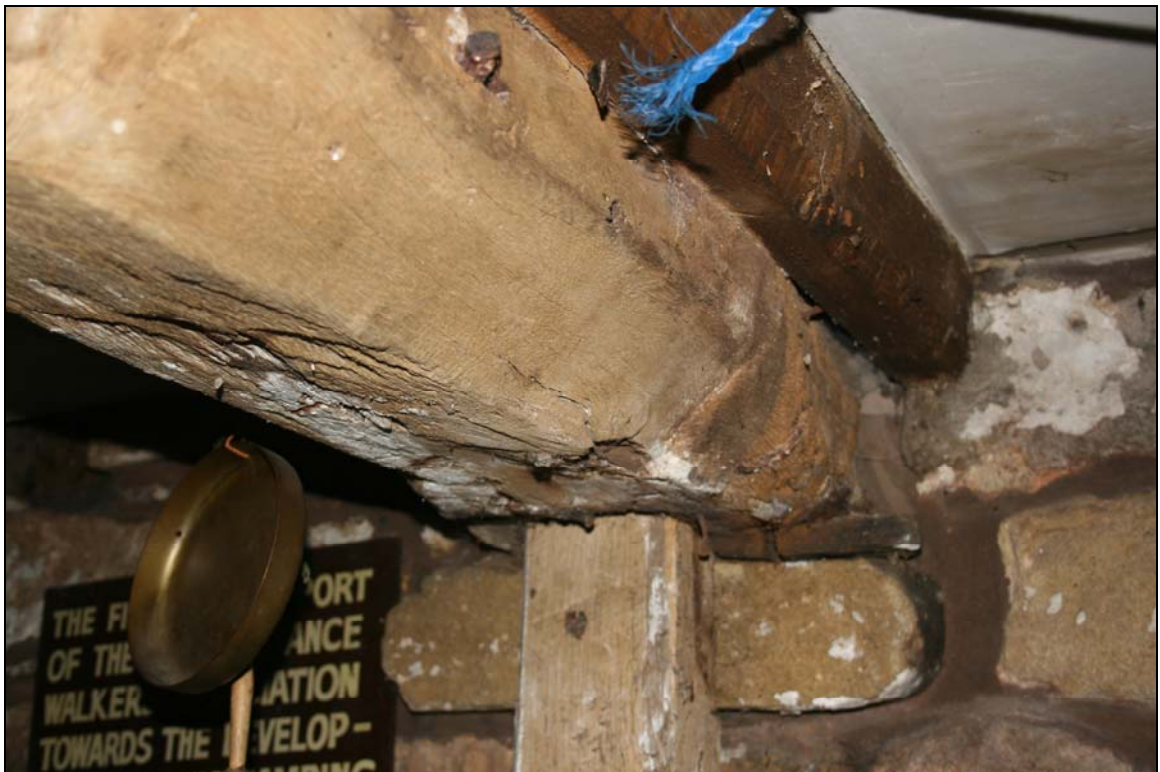
17. Detail of chamfered and stopped beam

- **Roof structure**
Reason: important original feature of early 17th century
- **Stop-chamfered beam in camping barn**
Reason: important original feature of early 17th century

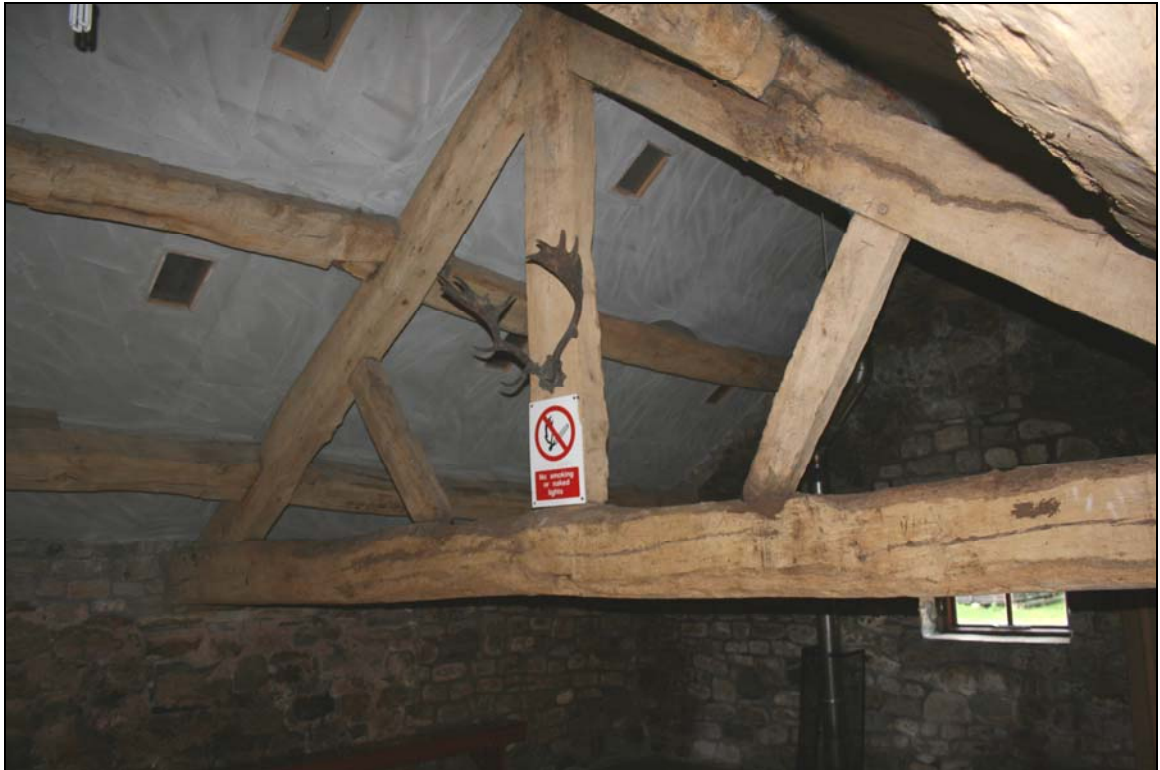
18. Kingpost roof truss over camping barn

The walling material is coursed rubble with quoins; the roof, of modern tile, is carried upon three kingpost trusses with raked angle struts; that over the camping barn has some assembly marks visible. Use of kingpost trusses, a superior form, denotes a high-status building.

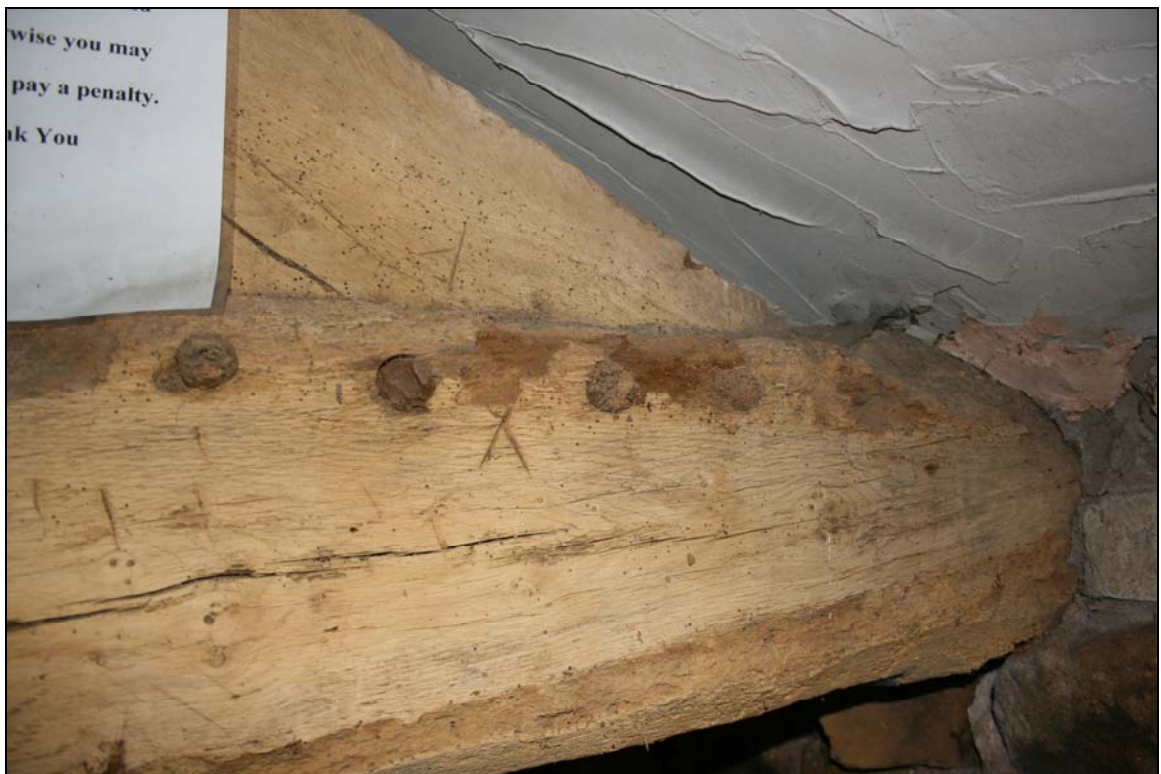
19. Assembly marks on east face of truss

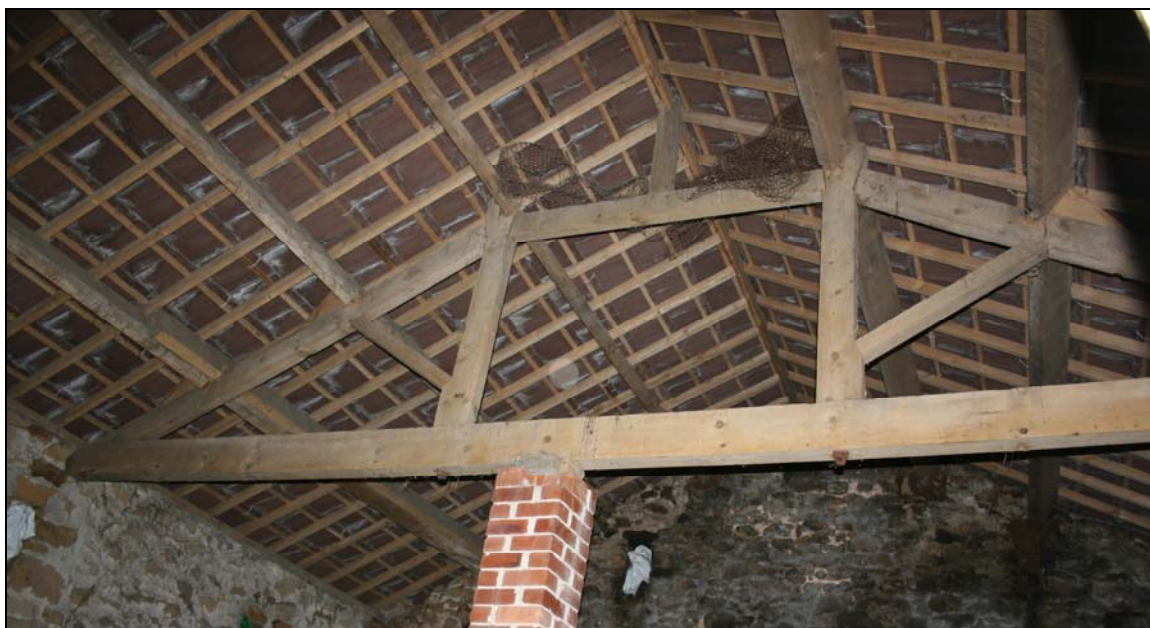
23. Truss above shippon and hayloft

The walling is similar to the shippon, of coursed rubble with quoins. The modern tile roof is carried upon three machine-sawn, bolted trusses with queenposts supporting a collar and short kingpost; two flank the threshing bay and one stands above the shippon. They are supported by inserted brick piers, probably early 20th century.

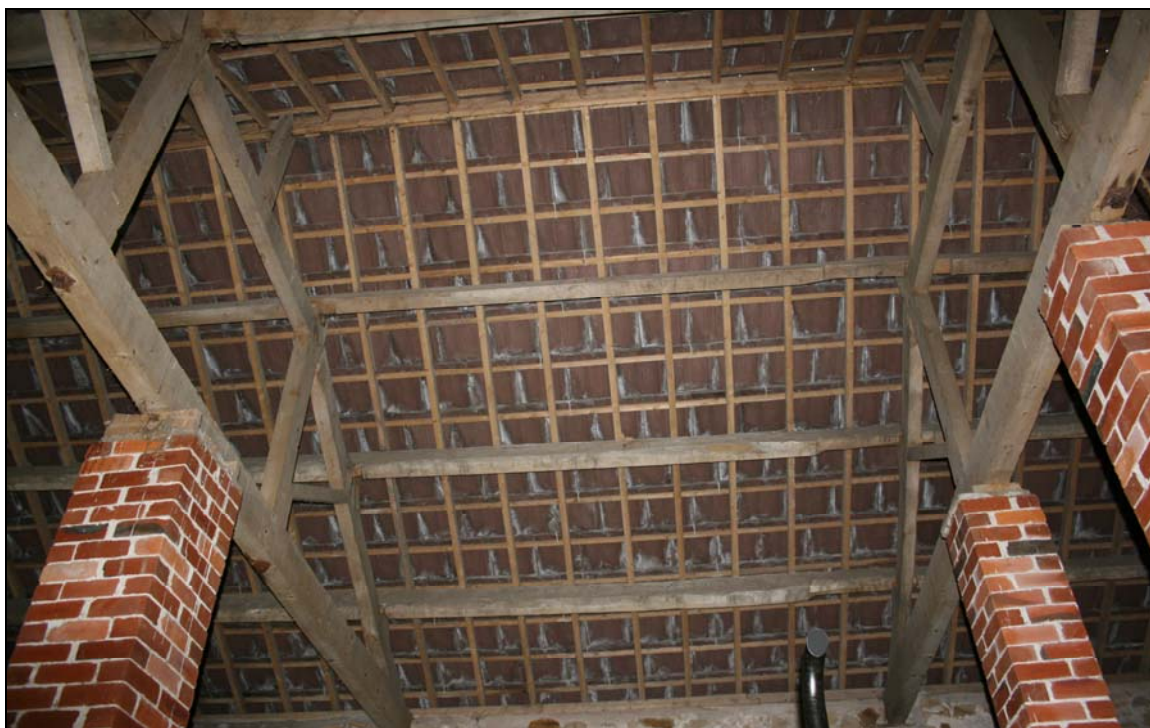
24. Trusses flanking threshing bay

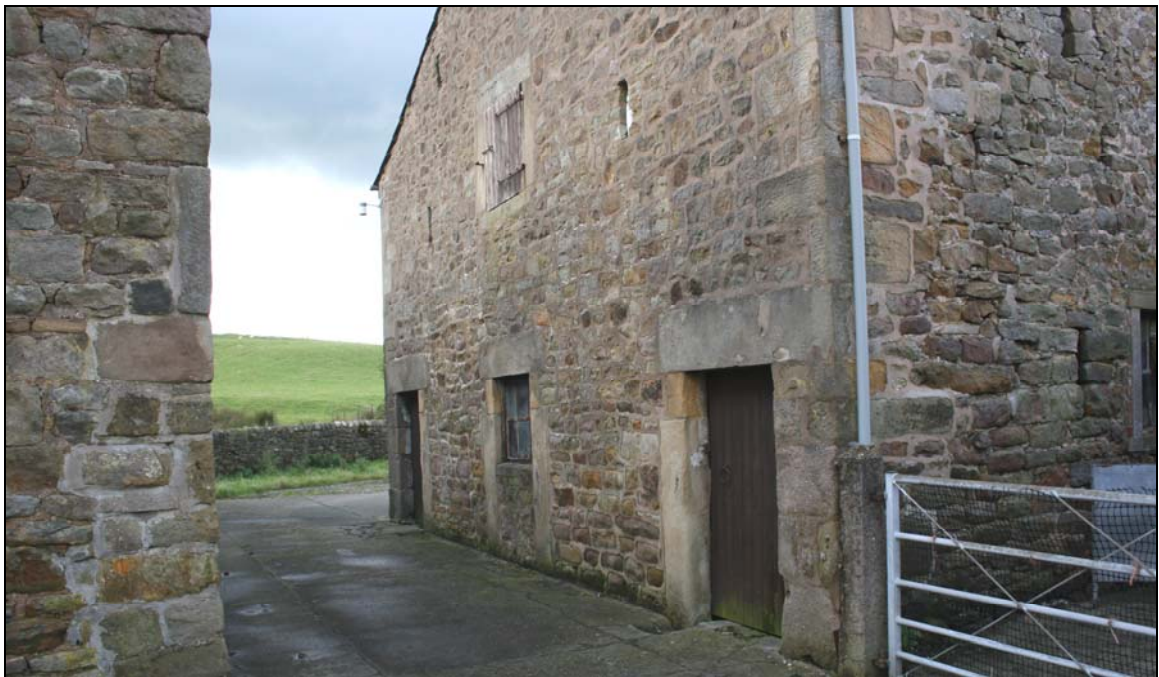
25. South gable showing three-door arrangement of shippon

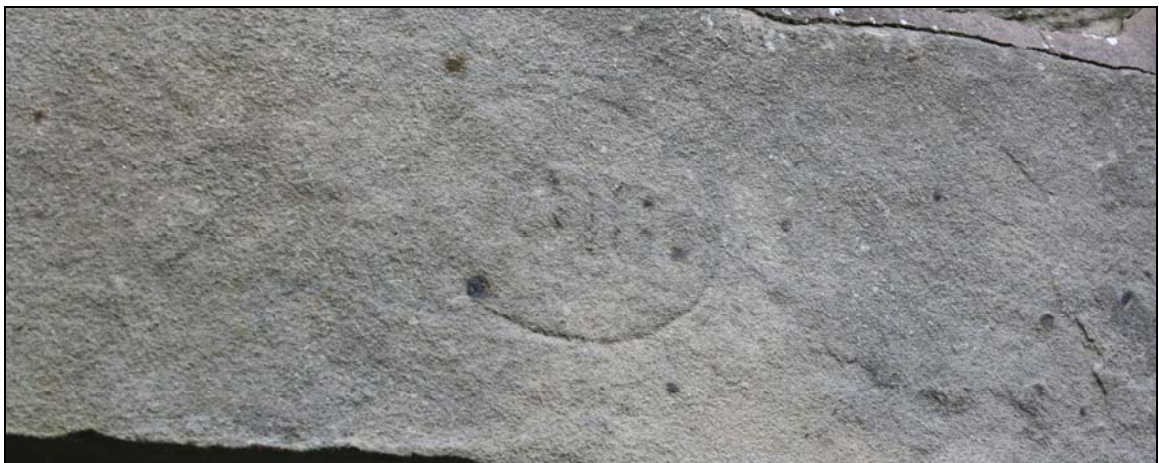
26. Lintel of central feeding passage, dated 1818

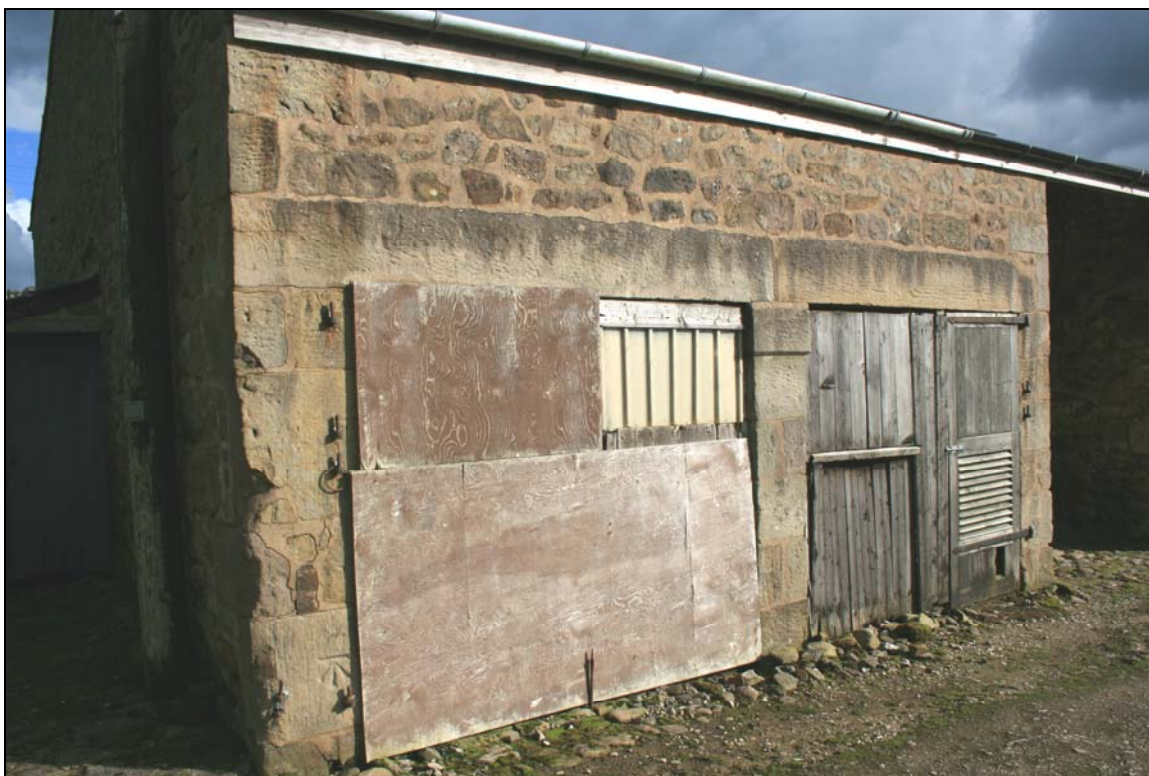
28. Former cartshed entrances; gudgeon pins for doors remain in situ

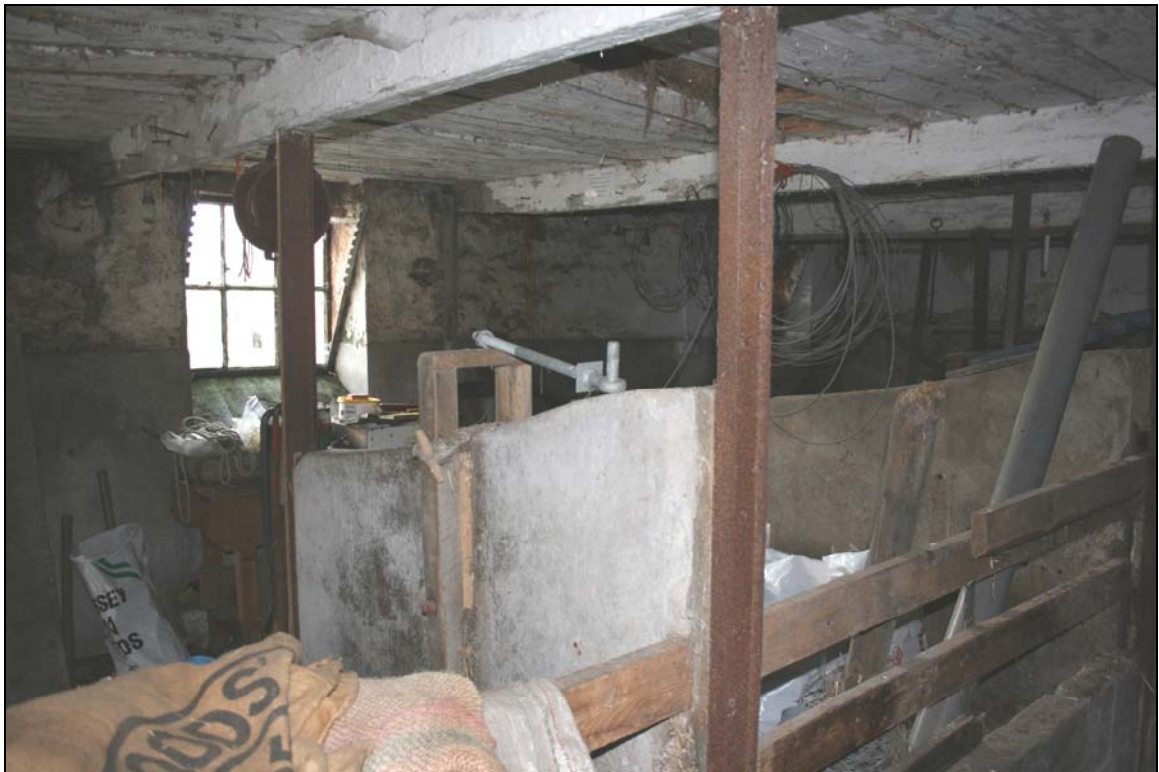
29. Interior of shippon showing modern boskins

Few features of interest remain. The interior shippon has concrete boskins of mid-late 20th century date, replacing earlier wooden ones whose presence is indicated by mortices for posts in the soffit of the thin ceiling beams. A brick pier, probably late 19th or early 20th century, has been inserted to support the roof. Modern boskins exist in the former cartshed, in which breathers in the barn walls are visible (see below for implications); so too does the lean-to store, whose interior has no other interest. The threshing floor has some large flagstones visible.

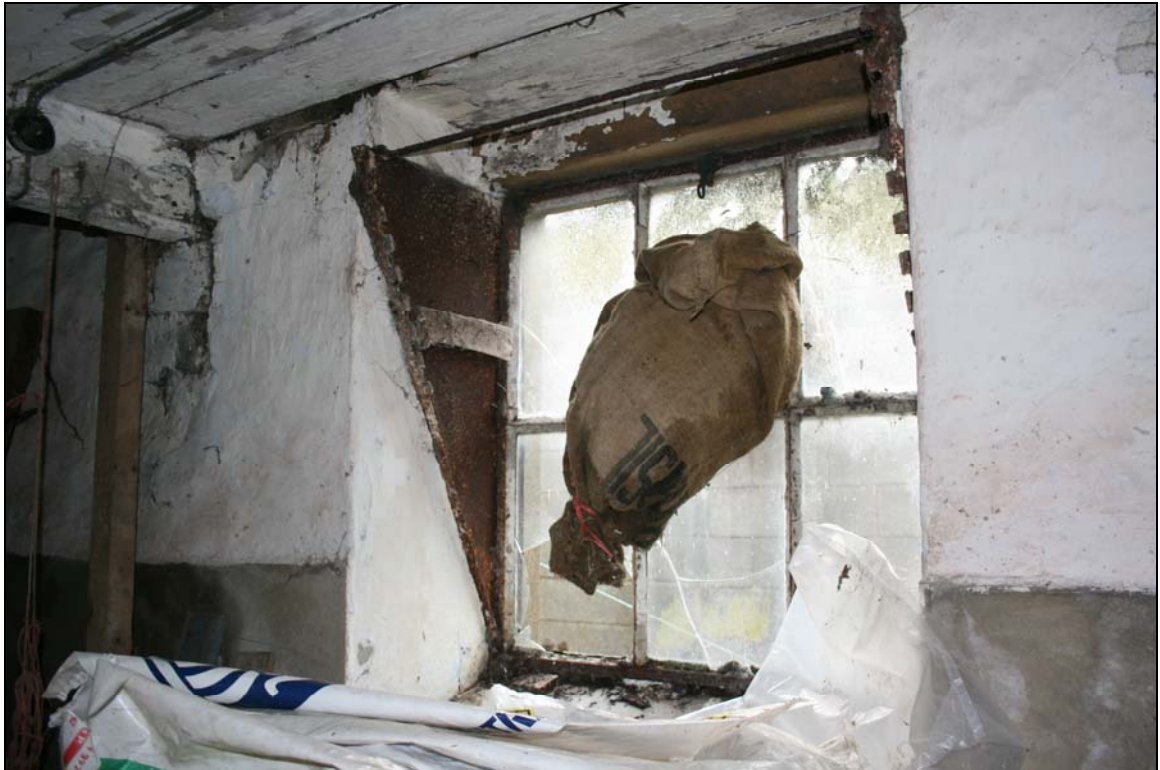
30. Hopper-type window in shippon

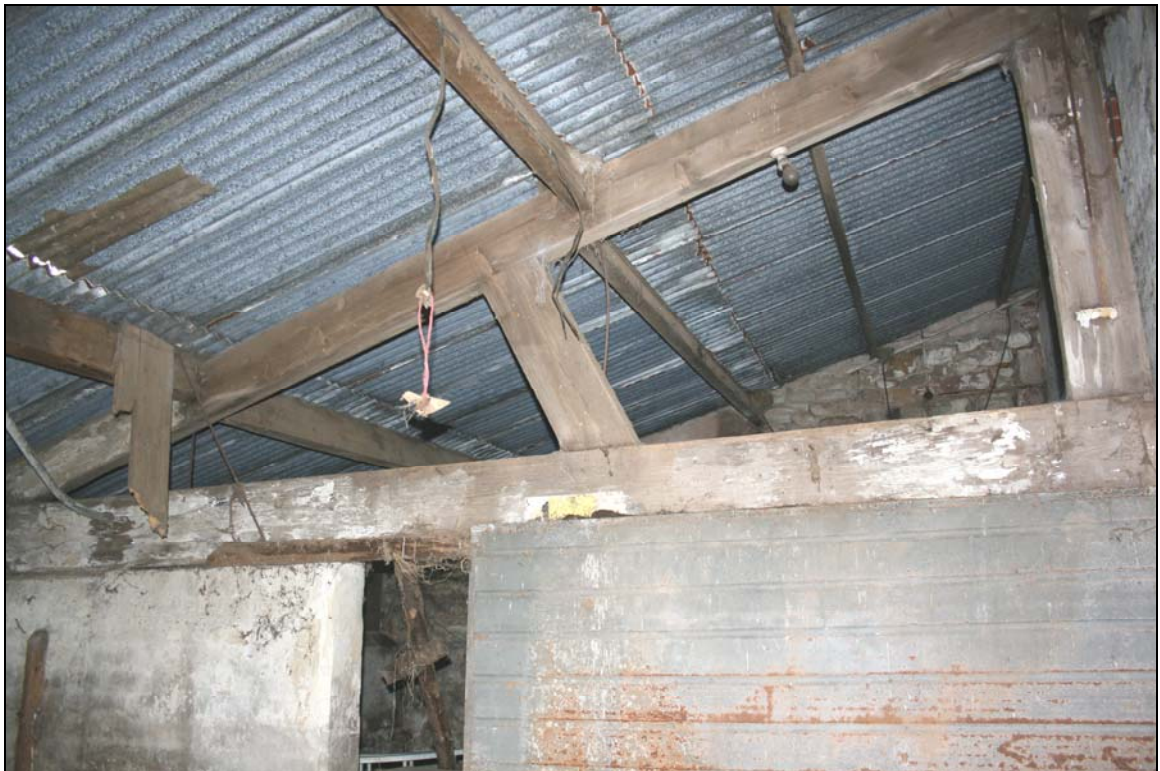
35. Half-truss within the garage
