Application for Planning Permission.  
Town and Country Planning Act 1990

Re: Daylight scoping survey (bats): Barn at Bowfield Farm, Bowfield Lane, Balderstone, BB2 7LW.

## Conversion Assessment - - - Bowfields Barn, Balderstones

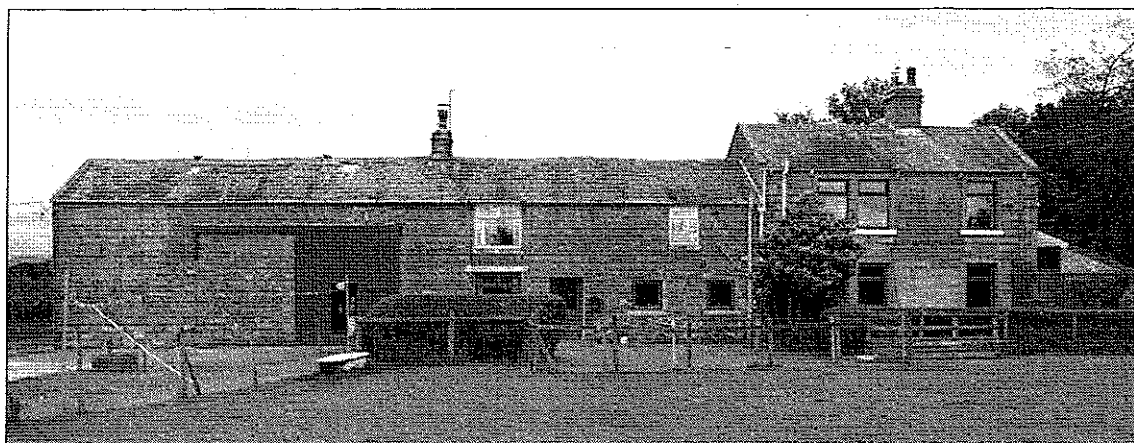
**Photo 1:** Barn (at left) with adjacent houses

The property is a stone barn attached to the farmhouse, a block work wall separates the two buildings and there is a mixture of stone and brick material in some of the internal walls. The barn has a traditional rubble infill wall construction and duo-pitched slate roof. At the rear of the barn is a lean-to shippon area with an extended 'cat-slide' roof (figure 1).

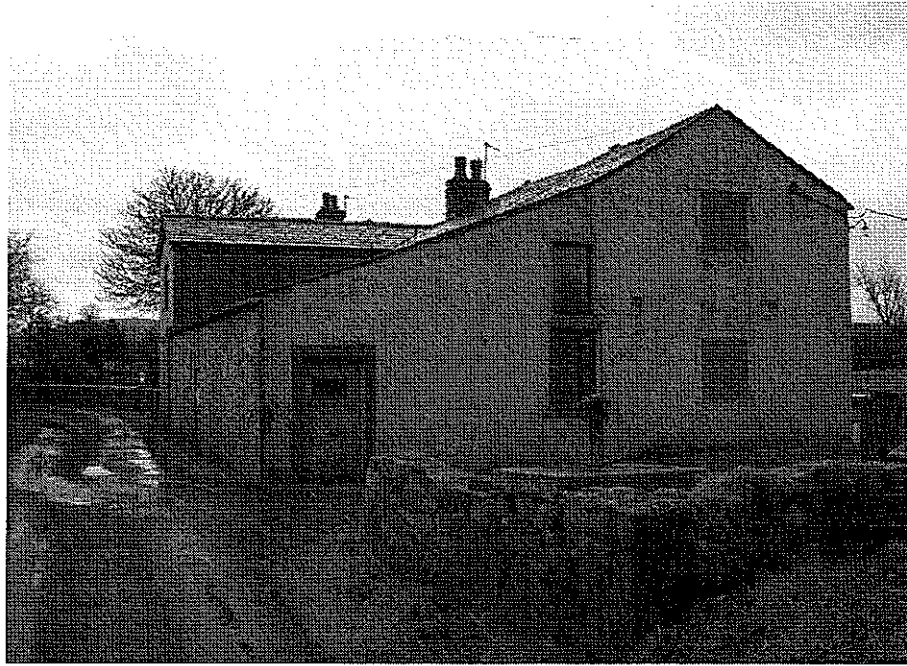
Photo 1 : West Elevation – As existing

Generally the existing walls of the property are 440mm thick and are constructed of coursed natural stone to the South elevation, random stone to the North and acrylic painted cement render over random stone (presumed) to the West. Structurally all the walls appear to be in sound condition with no visible signs of bulging or leaning, there are small areas of the building which have been weathered that would benefit from re-pointing but generally the walls have been well maintained. The cement render to the west elevation is a fairly modern covering and prevents the natural stone wall behind from breathing, which can cause moisture to become trapped within the wall construction, producing hidden defects. It would be advised that the cement render be removed and the stone behind re-pointed with a lime and ash mortar to match the rest of the property. If the damage to the stone work is substantial the wall should be lime rendered and lime washed on a 3/5 year basis in order to provide a breathable weatherproof covering.

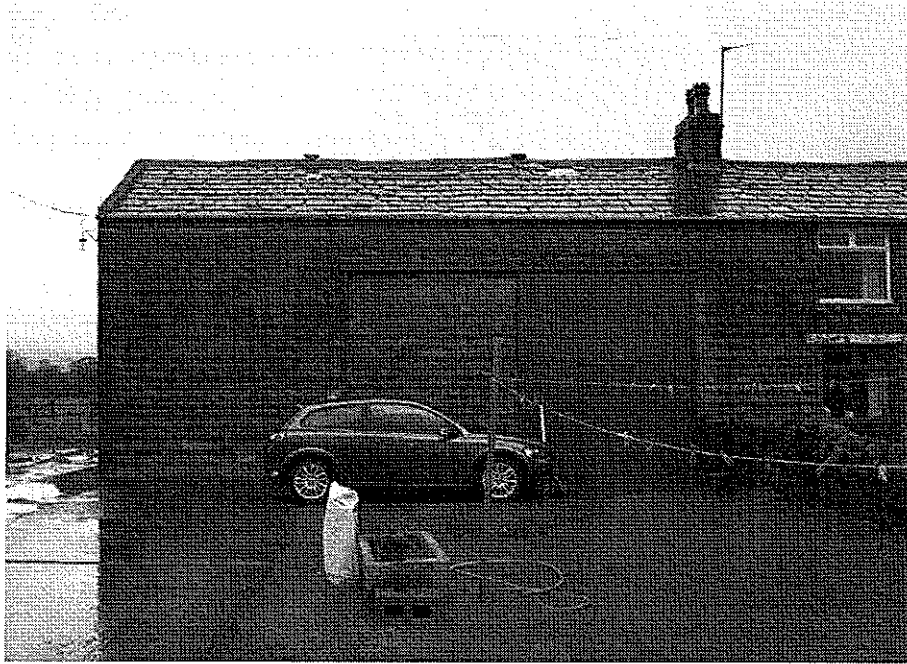
Photo 2 – Existing South Elevation (Front)

The front (South) elevation consists of a single flat topped cart opening with steel lintel above in the far right bay; this historically would have been timber and is presumed to have been replaced due to decay. To either side of the opening at ground floor level are sockets for harr hung doors, the doors having been replaced previously with a large softwood sliding door with pedestrian access door to the centre. To the left hand side of the mid bay appears to be a previous opening which has previously been infilled to a very high standard, with the only evidence of its existence being a stone lintel above externally and timber lintel internally.

The to the front (South) elevation will be minimal, only requiring one opening reinstating and the head to the cart opening raising by 300mm to allow compliance with Part B of the Building Regulations. It is proposed that the new opening is to be inset 150mm from either end of the existing lintel with the stone to the sides being machine cut and finished by hand to match the texture of the external wall. Behind the stone lintel it is proposed that the existing timber lintel be removed and replace with a modern concrete member which will no deteriorate over time. As stated earlier, the proposals will require the replacement of the steel lintel above the opening which is to be replaced with a new steel member faced in timber.

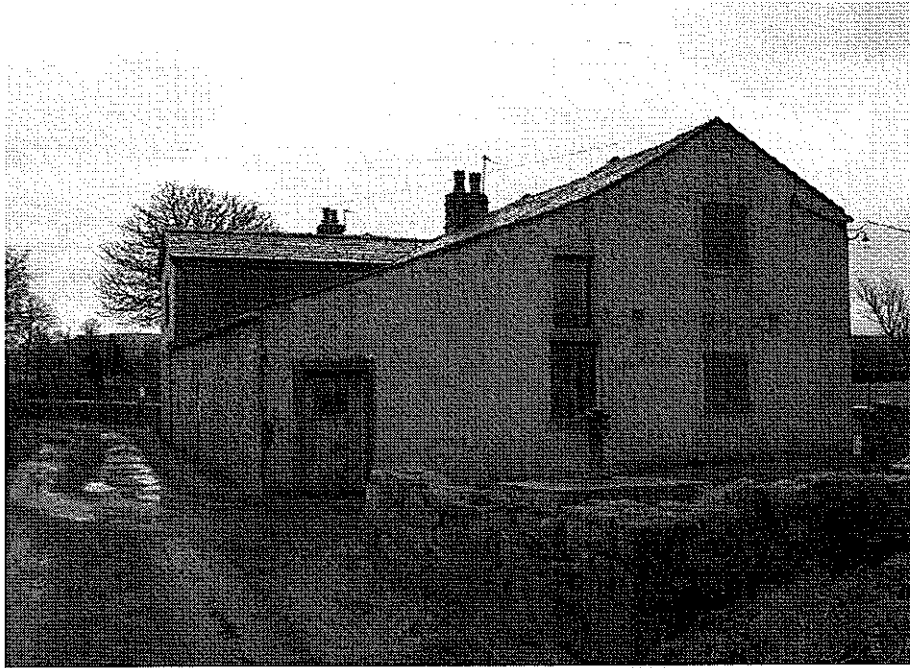
Photo 3 – Existing West Elevation (Side)

The side (West) elevation has two pitching holes to the gable of the main barn, one at first and one at second floor level. Both openings are roughly the same size and aligned centrally to the ridge, neither of the windows are currently in use and have been previously blocked up. Both openings are not thought to be original to the building, the upper being 20<sup>th</sup> C and the lower 21<sup>st</sup> C. The lean to shippon to the right of the main barn has a single pedestrian door with machine cut jambs and head to the left and two pitching holes (one directly above the other) to the right. The pitching holes to the right are separated by stone transom which lines up with the internal floor level and have a stone head to the top and sill at the bottom. It is thought the upper opening is original to the build with the lower being a later addition but due to the render covering the gable wall no evidence is forth coming to argue for or against this theory.

The side elevation is to see the removal of the upper window to the shippon and possible reforming of the window below, yet until the render is removed it is impossible to assess the likelihood of these works. The window to be removed is not seen as adding any architectural merit to property and with its removal the building will become aesthetically more pleasing and tie in better with its vernacular roots. The works will include the removal of the head and the infill with rough coursed stone with a lime ash mortar to match the rest of the property.

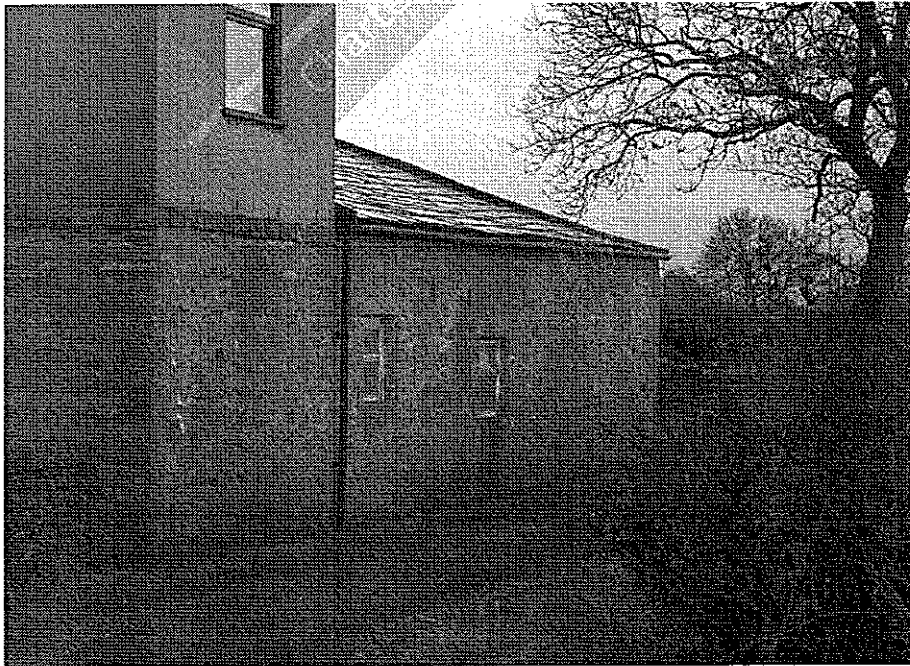
Photo 4 – Existing North Elevation (Lean-to)

The rear (North) elevation of shippon has two existing openings, the first being a small rectangular window in a portrait orientation and the seconding being double the width and slightly lower to the centre of the elevation. Both windows have hand cut heads and cills and are fitted with top hung softwood timber windows which are showing signs of advanced decay to the cill and bottom rail timbers.

The rear (North) of the property is to see the formalization of the windows to allow them to be practical in the conversion and the insertion of a matching window right of centre. The reforming of the windows are to be undertaken using reclaimed natural stone which is to have a rough un-uniformed finished with the sides constructed with stone returns. The new window is to be constructed to match the reformed openings to its left so as to be consistent. \*\*Note : The stone should be chosen under the guidance of the council or designer.

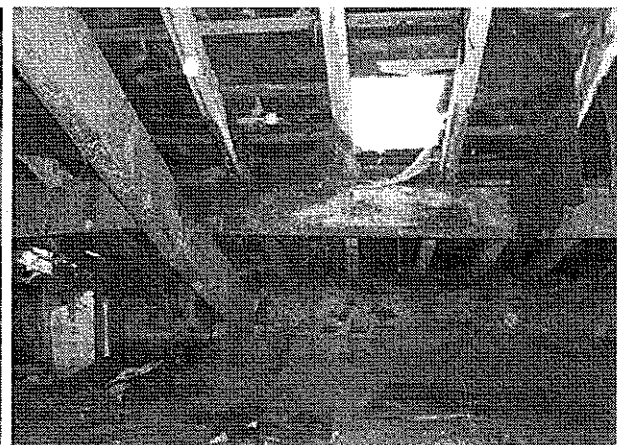
The mono pitch roof to the shippon is constructed with clear spanning machine sawn softwood principle between which softwood purlins span supporting the rafters and roof covering. Generally, there would be concern about clear spanning over such a distance as it can lead to the leaning in the external walls but as previously noted none of the external walls were out of plumb. It must however be noted that the first floor in the shippon ties into the wall just below the rafters and will provide a degree of lateral restraint to the north wall acting in a similar way to the of a half truss. The roof cover externally. The timbers to the roof show signs of recent water damage constant with that of a failing roof cover.

Photo 12 – Roof Timbers – Shippon

Photo 13 – Roof Timbers – Shippon

Due to the concerns over large span principle rafters it would be proposed that some of the internal walls to the shippon be constructed in load bearing blockwork to allow purlins to be supported between and removing the uncertainty surrounding the possible issues with the rafters. This would require the complete removal of the shippon roof yet the given solution will provide more than sufficient structural support for the life of the property.

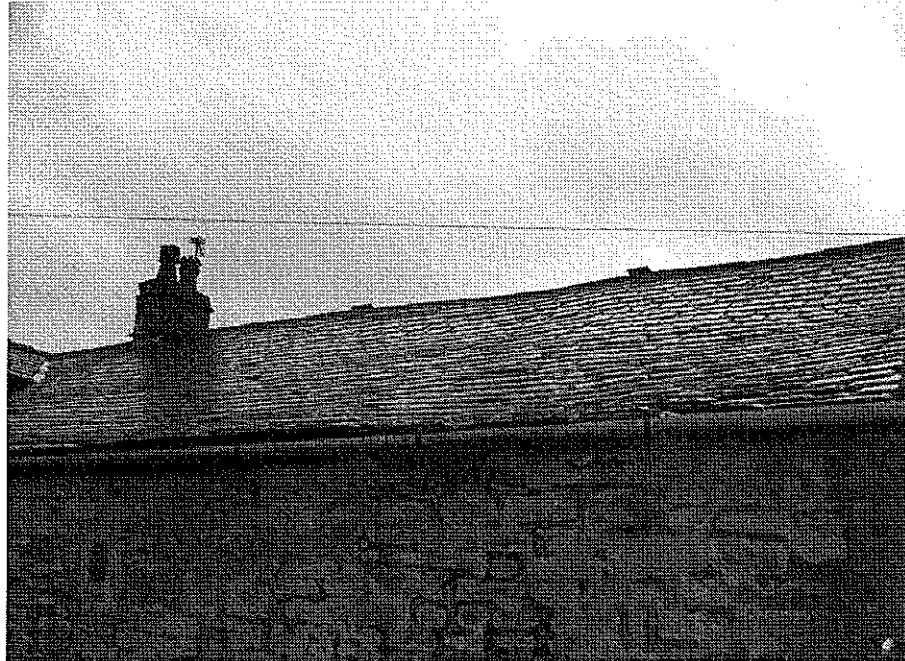
Photo 14 – Roof Covering – Main Barn/ Shippon, North Face

The roof covering on external inspection is as bad if not worse than that on the main building with areas of slipped slates and inconsistent spacing between slates in places, both providing the opportunity for water ingress. Upon the internal inspection it became apparent that the rood had been relayed

probably at the same time as the main roof due to the presence of bituminous roof felt. This was however severely damaged in places and daylight could be seen where slates had also moved. This has, as previously stated allowed water into the property which unless resolved will cause irreparable damage to the timber roof structure.

The roof would require to be overhauled in any instance due to the defects present. In the proposed scheme the roof would be stripped back to the roof structure (Trusses & Purlins). The proposed roof will comprise of reused reducing slates nailed to tanalised softwood battens and counter battens running inline with the rafters. Below which a high performance breathable roofing felt is to be installed over softwood rafters which are to be supported by the existing roof structure. The undersides of the rafters are to be finished with a vapour control layer, plaster board and skim. To comply with the requirements set out in Part L1b of the Building Regulation 2010 it is propose that the roof is to be insulated inline with the rafters with 150mm Kingspan K7 Insulation. (See Figure E)

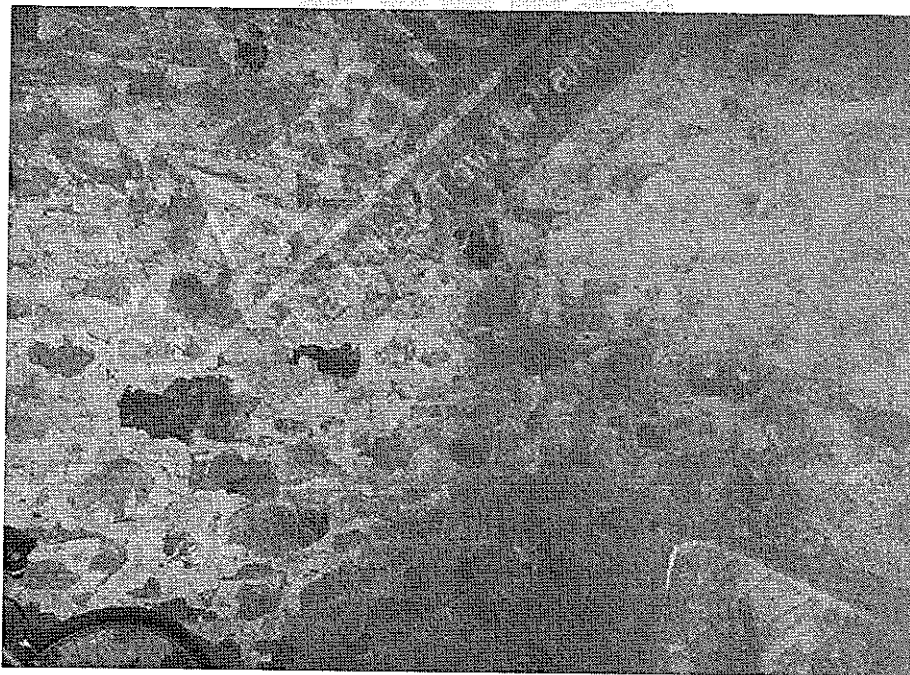
Photos 15 – Internal rubble wall

Upon an internal inspection to the internal faces of the external walls it is apparent that not only are there signs of water penetration from the roof but also signs of rising damp in the lower sections of the walls, this is also evident in the internal separating walls. To some extent this will have been caused by the raised ground levels surrounding the building but due to the height and the location of the affected areas it is more likely to be connected with a high ground water level and lack of a physical damp proof course to prevent the movement of moisture by capillary action (rising damp).

The majority of internal partitioning walls within the property are traditionally built 440mm solid stone walls, which would previously have been the external wall to the main barn, yet there is a later section between the west bay of the main barn and the shippon which is of red brick construction. These walls provide structural support to the first floor and the roof by transferring loads from the purlins, trusses and floor joists. From our inspection it is apparent that there has been only two opening formed in the wall and a section rebuilt as previously mentioned in red brick.
