## Householder Application for Planning Permission for works or extension to a dwelling. Town and Country Planning Act 1990

**PROPOSED EXTERNAL MATERIAL AND ROOF WINDOW**

**EXTENSION OF PENDLE HOUSE,**

**N0. 17 GEORGE LANE, READ BB12 7RQ**

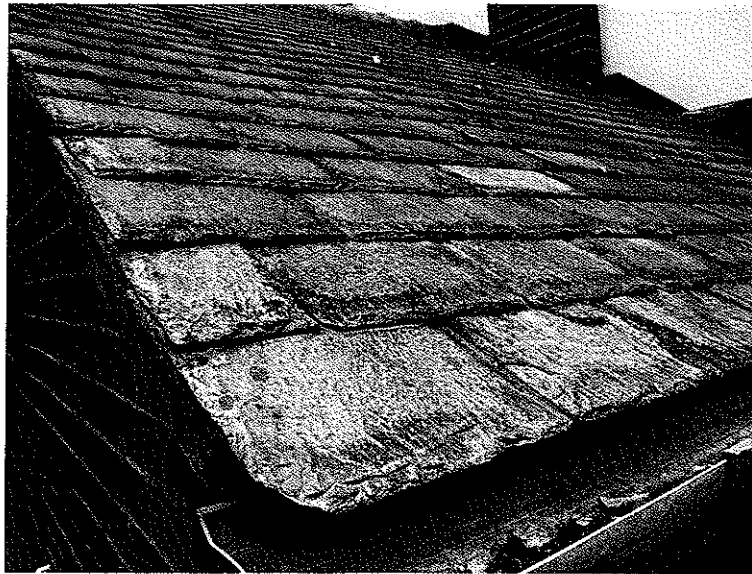
Pl. 3 The above photograph shows the kind of Westmoreland Green slates that would be used to finish the proposed extension roof, which would match the existing house.

Natural slate finish to pitched roof with hip / ridge tiles and with mitred slate hips to dormer windows.

Natural slate finish to pitched roofs with hip / ridge tiles and with mitred slate hips to dormer windows all to match existing and with conservation type flush fitting rooflights.

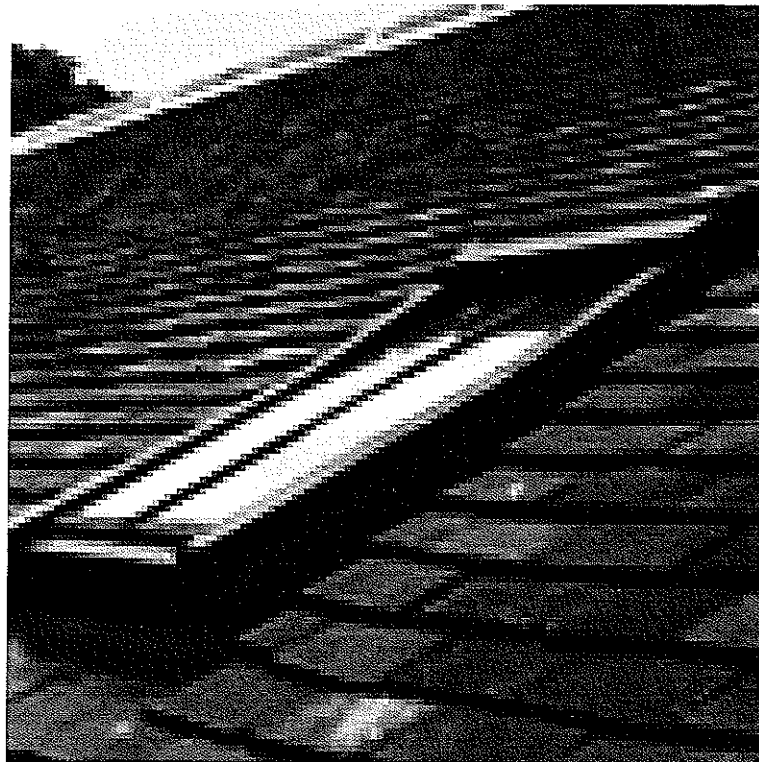
Pl. 4 Photograph showing the Velux Conservation roof window to be used in the roof of the proposed single storey extension

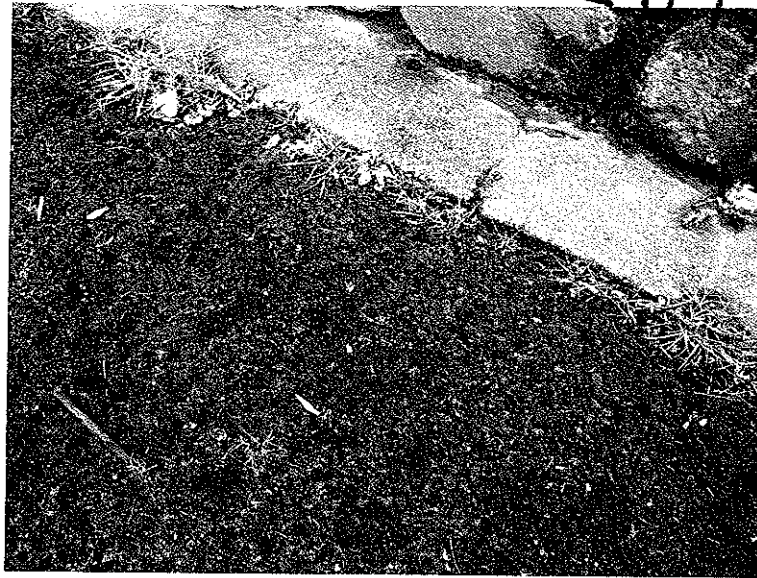
Pl.5 Photograph showing existing tarmac drive and stone sett edgings that would be used for the new driveway.

Tarmac finish to extended drive and vehicle turning area with stone sett edgings.

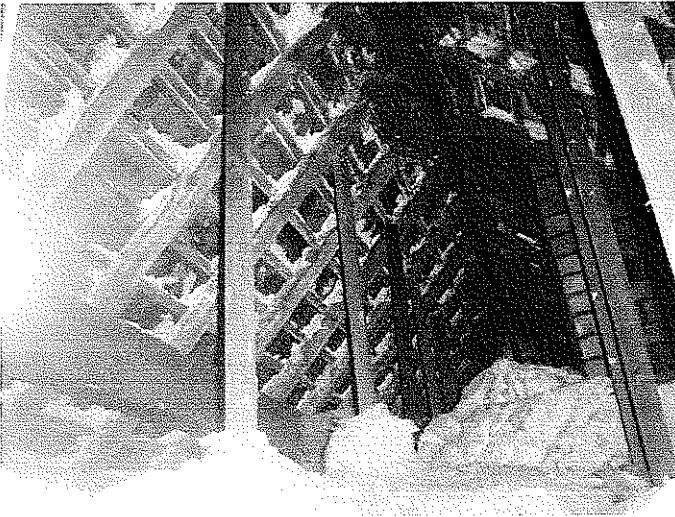
Roof space.

COMMENTS: The rafters and purlins are in good condition with no cracks or crevices. The abutment of slates with battens and rafters have been pointed. There is insulation at ceiling level and substantial amount of cobwebs but due to the lack of felt it does not provide a suitable environment for Bats. The garage roof internally is boarding over joists in very good condition with no gaps.

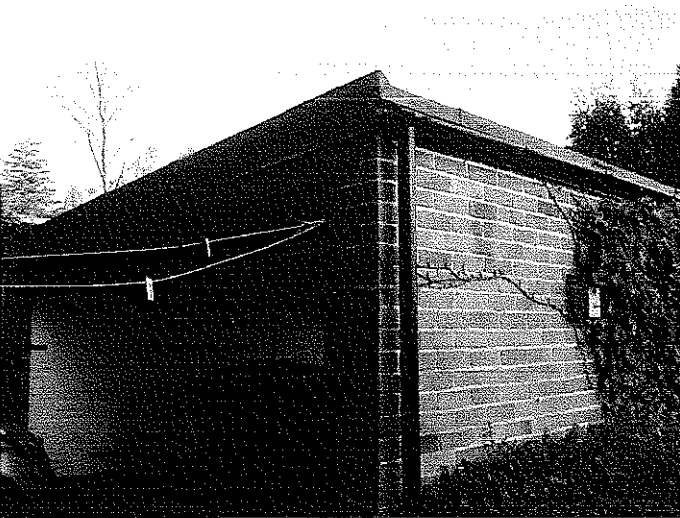
Detached garage.

COMMENTS: The property is a detached house with detached garage to rear.

COMMENTS: The walls are brick with rendered sections. The garage is brick.

COMMENTS: The roof is slate with dormer windows. The Garage has a felt flat roof.
