*Arboricultural Impact Assessment
of Outline Proposal for Residential Development at*

Waddow View, Clitheroe, Lancashire

October 2012

**ARBORICULTURAL IMPACT ASSESSMENT
WADDOW VIEW, CLITHEROE**

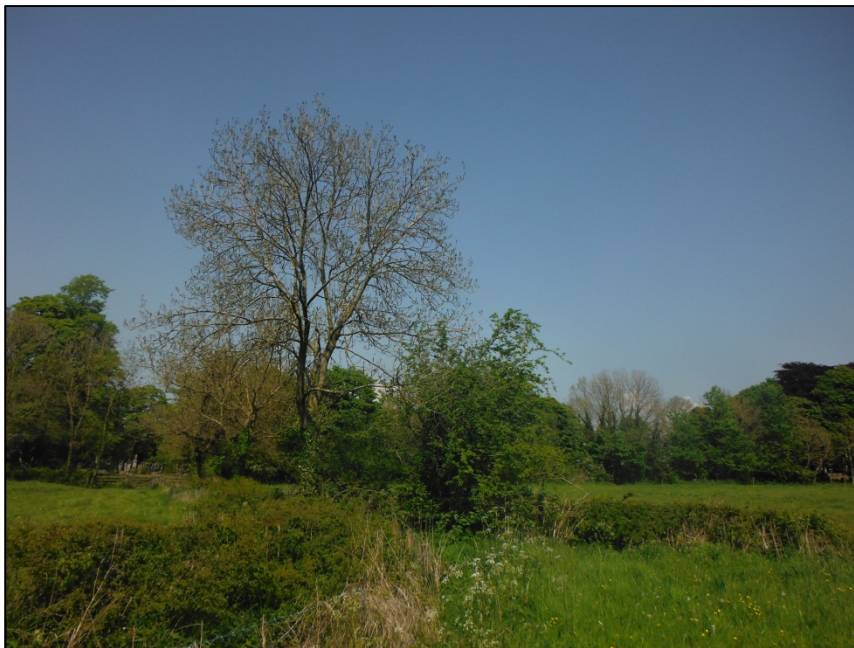
Fig 1: The northern section of the site, looking east

- 3.1 The site, which is greenfield, is located at the rural edge to the western boundary of the town of Clitheroe, Lancashire. It consists of various fields that are under agricultural usage and are divided by ditches, maintained and outgrown hedgerows and fences, with individual trees and groups of trees in various locations throughout (see Fig. 1, overleaf). According

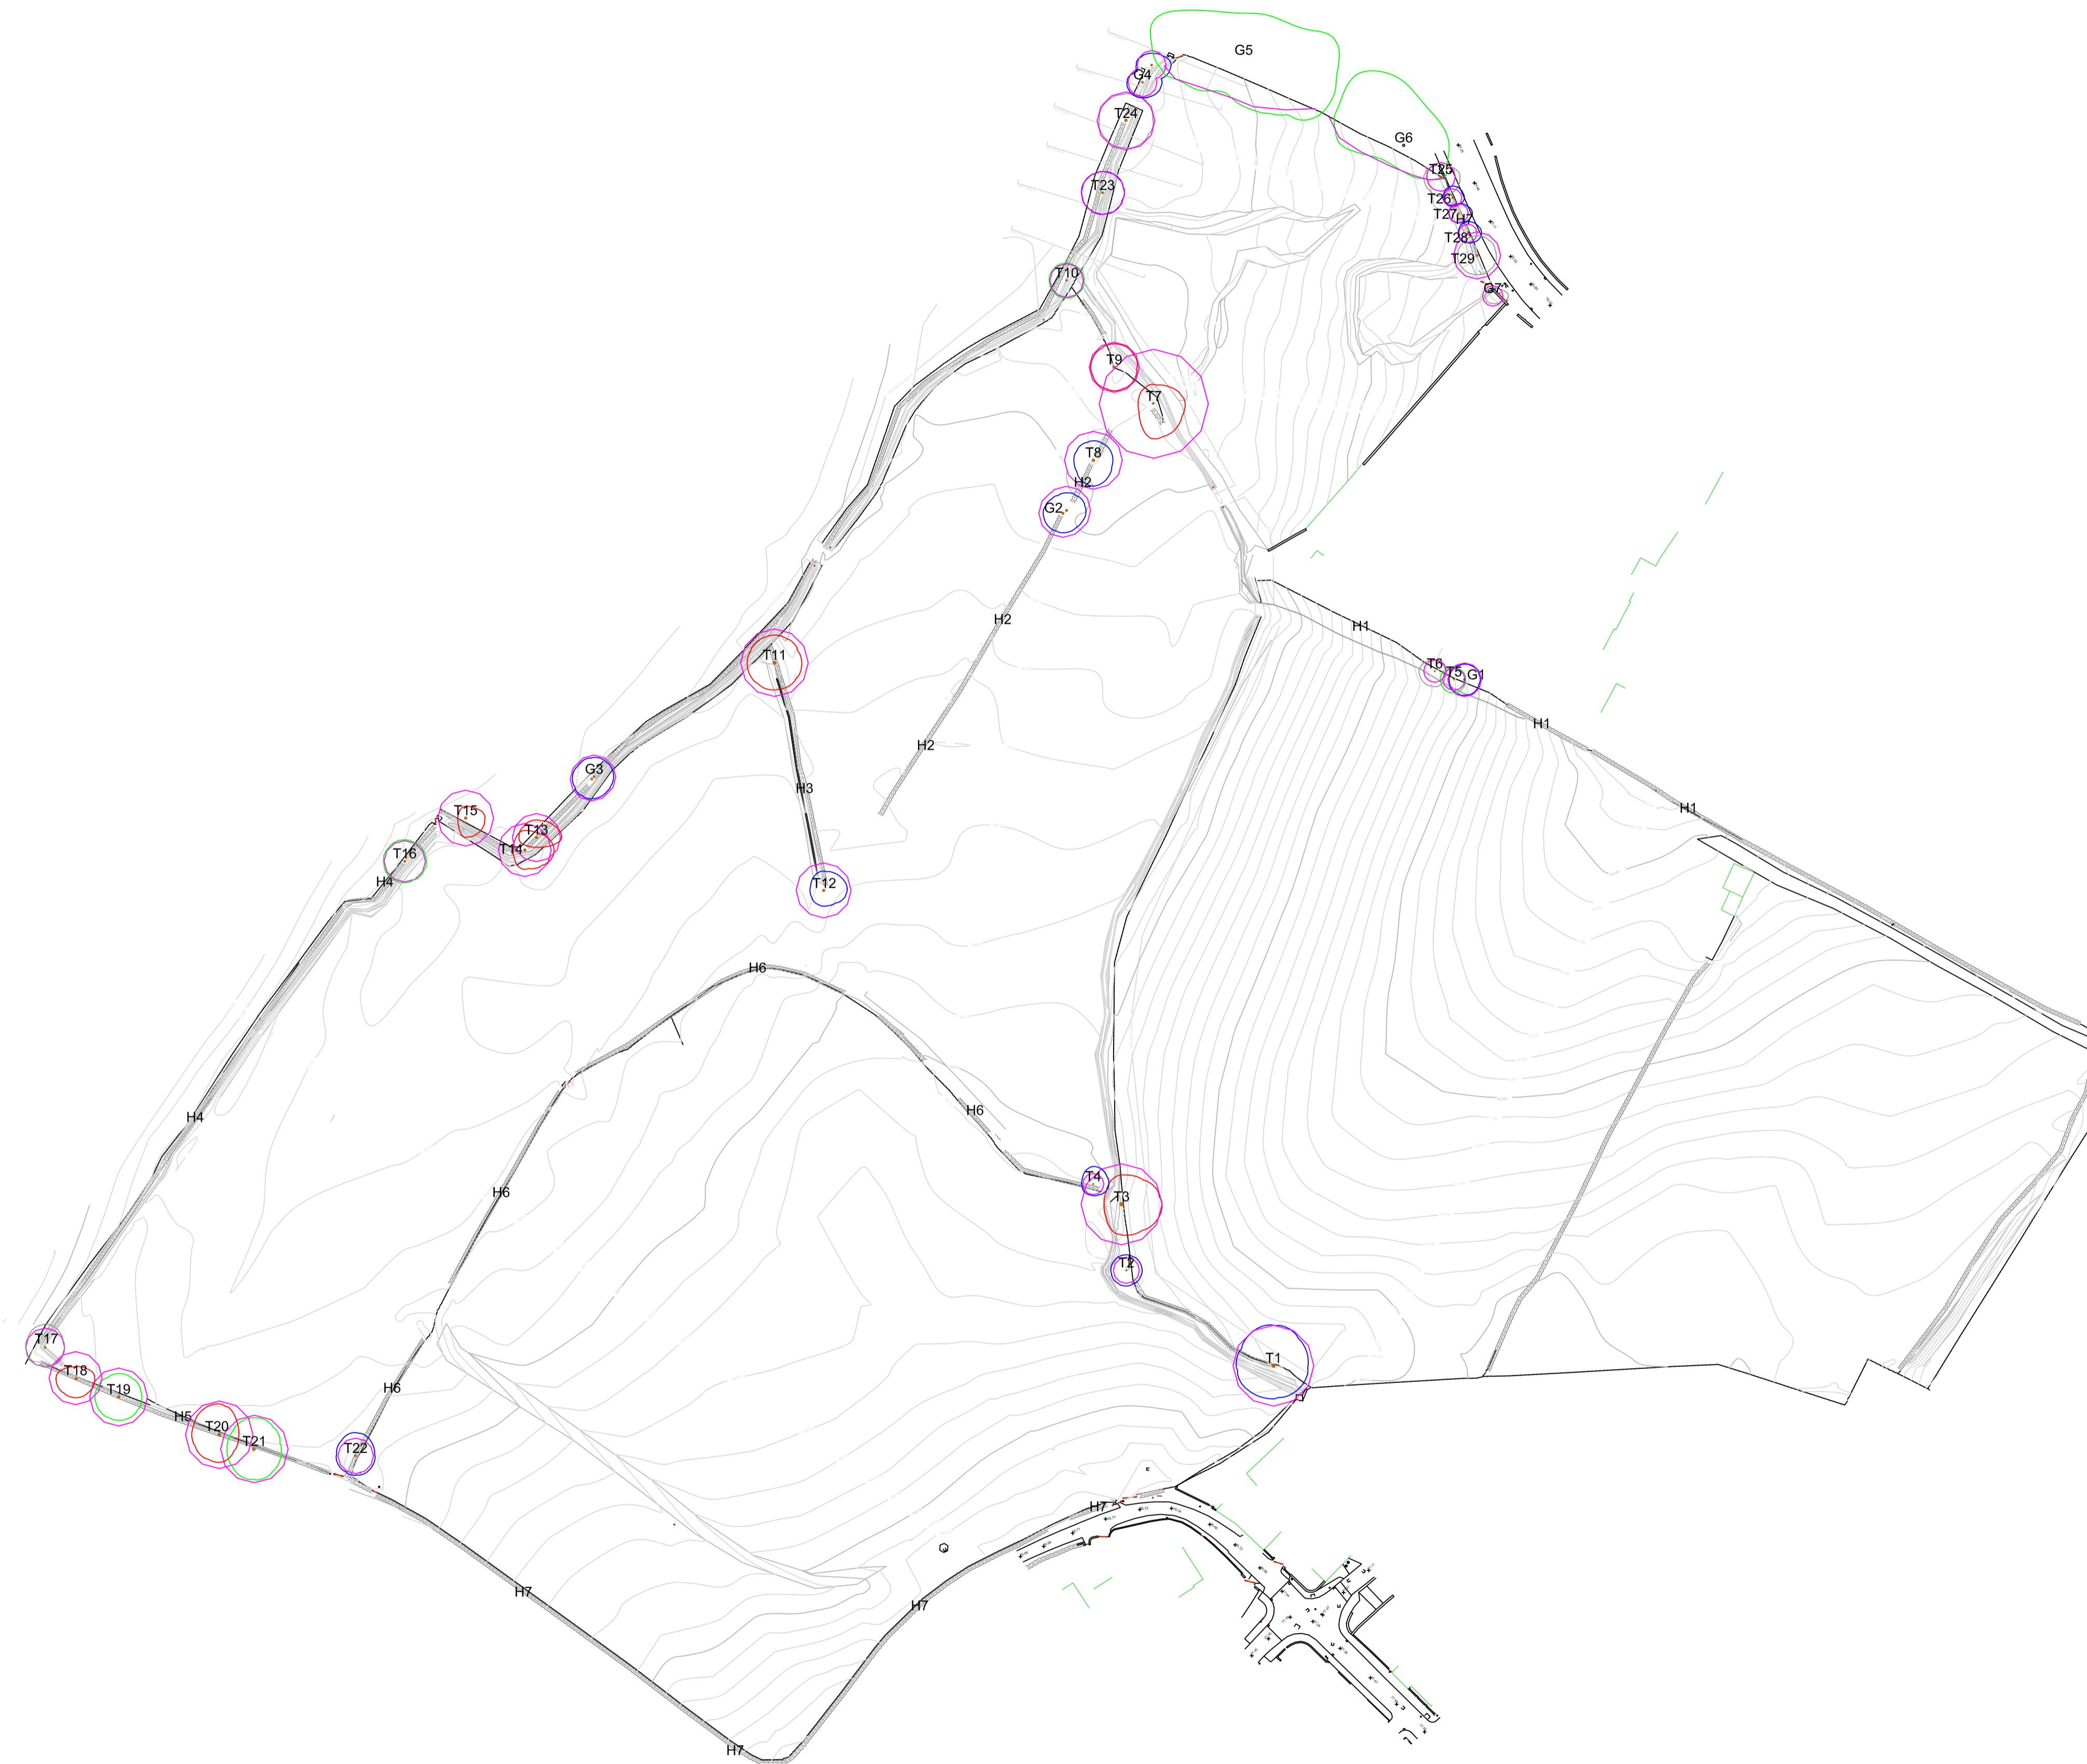
Title:
TREE CONSTRAINTS PLAN
 in Relation to Outline Proposal for Residential
 Development

Category 'U' Tree/Group/Hedge
Those in Such a Condition that they Cannot Realistically be Retained as Living Trees in the Context of the Current Land Use for Longer Than 10 Years

- Broadly assess and advise on the tree protection measures required during development;
 - Annotate the site proposal plan to identify tree numbers, retention categories, crown spreads and Root Protection Areas to indicate tree related constraints in order to produce a Tree Constraints Plan; and

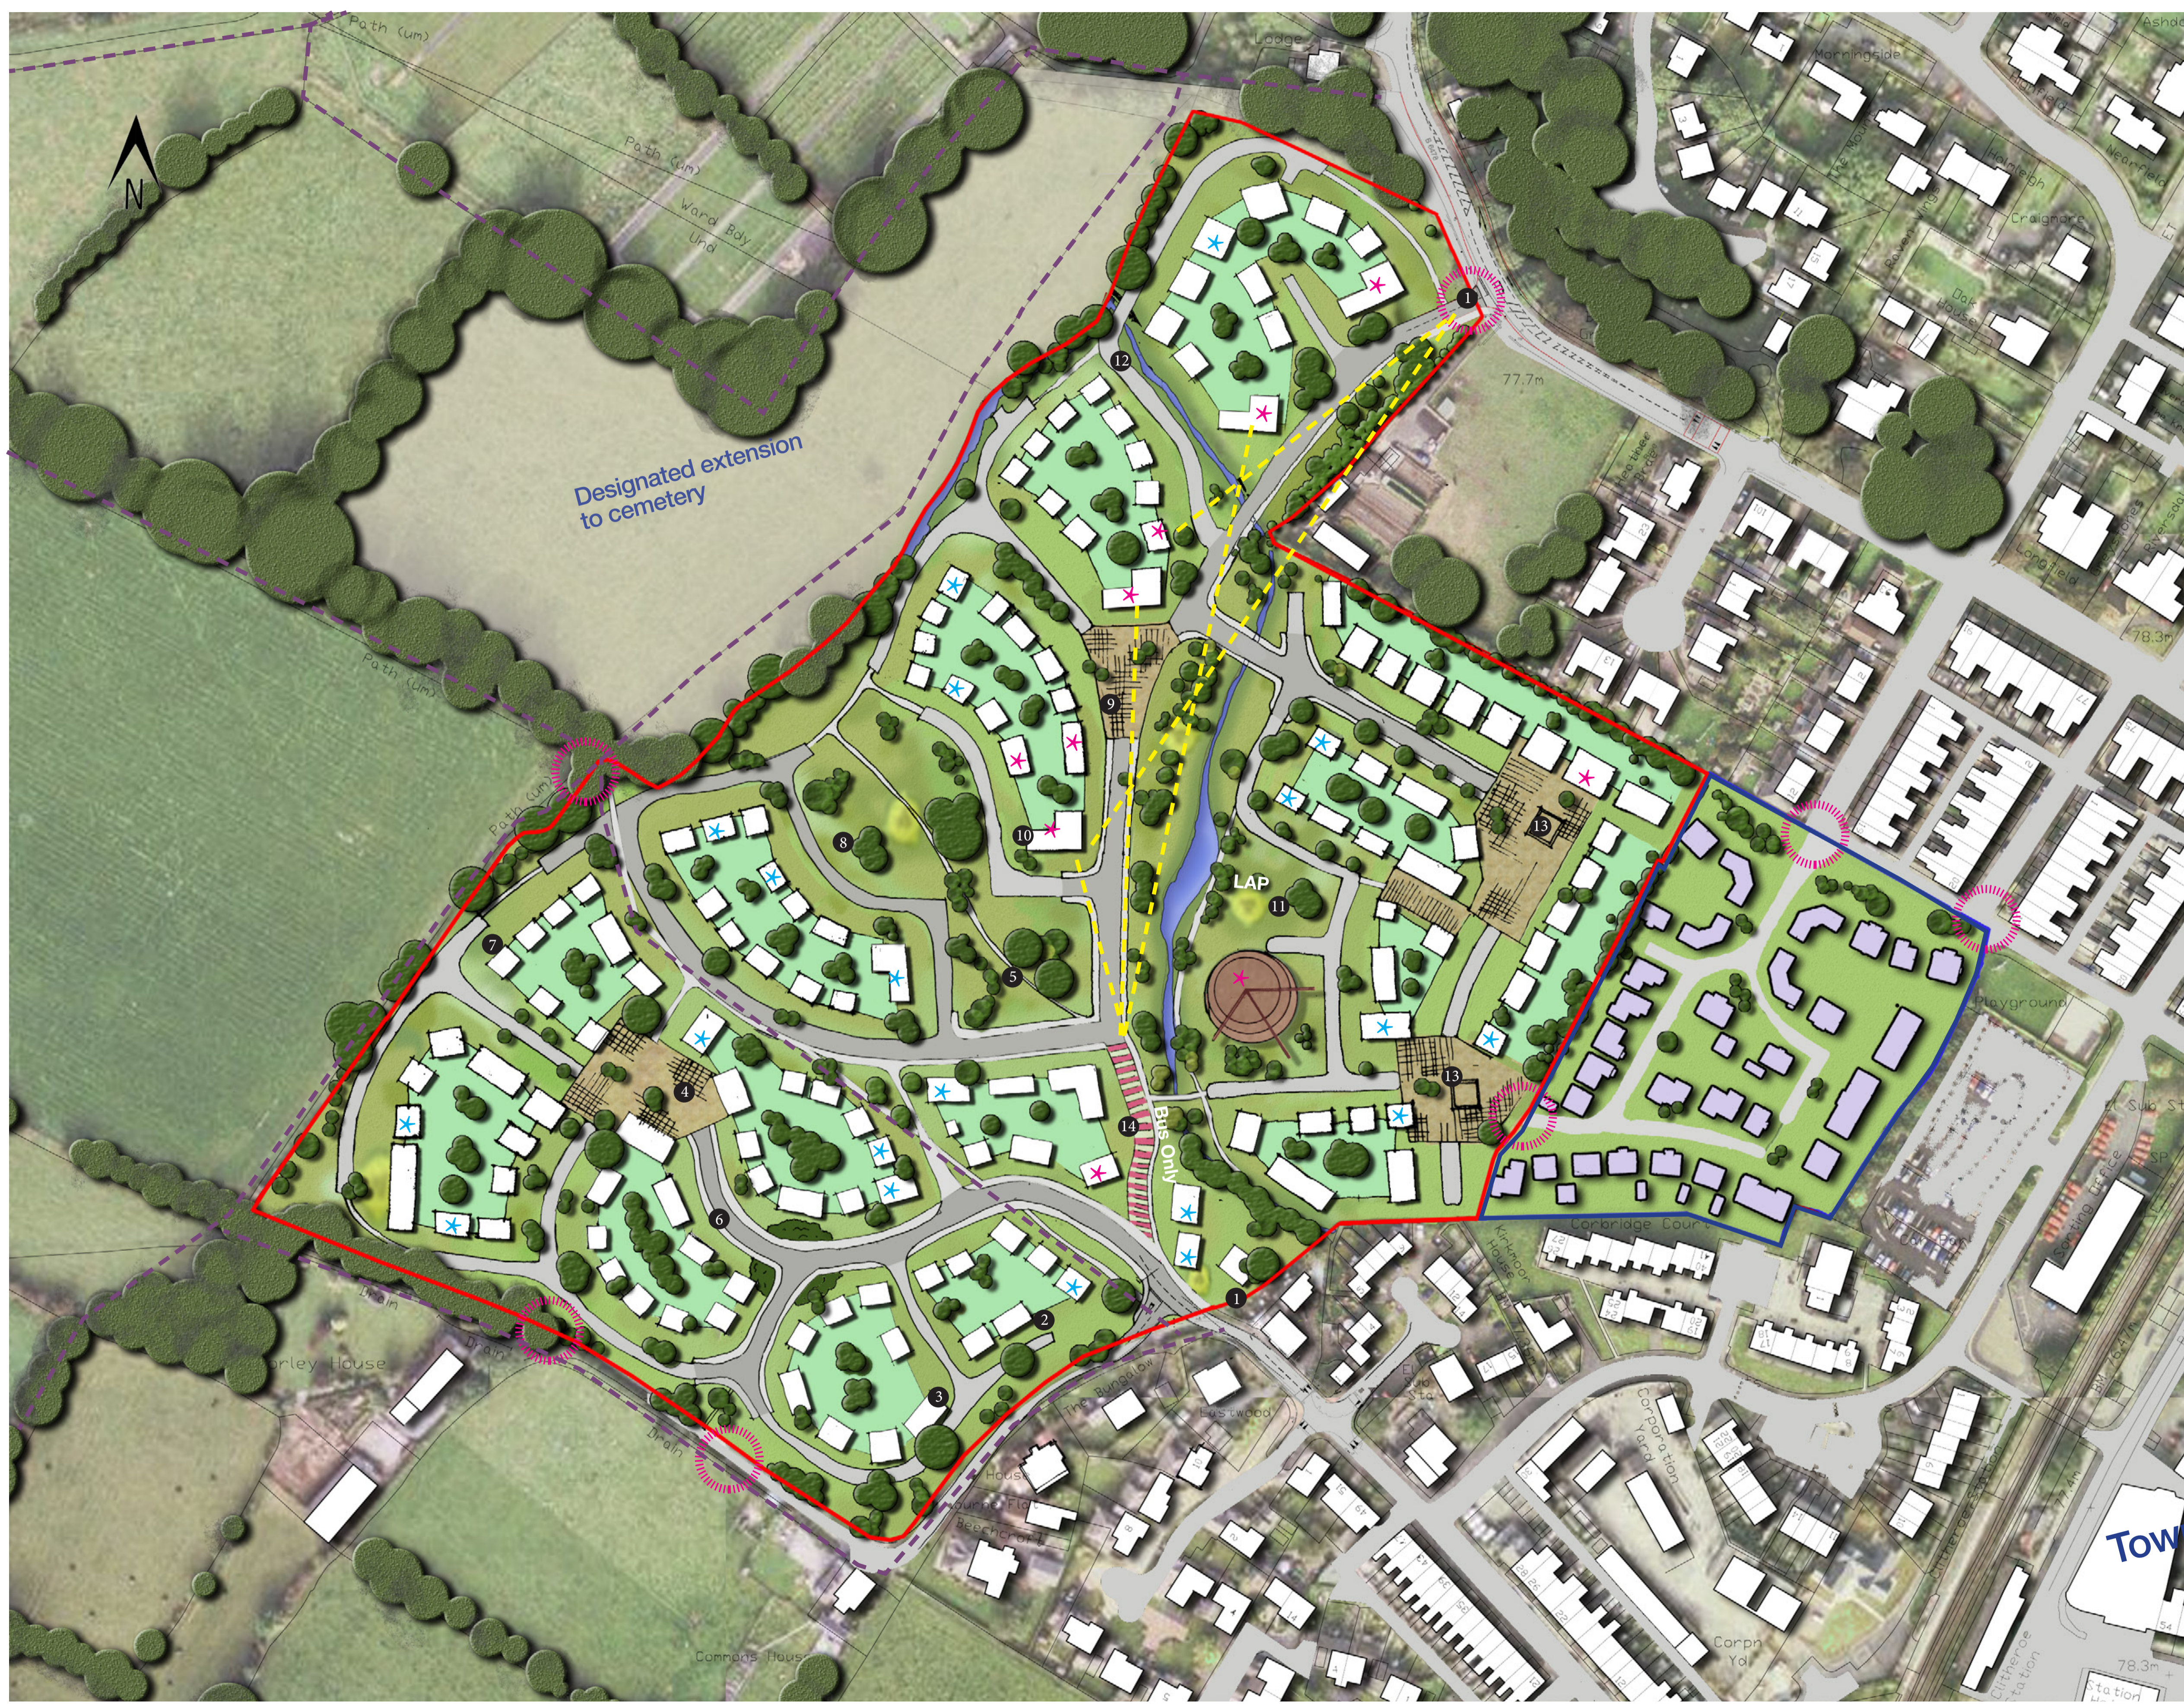
- 1 New primary entrance with carefully designed landscape features create an inviting access point.
- 2 Carefully spaced outward facing feature blocks, overlooking a landscaped amenity area creating an attractive setting along Kirkmoor Road. On street parking restricted providing an uncluttered frontages at the gateway into the development.

- 8.4 An evaluation of the Illustrative Masterplan has indicated that development of the site as shown can be satisfactorily achieved whilst retaining the majority of the surveyed trees, in particular those of moderate and high quality, by incorporating them into areas of public open space or suitably sizeable gardens.
