Waddow View, Clitheroe: Proposed Housing Development Scheme

A Geophysical Survey at Waddow View, Clitheroe, Lancashire

ARS Ltd Report 2012/242
September 2012

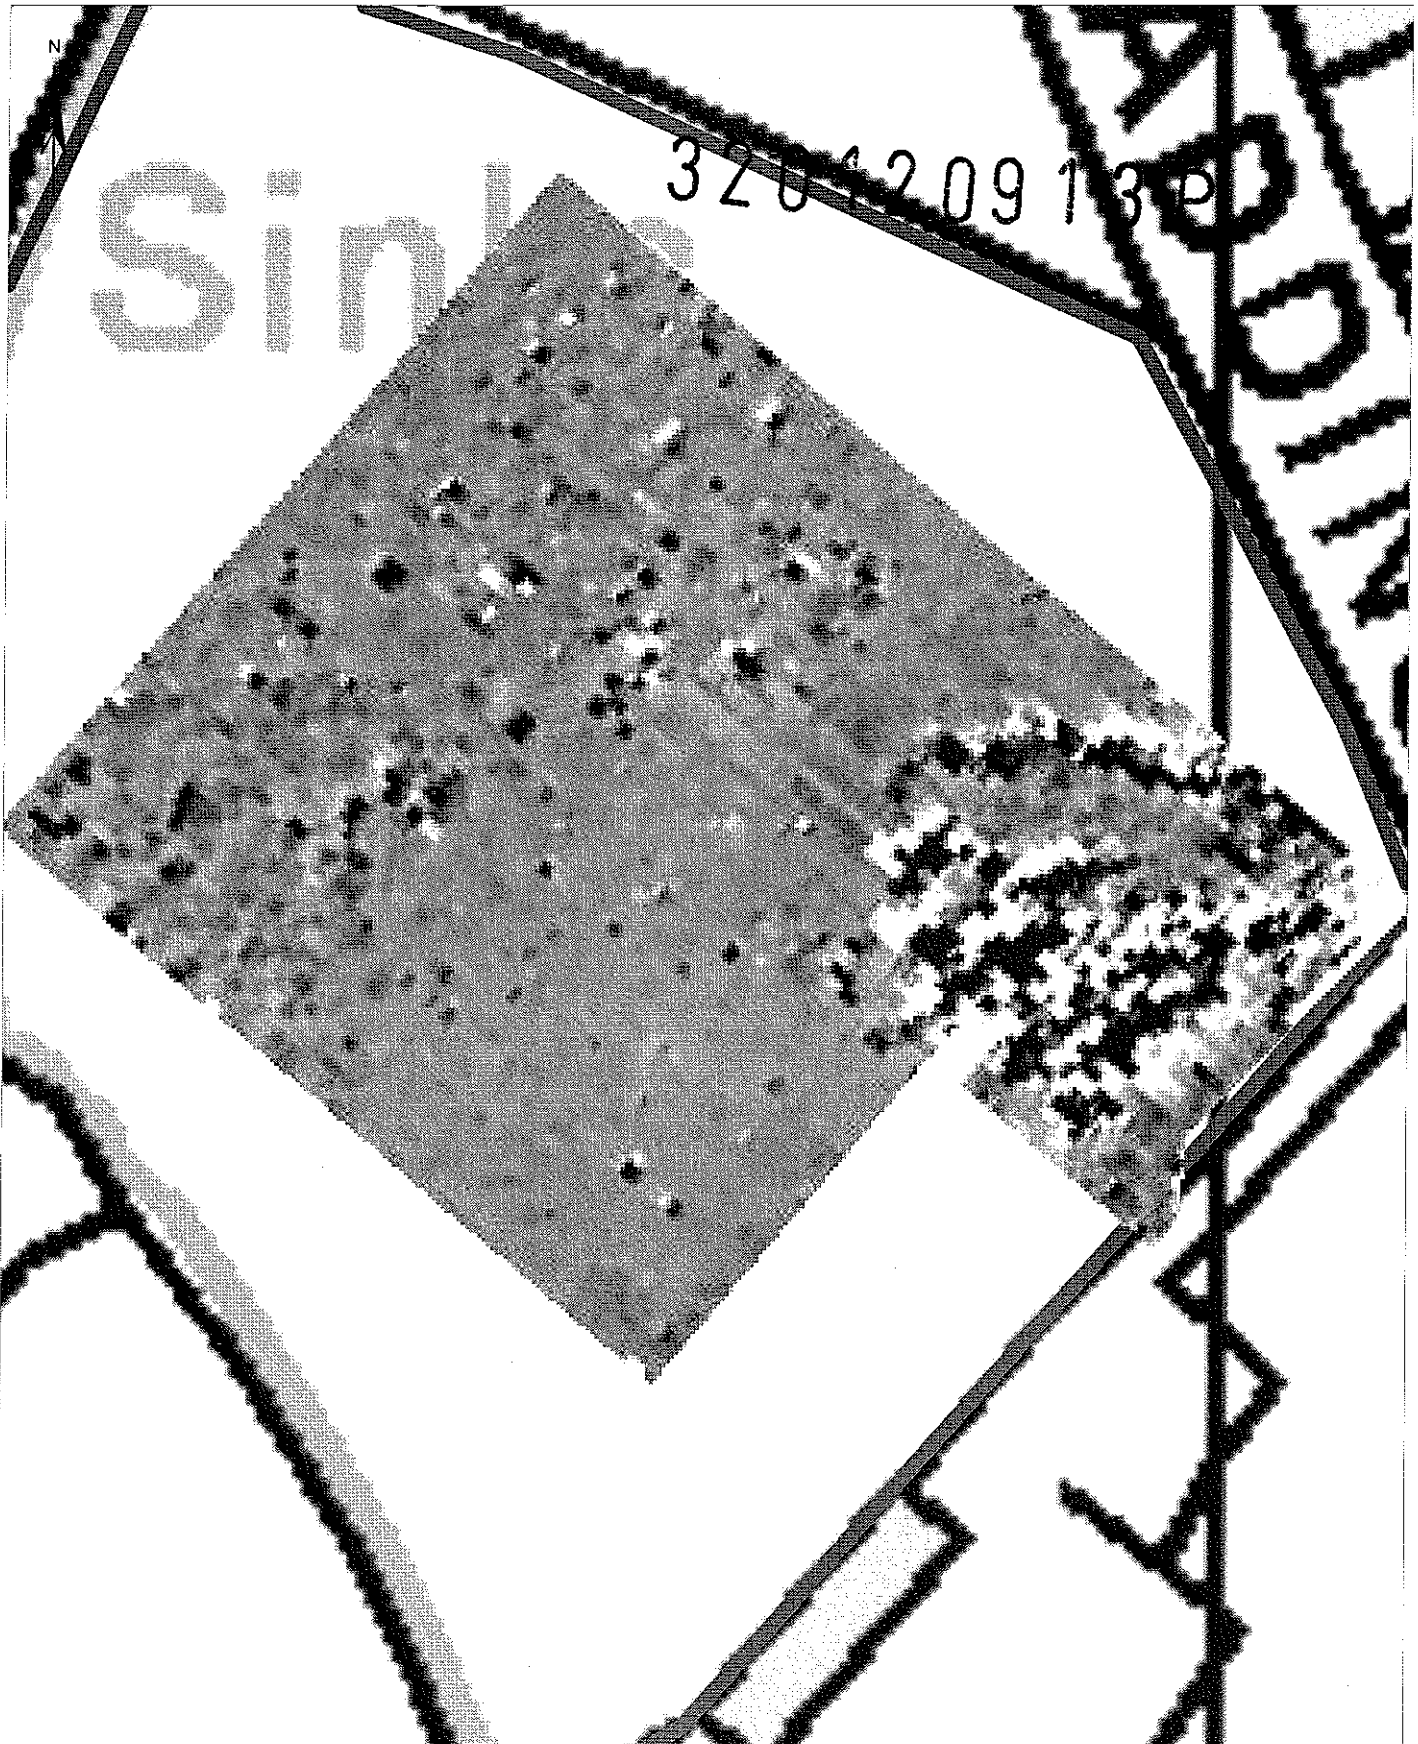
3.2.3.1 This area appeared to contain a range of platforms, banks and depressions, and an extra grid was surveyed in the south-east corner to pick up the extent of one of the raised platform areas. The subsequent survey in both the western and eastern parts of the field either side of a lower-lying dip in the field revealed strong mixed magnetic responses, which are likely to be caused by made-up ground or ground disturbance. Any subtle features of an archaeological origin that may be within this area are likely to be obscured by these high levels of magnetic disturbance.

3.2.3.2 Further strong discrete mixed magnetic responses were recorded throughout the site. These may relate to areas of modern disturbance, modern ferrous materials or boulders in the Devensian Till underlying the site
