Householder Application for Planning Permission for works or extension to a dwelling.  
Town and Country Planning Act 1990

raise height of part of existing roof, new dormer window to front elevation and new porch

**BROAD LEE  
RIBCHESTER ROAD  
CLAYTON LE DALE  
BB1 9EE**

**BAT SURVEY**

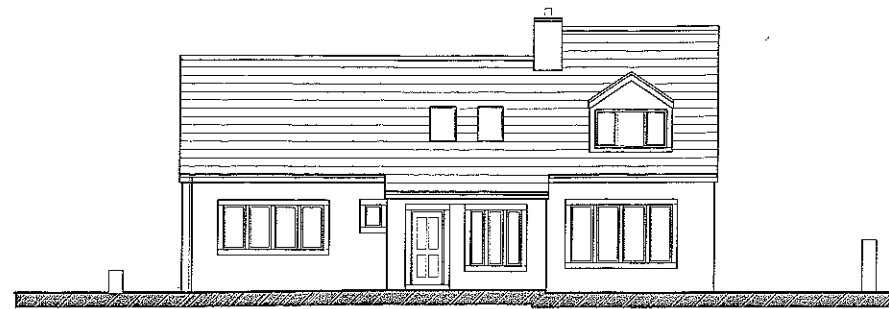
front (north) elevation.

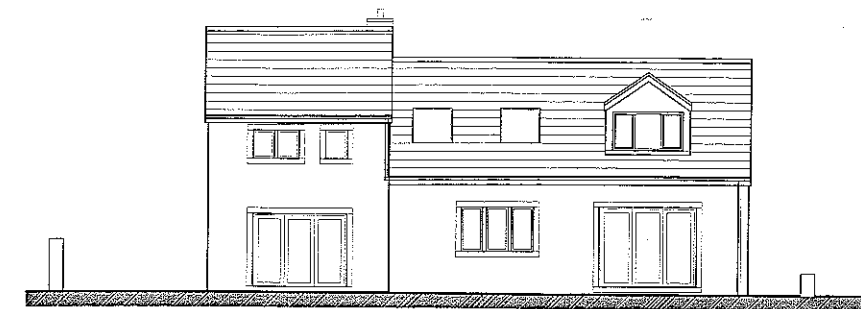
rear (south) elevation.

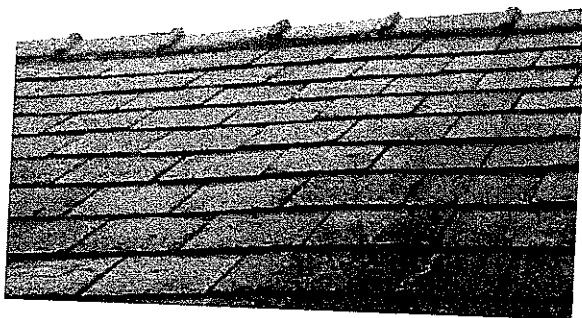
**Photograph 5.**

Roof is in general good order
