Appendix 8.2 Archaeological Desk Based Assessment (October 2011)

Land at Higher Standen Farm Clitheroe Lancashire archaeological desk-based assessment

> report 2741 October 2011

Higher Standen Farm Clitheroe Lancashire geophysical survey report 2811 January 2012

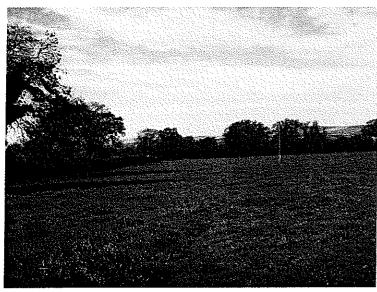
Figure 13: Field 5 with slight undulations visible in the hedge line, looking west

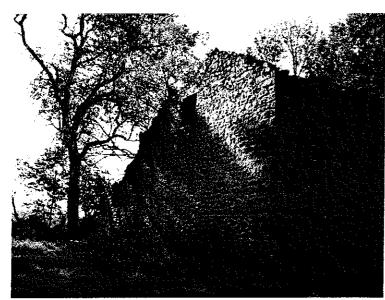
Figure 14: Ruined barn in field 6

- 1.7 Two barns of 19th-century (or possibly late 18th-century) date survive. One in the northern part of the area is in a ruined state. The one at Little Moor is in a good state of repair.

- 6.4 Two barns of 19th-century (or possibly late 18th-century) date survive. One in the northern part of the area is in a ruined state but was roofed until the 1970s. The one at Little Moor is in a good state of repair.

- 8.3 It is recommended that consideration is given to the retention of the existing historic barn structures within the proposed development, which may involve their redevelopment for future use. Impact upon the structures can be mitigated by a programme of archaeological building recording.

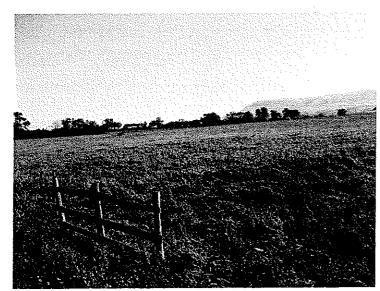
Figure 20: Field 12, looking north-east along the line of the Roman road

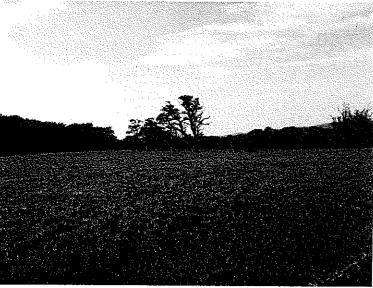
Figure 22: Field 14 with trees marking a former field boundary, looking south

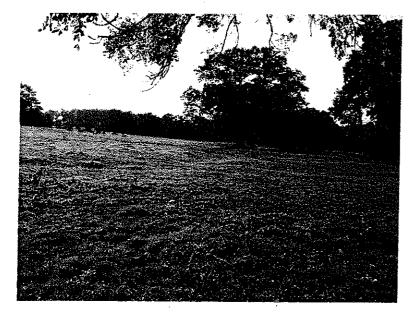
Figure 23: Field 15, looking south-west along the line of the Roman road

- 4.16 Field 15 was covered in close-cropped grass and there were cows grazing. In its western part was a slight ridge with trees extending along it (Figure 23). Numerous other undulations were noted and the line of the Roman road was visible as an earthwork. The field rose to the south-east towards a tree-belt around Standen Hall. The western part of the field was crossed by a footpath.

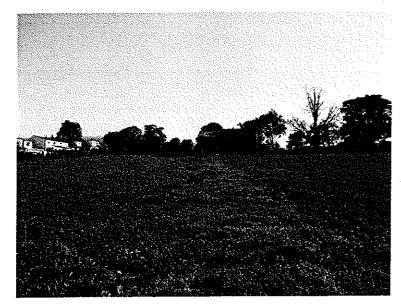
Figure 26: Field 18, looking east towards the barn
