**Application for Planning Permission.  
Town and Country Planning Act 1990**

Proposed conversion of stone barn to residential dwelling

AL 1038 LOW BARN\_WATT CLOSE FARM  
(2-33) PROPOSED SITE AND LOCATION PLANS  
SCALE AS INDICATED

Brooks Ecological was commissioned by to carry out a bat survey of two barns at Watts Close Farm, Gisburn (SD 832 471). These are referred to in the report as the Stone Barn and the Low Barn.

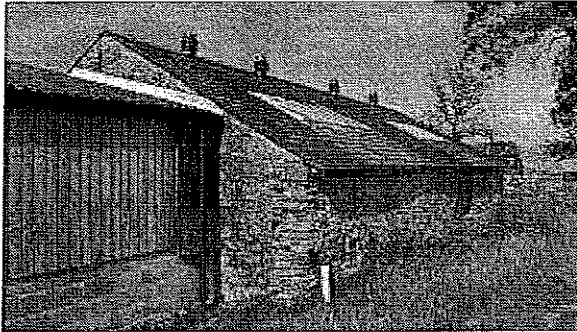
**Figure 2**

The low barn form the west with adjoining paddock building in the foreground.

The barn is of local stone construction and throughout most of the building the mortar pointing is flush to and seals the exterior of the walls. In a few places where pointing is missing small shallow crevices area apparent, as seen the front corner in the picture above.

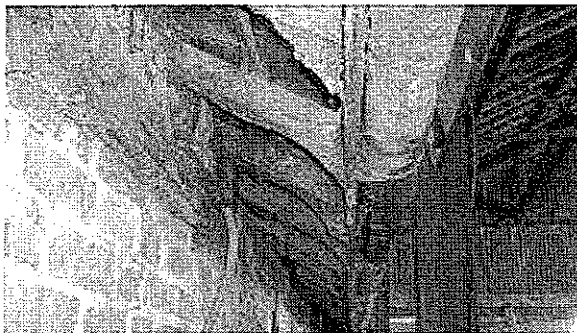
**Figure 3**

The eaves throughout the building are un-guarded and the wall tops accessible, although in many places these are well sealed tot the roof above with mortar, or (as in the covered sections adjoining buildings) are heavily cobwebbed.

Cobwebbed eaves found under the covered section to the north of the low barn

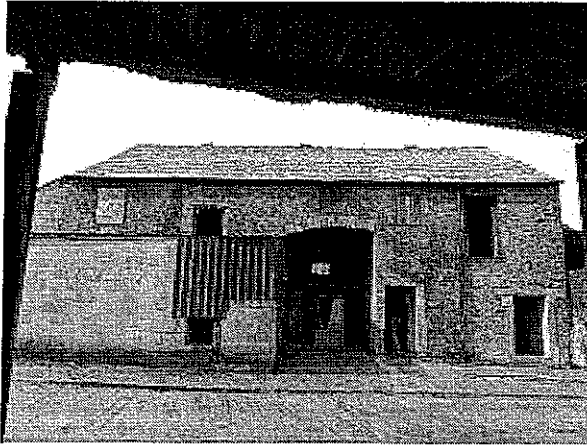
**Figure 4**

The stone barn viewed from the east.

In generally sound repair, most of the building's mortar pointing is flush to and seals the exterior of the walls, extensions have a layer of mortar render similarly precluding access for bats. Occasionally areas of pointing have fallen away to create crevices in the walls and in places and where vent holes breach the walls and where pipe work has been inserted in the past there are now holes in the outer walls which provide access to the interior of the barn for bats. Windows or doors within the barn are either missing or ill fitting and similarly provide ample access for bats directly into the interior of the barn.

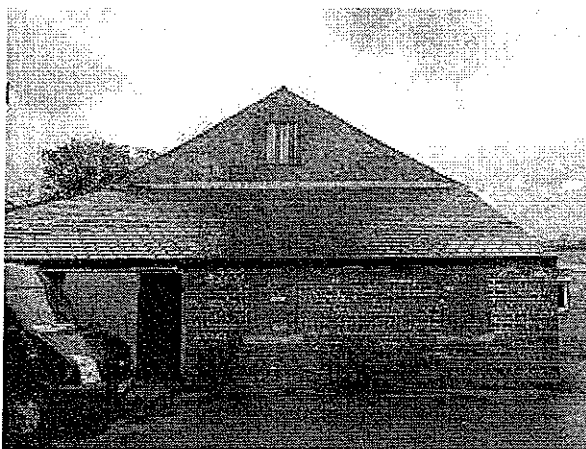
**Figure 5**

The western extension section has a corrugated asbestos roof but otherwise the roofs associated with the building are of blue slate construction and are in good repair with no significantly moved slates, an area of lead flashing which seals the southern extension to the main barn is hanging off and would provide access to crevice space behind.

Typical roof detail, this showing the single pitch of the southern lean-to extension and peeling lead flashing.

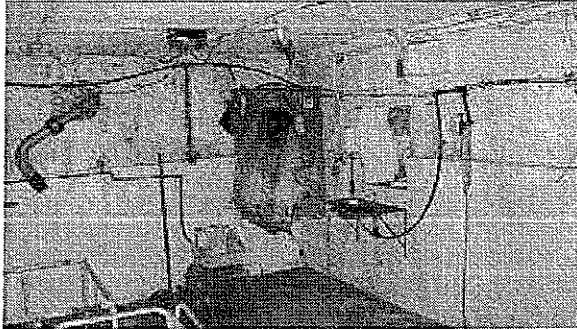
**Figure 6**

Typical interior of the dairy occupying the southern extension.

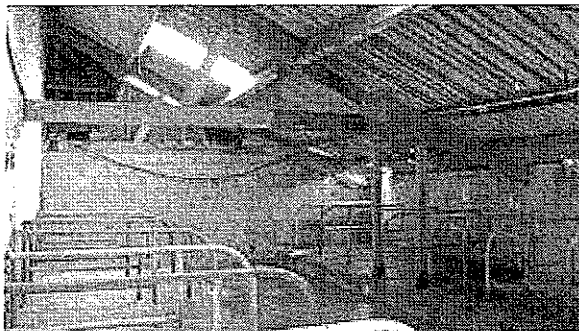
**Figure 7**

The western section contains cow stalls and roof lights and a large open door to the north make it light and airy inside.

Stalls in the western extension.

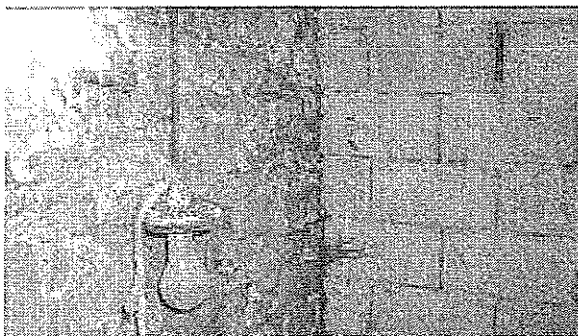
**Figure 8**

The main barn is occupied on the ground floor by a milking parlour and further dairy /processing areas. Partition walls have been used to divide this area up and now provide some potential roost crevices in the form of un-pointed block-work. Gaps leading upwards from the wooden door lintels also lead into small potential roost spaces.

Gaps within the block-work walls inside the main barn.

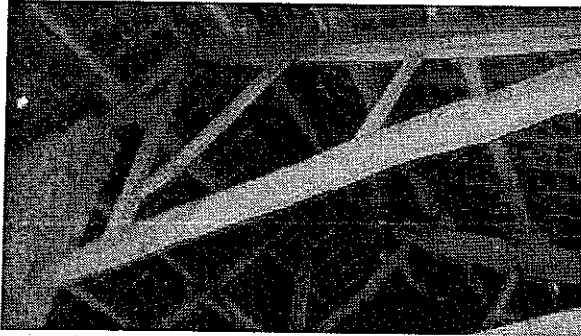
**Figure 9**

The upper storey of the barn is accessible via ladders to hayloft style floors, in the northern and southern ends of the barn. The interior of the roof is unlined in the southern section and has a plastic lining in the northern half. The ancient timbers supporting the roof are un-planed and contain significant joint work, these provide plenty in the way of suitable crevice space and the interior of the barn is relatively sheltered and dark and is likely to be attractive to roosting bats. The interior walls of the main barn also present crevices and accessible wall tops.

Typical beam-work within the original barn section of this building

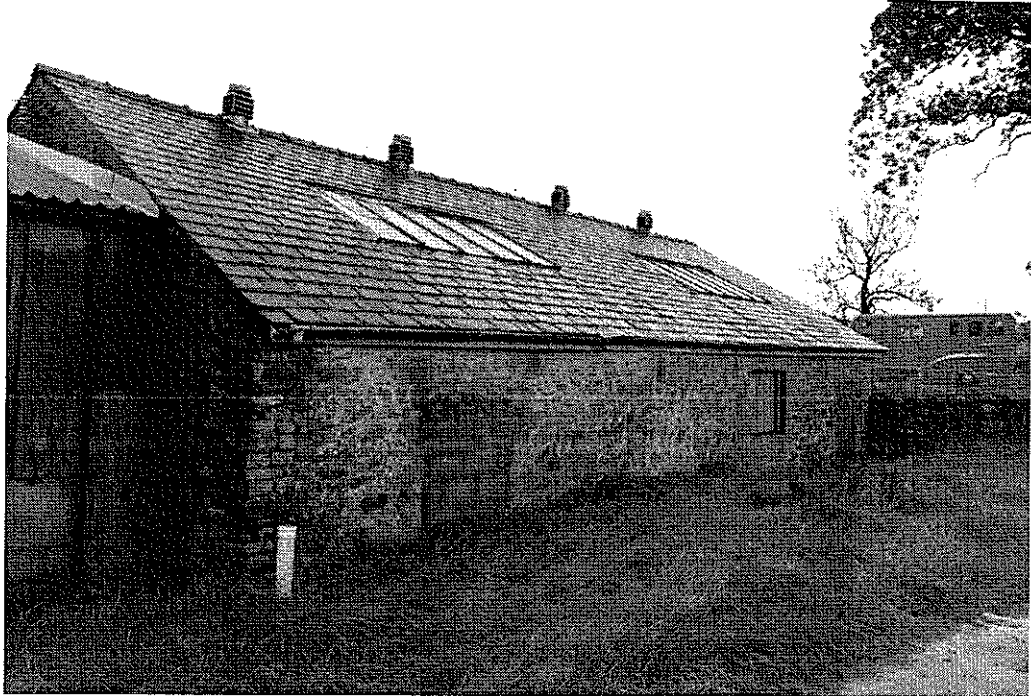
South Elevation of Goodcrooks Laithe

- 5.1. The external materials and construction of the barn indicate that it originates from the period beginning in 1750. The slate roofing materials will have likely arrived with the either the Canal or Railway. Given the mention of the barn in the 1810 conveyance, it is likely that the building was covered in a different roofing material prior to the coming of the canal or railway.
- 5.2. The existing rubble stone walls have been partially rendered. Elements within the walls indicate areas where stone has been more regularly finished which is attributable to the late 18<sup>th</sup>, early 19<sup>th</sup> Century Barn architecture.
- 5.3. The barn is of sufficient height to sustain two storey's.

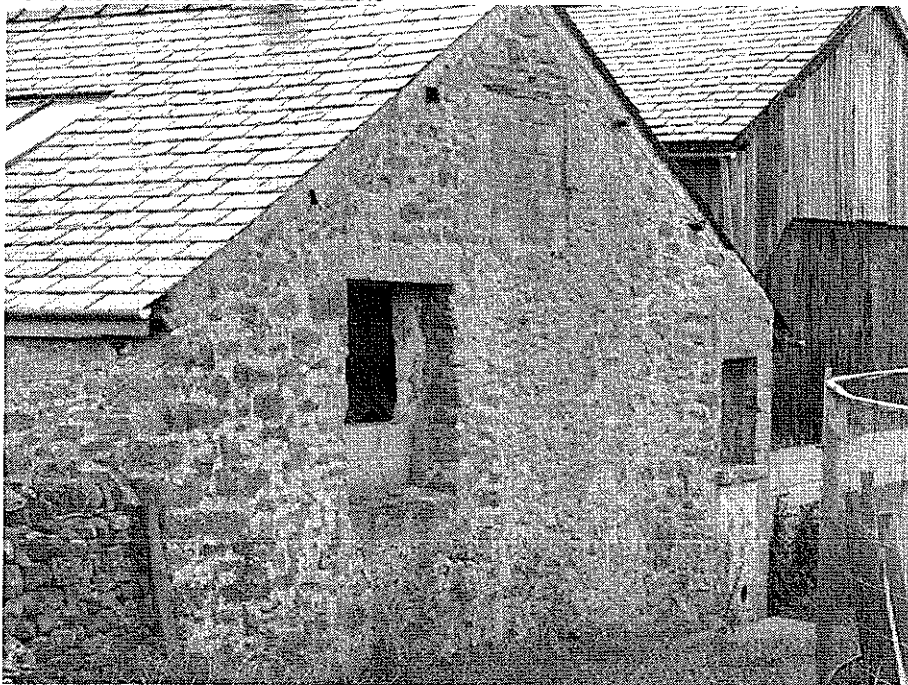
East Elevation of Goodcrooks Laithe
