## Background and Supporting Information

Sheepfold Farm, Balderstone, Lancashire

Investigate the presence or absence of bat species as part of a planning application for the conversion of a barn and demolition and reconstruction of a farmhouse at Sheepfold Farm, Balderstone, Lancashire.

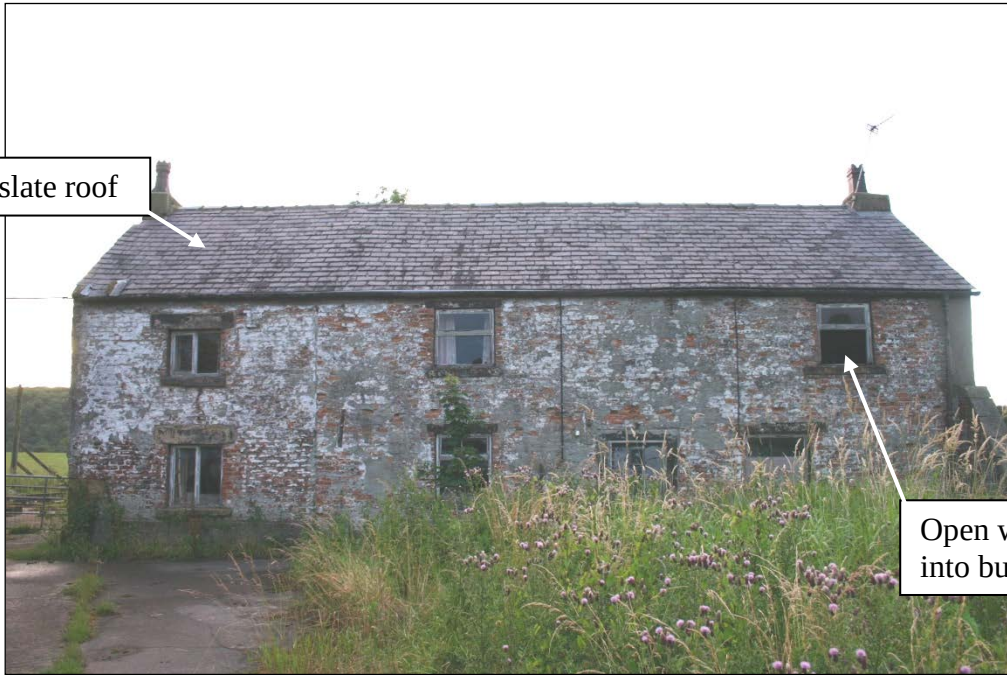
*Plate 1. South elevation of farmhouse*

Well-sealed slate roof

Open window access  
into building

**Farmhouse** – The farmhouse is constructed from red brick, which is rendered on the Eastern elevation. Externally, the brick work and rendering appear well sealed, with no cracks or gaps thought to be suitable for roosting bats. There are some small gaps on the roof verge on the Western gable end of the farmhouse which may be suitable for crevice dwelling bats e.g. Pipistrelle species, along with a crack on the wall on this elevation. All areas of the walls could be inspected with a ladder, torch and or endoscope.

The slate tile roof appears to be in good condition with only a few lifted slates which may be suitable for crevice dwelling species. Internally, the roof is lined, though the loft space is not insulated. The apex of the roof was partially cobwebbed and no droppings were located in the void. The loft hatch was open as was the master bedroom window allowing bats and birds free access into both the house and the loft void.

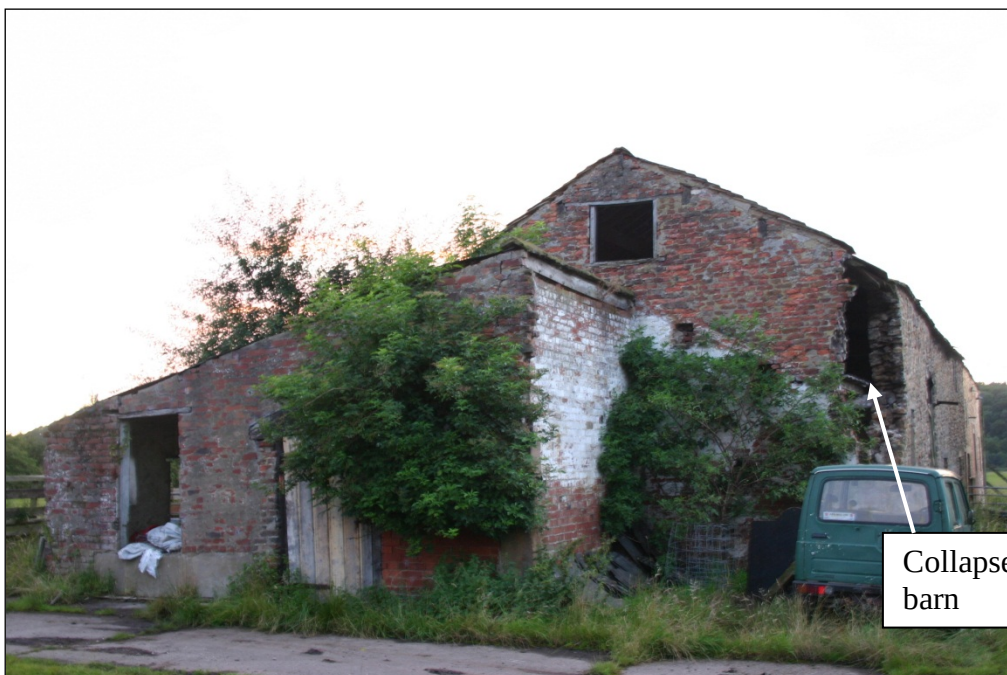
*Plate 2. Southern elevation of barn*

Collapsed corner of  
barn

**Barn** – The barn is split into 2 distinct halves. The more Southerly half is of stone construction with an unlined slate roof. Intact walls are well-sealed externally, though the South Eastern corner of the barn is collapsed making the internal space very draughty. All areas of the walls could be inspected with a ladder, torch and/or endoscope.
