**BOW17/426 Bowland High School**

***Bat Inspection and Emergence Survey Report***

October 2012

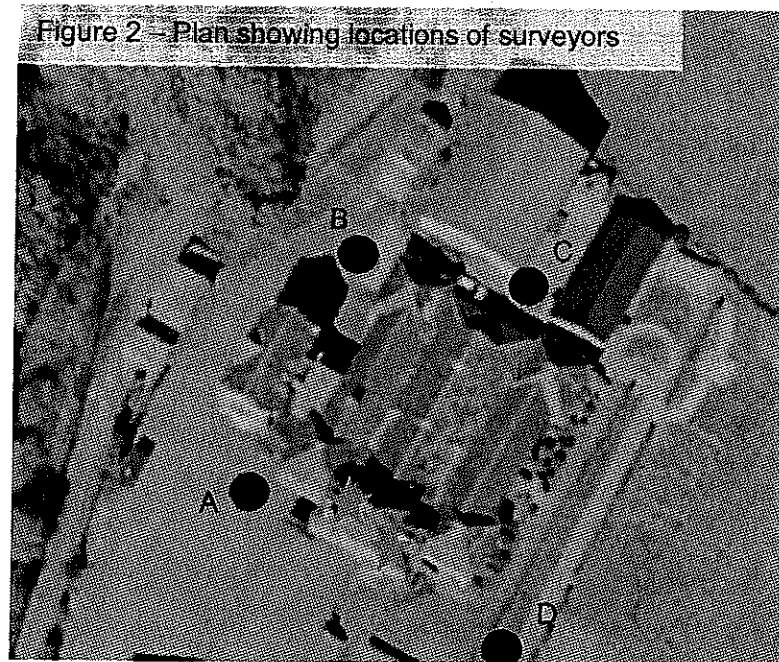
- 2.1. A dusk emergence survey was carried out on the building on 19<sup>th</sup> September 2012 by David Fisher, Gemma Waddington, Mark Brakes and David Anderson. The survey was undertaken from 18.55 until 20.45 with sunset at approximately 19.14. Surveyors were positioned to give the best coverage of the entire building and to cover all possible emergence locations as informed by the day-time inspections. Surveyor locations are shown on Figure 2 below.

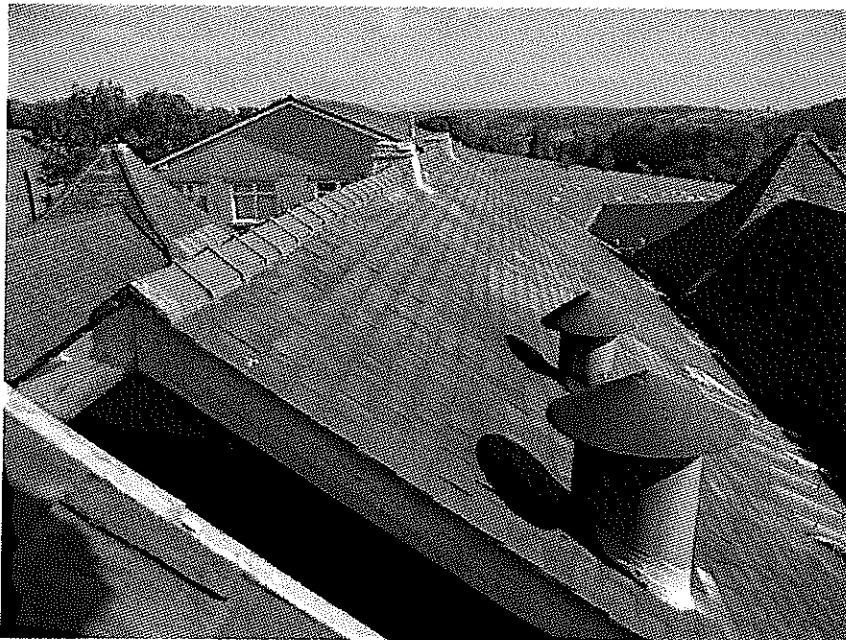
- 3.5 The slate roof is a complex multi pitched construction which is in a reasonable condition (see Photo 1 – Appendix 1). Flashing is common throughout, (concentrated in hip joints, chimneys, and valleys) and provides gaps that are potential roost access points.

Photo 1 – View of multi pitched roof

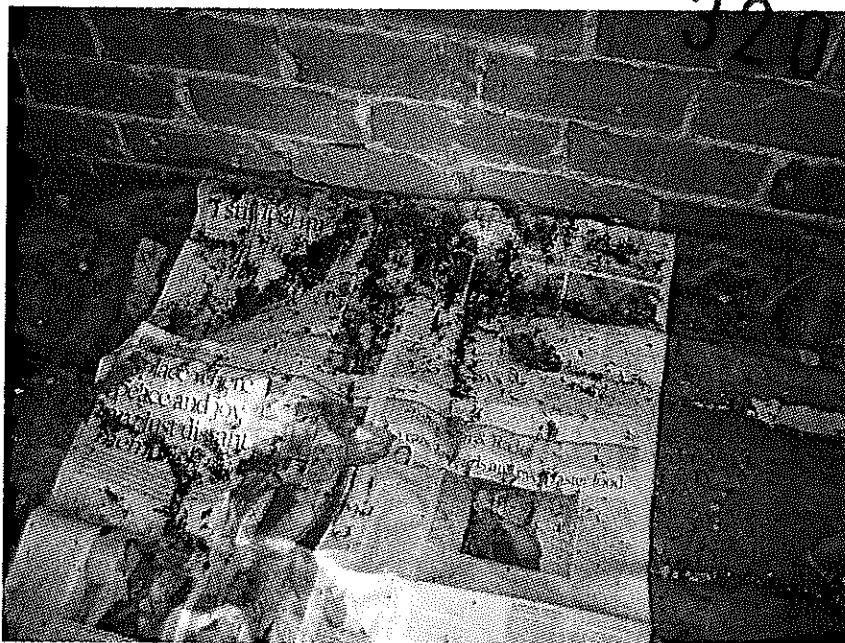
- 3.7 Bat droppings were found in a number of places within the loft enclosures and are shown in Figure 1. From the droppings, the species are likely to be brown long eared/natterer's and pipistrelle species.
- 3.8 The droppings in location 1 on the plan below were found in the two far sections of the roof on top of newspaper dated 2009. The droppings were from brown long eared and pipistrelle species. Large amounts of older droppings were found beneath the newspaper. The droppings were concentrated under the ridge beam with higher concentrations found below the north gable wall and the second internal brick wall. The number of droppings suggests a maternity roost of brown long eared and pipistrelle bats. See photos 7 and 8 in Appendix 1.

Photo 7 – Photo of droppings on newspaper below ridge at gable end

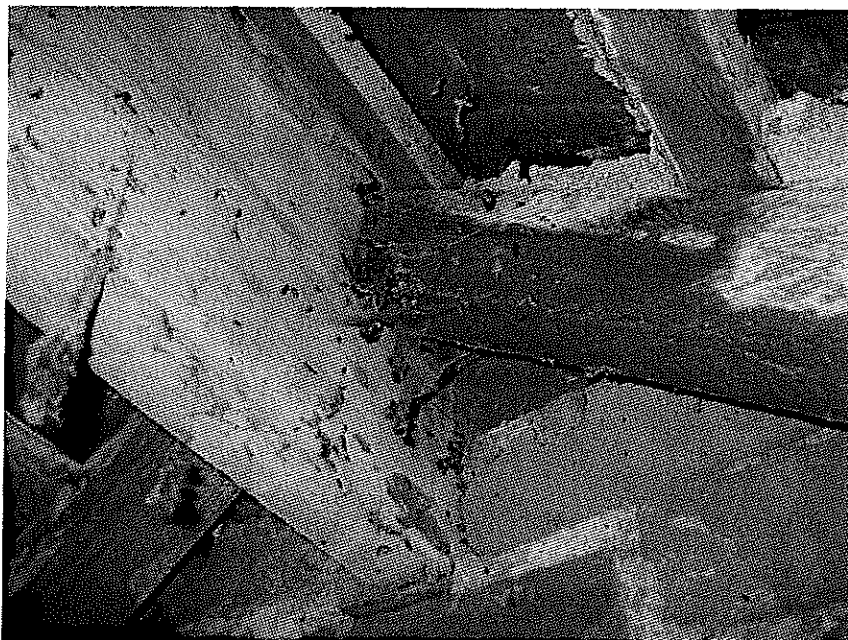
Photo 8 – Photo of droppings at ridge

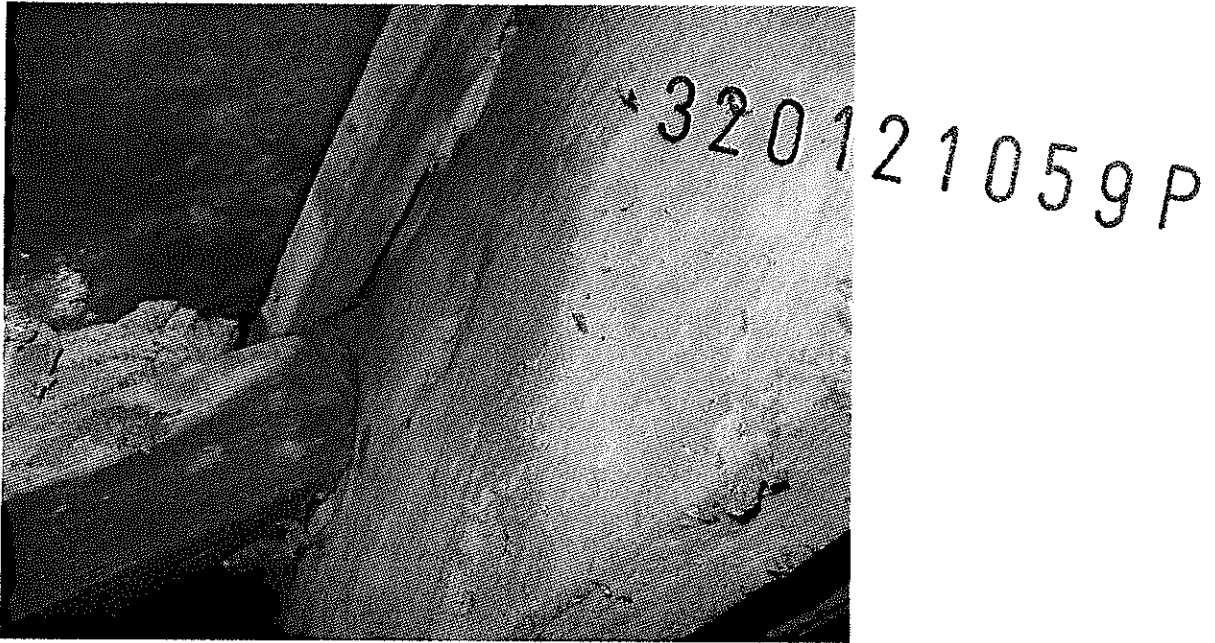
- 3.9 In the section of the roof where droppings were found the ridge beam had fewer cobwebs than elsewhere, and oil staining from the bats' fur was evident on the ridge beam (see photo 9 Appendix 1).
- 3.10 Externally a small number of droppings were seen on and around the fascia boards at point 1 above.
- 3.11 Location 2 had a small number of droppings from brown long eared and pipistrelle bats, indicating a small summer roost is present.
- 3.12 In location 3, a small number of scattered pipistrelle droppings were found indicating a small summer roost.

Photo 9 – Photo of likely roosting space along ridge with oil staining

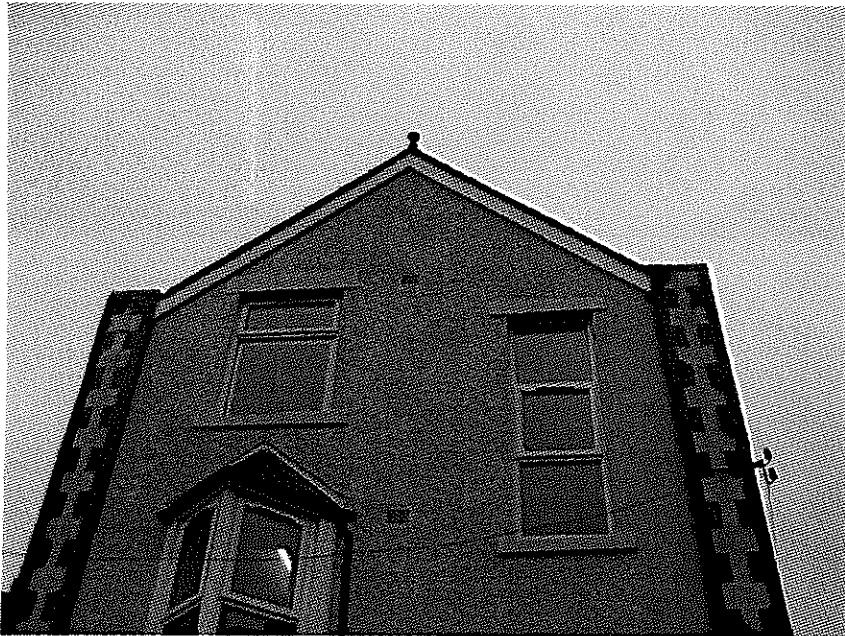
Photo 10 – External view of gable end where droppings were found

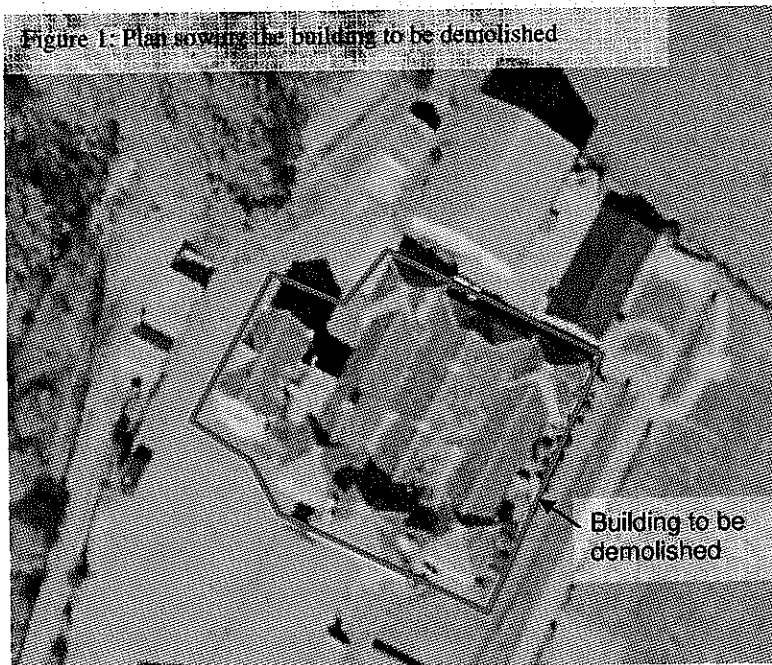
Figure 1: Plan showing the building to be demolished

An aerial photograph showing a large, irregularly shaped building complex. A rectangular area within the complex is outlined with a white line. An arrow points from the text 'Building to be demolished' to this outlined area. The surrounding area appears to be a mix of open land and other structures.

- C.5.1 The building that is to be affected by the demolition works is situated within the school grounds of Bowland High School between two buildings (to the north and south/southwest) The school is situated in a rural location on the edge of Grindleton a small village within the Ribble Valley. Immediately to the north west of the site is a small woodland clough. The land in the wider landscape is dominated by cattle and sheep grazed pastures. Small blocks of woodland occur within the landscape connected by hedgerows and mature trees. The River Ribble is located to the east of the site and is at its closest 350m.

- C.5.2 The building is a complex building housing classrooms, offices, kitchen and main hall. A number of rooms are being used for storage. The building is of a pebble dashed brick construction. The building is painted and in good condition.

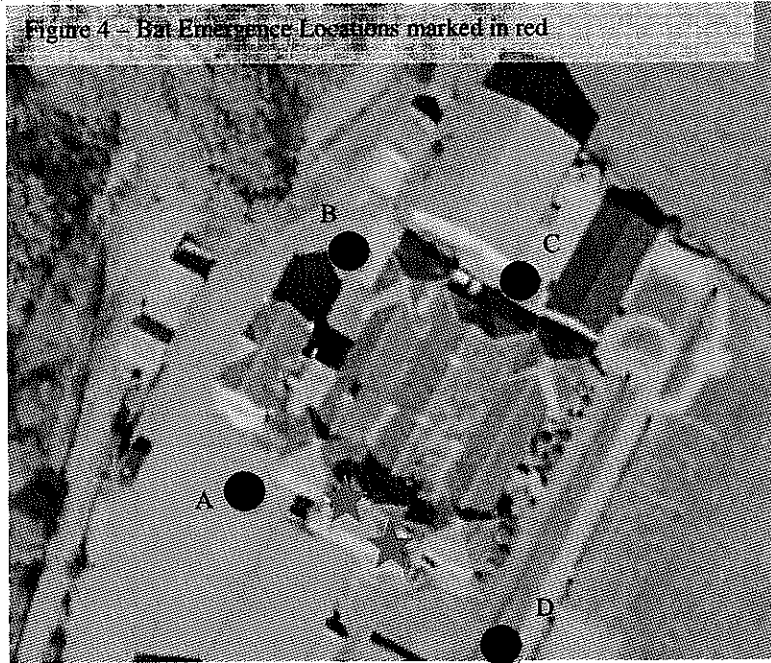
Figure 4 – Bat Emergence Locations marked in red

Bats could gain access to the building through a number of locations including under the fascia boards (where present), gaps in slates/ridge tiles and through the large main barn door and a series of small barn doors which appear as though they are left ajar permanently. In addition, there are open windows and air slits within the stone work that bats could use to access the building. Bats could also access the building where the roof meets the top of the stone wall as there are gaps present.

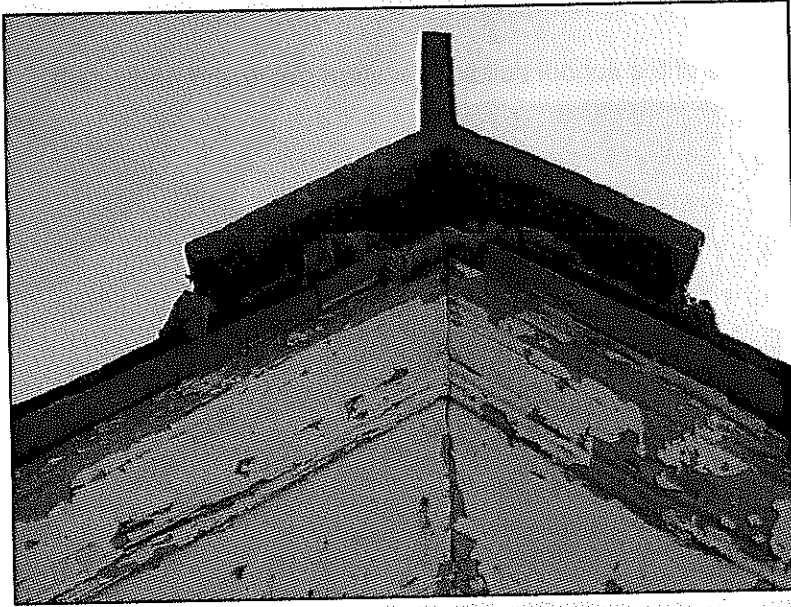
Plate 4: The Eastern roof apex and ridge, below which droppings were found.

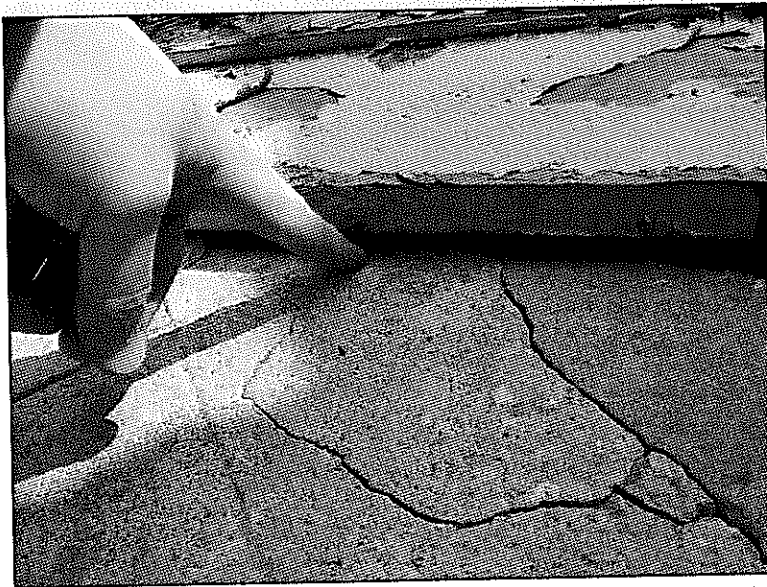
Plate 5: Detail of eastern gable end, showing gaps with excellent potential for entry/exit by bats.

- 4.1.3 As can be seen from Plates 1-6, although the roof is in reasonable state of repair, the exterior of the building provides opportunities for bats to gain entry to the building. All of the typical areas of a roof which bats tend to use for entry/exit were searched. The entire roof was in reasonably good condition, with no slipped or missing tiles (Plate 3). The pointing at the western gable end was well cemented and no gaps were present at the edge of the roof tiles. Other possible bat entry/exit points such as the ridge tiles were in fair condition and well cemented, with the exception of the eastern gable end ridge (Plate 4). Also, there was a 3cm gap between the bargeboards and the wall on the eastern gable and this provided excellent possibilities for bats to enter the roof (Plate 5).

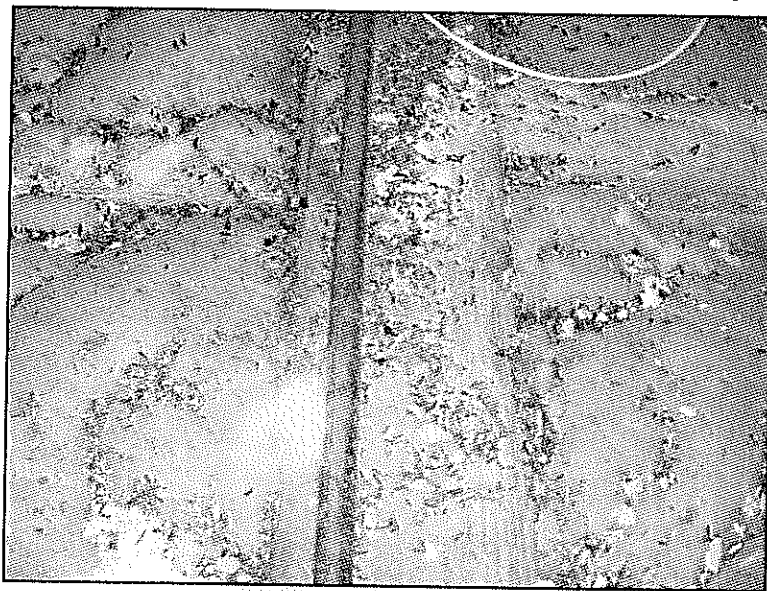
Plate 9: Large number of bat droppings present along the central joist.

- 4.2.3 *Within the second and third sections of the loft numerous droppings and discarded prey items were found which indicate the presence of bats.* The number of droppings increased with distance away from the skylight. Plate 9 shows a small large of droppings directly beneath the ridge beam. Samples of these droppings were visually analysed. The findings indicate the likely presence of *Plecotus* or *Myotis* species. In addition, the varied shape and size of droppings present also indicates likely presence of *Pipistrellus* species. In addition to the droppings, the lack of cobwebs on the ridge beam is a typical indicator of bat activity (Plate 10). Despite a through search, no single location could be pinpointed as an obvious roost entry/exit point.

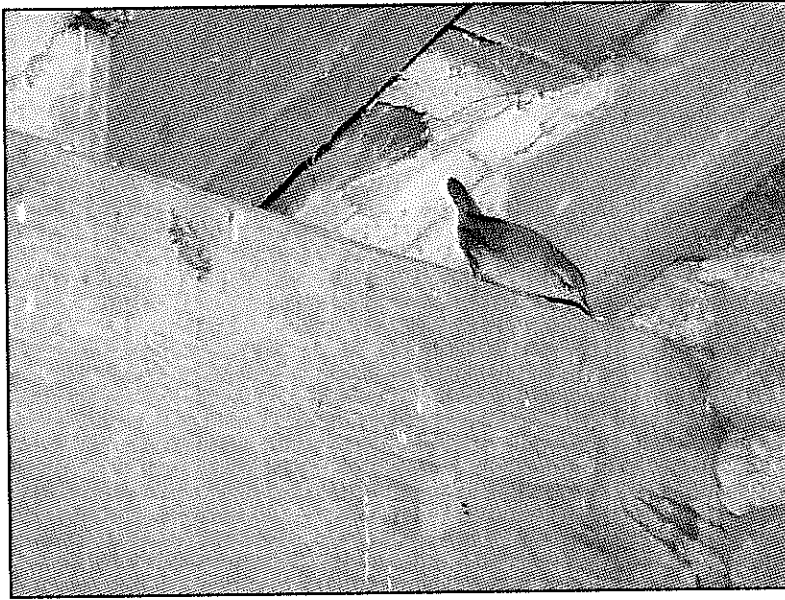
Plate 11: Evidence of activity was abundant within the loft and a wren was observed.

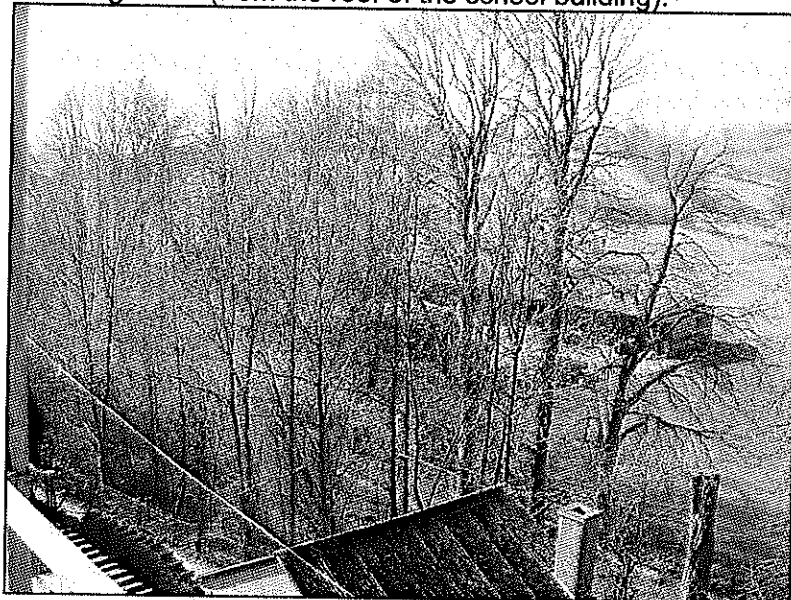
Plate 12: Facing North (from the roof of the school building).

- 4.4.1 The building is in a rural area, the great majority of which is permanent pasture with hedgerows and scattered woodland cover (Plate 12). The surrounding area within 1km has a few minor roads, with farms and small villages. The nearest waterbody which could potentially be used by bats is the River Ribble which is only 400m to the East.

- 4.4.2 Overall, this habitat is likely to have a relatively good value for many species of bat.

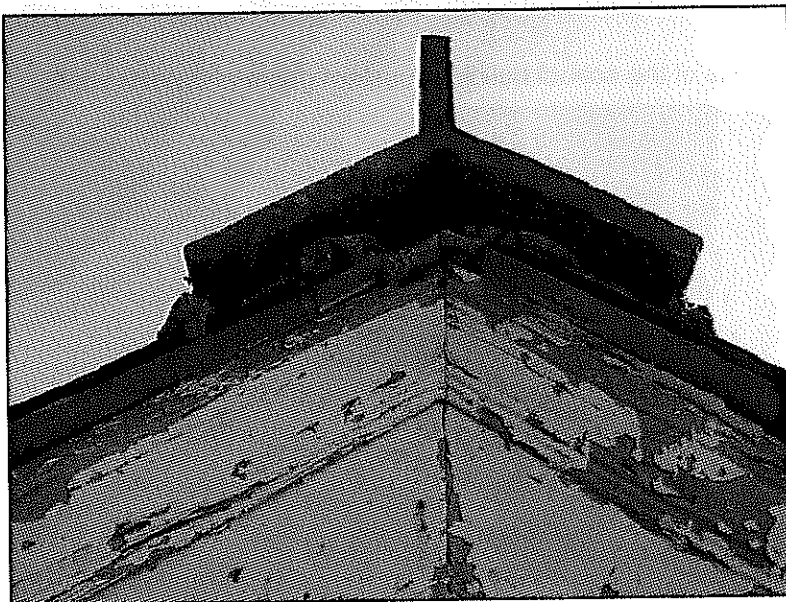
Plate 4: The Eastern roof apex and ridge, below which droppings were found.

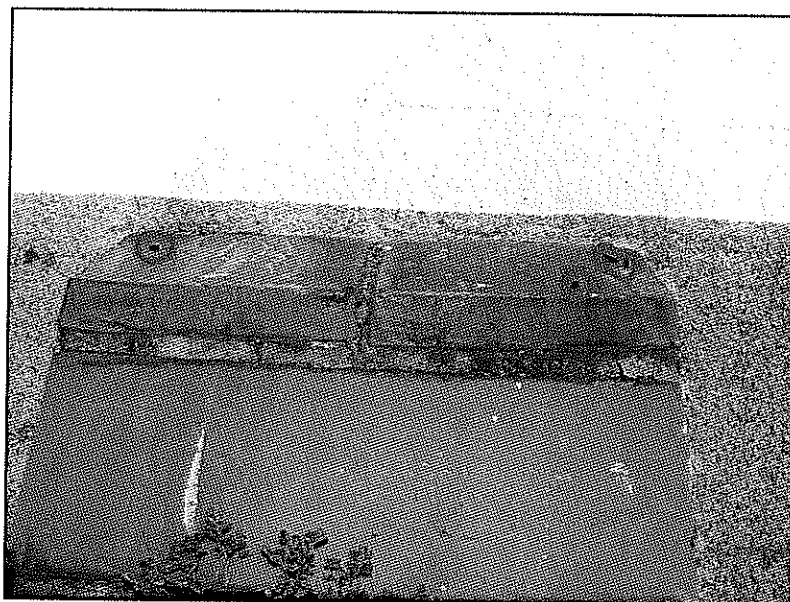
Plate 6: Bat droppings found on external feature directly below ridge apex.

- 4.1.5 The eastern gable end could provide access into the building and a search of a projecting brickwork feature below the ridge apex found fresh bat droppings (Plate 6). The whole barge board and ridge tile at the eastern end of the main building has a gap behind it and could be used by bats.

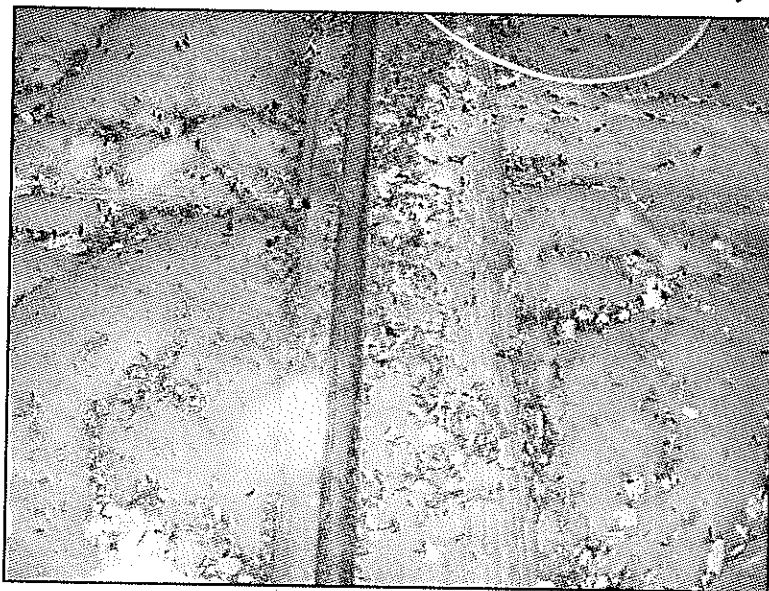
Plate 9: Large number of bat droppings present along the central joist.

- 4.2.3 *Within the second and third sections of the loft numerous droppings and discarded prey items were found which indicate the presence of bats.* The number of droppings increased with distance away from the skylight. Plate 9 shows a small large of droppings directly beneath the ridge beam. Samples of these droppings were visually analysed. The findings indicate the likely presence of *Plecotus* or *Myotis* species. In addition, the varied shape and size of droppings present also indicates likely presence of *Pipistrellus* species. In addition to the droppings, the lack of cobwebs on the ridge beam is a typical indicator of bat activity (Plate 10). Despite a thorough search, no single location could be pinpointed as an obvious roost entry/exit point.
