# Henthorn Road, Clitheroe

Preliminary risk assessment

Project no. 321124

DECEMBER 2012

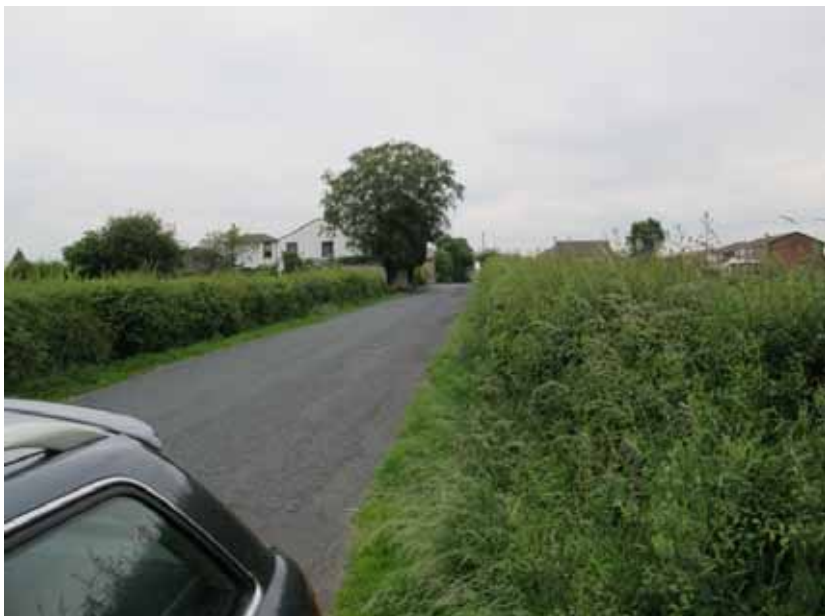
| PHOTOGRAPHIC LOG | | |
|---|---|---|
| 1 | 26/6/12 | |

| PHOTOGRAPHIC LOG | | |
|---|---|---|
| <p>Henthorn Road, adjacent to northern part of site. Looking towards existing Henthorn Villa north of site and 1970's housing east of site.</p> | | |

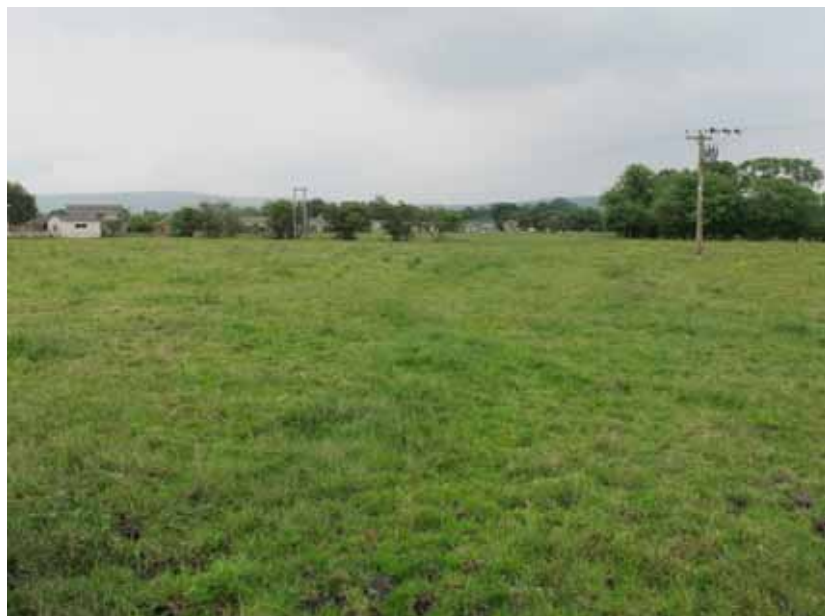
| <b>Photo No.</b><br><br>2 | <b>Date:</b><br><br>26/6/12 | |

| <b>Description:</b><br><br>Site area boggy/wet.<br>Power lines cross site.<br>Sparse dividing hedge in middle distance. Some mature trees in boundary hedges. Views towards Pendleton Moor. | | |

Much of the site appeared poorly drained and wet. The watercourses flowing southwards across the western part of the site and along part of the southern boundary could provide a possible pathway for contaminants to reach the Pendleton Brook and thence the River Ribble. The watercourse appeared to be clean at the point where it enters the site at Henthorn Road.

Overhead powerlines on wooden poles cross the northern part of the site, running east-west, and would restrict the developable area, unless they could be diverted.

Existing hedges divide the site. There are likely to be planning restrictions on their removal, but if they were to be removed there may be implications on foundation design, depending upon the properties of the underlying clay. There are a number of large trees within the boundary hedges, which may restrict developable area, because of tree

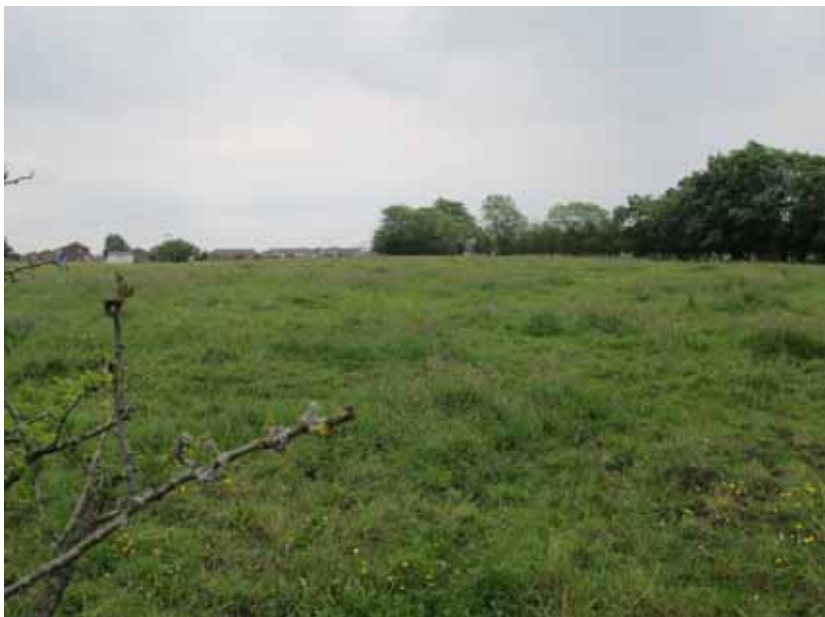
| <b>Photo No.</b><br><br>3 | <b>Date:</b><br><br>26/6/12 | |

| <b>Description:</b><br><br>Looking across most of the site, towards the 1970's housing to the northeast. Some mature trees in boundary hedges. | | |

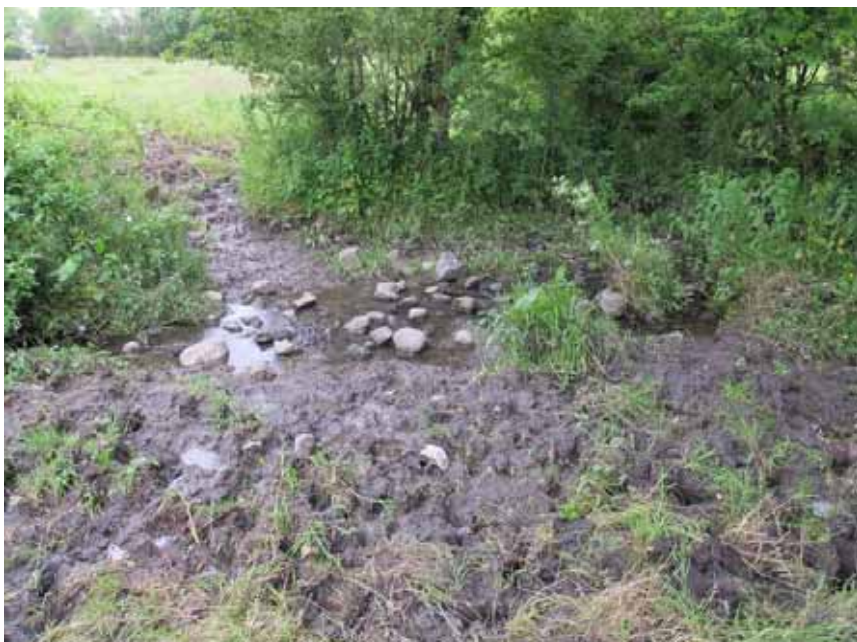
| <b>Photo No.</b><br><br>4 | <b>Date:</b><br><br>26/6/12 | |

| <b>Description:</b><br><br>The watercourse crossing the site (flowing from left to right), photograph taken close to southern site boundary. | | |
