## Application for Planning Permission. Town and Country Planning Act 1990

Extension of dwelling into adjoining barn, conversion of outbuildings into one dwelling and erection of menage, stables and garden store

| House name: | Quarry House | | |

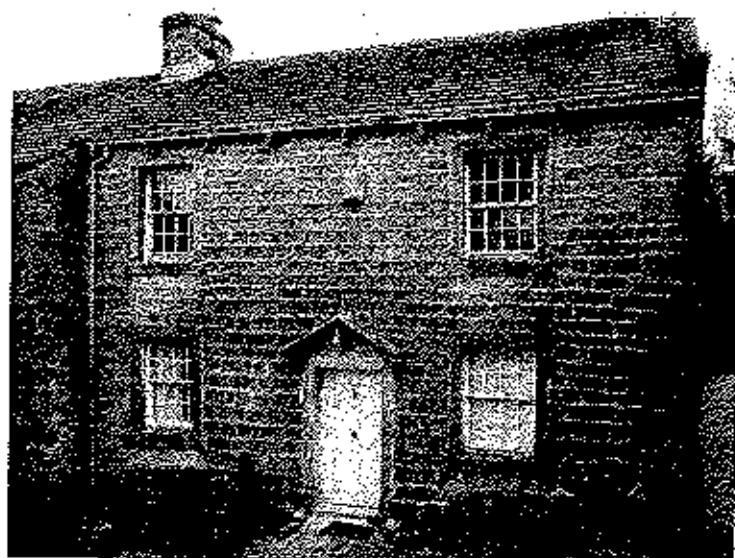
- a) Front Elevation  
The wall was checked at ground floor level.  
The wall leans out at 15 in 1000 on the left hand side becoming virtually plumb adjacent to the right.
- c) Rear Elevation  
The wall was checked at ground floor level.  
The wall is very uneven on the right hand side.  
The wall generally is in a very poor condition

Front Elevation - House

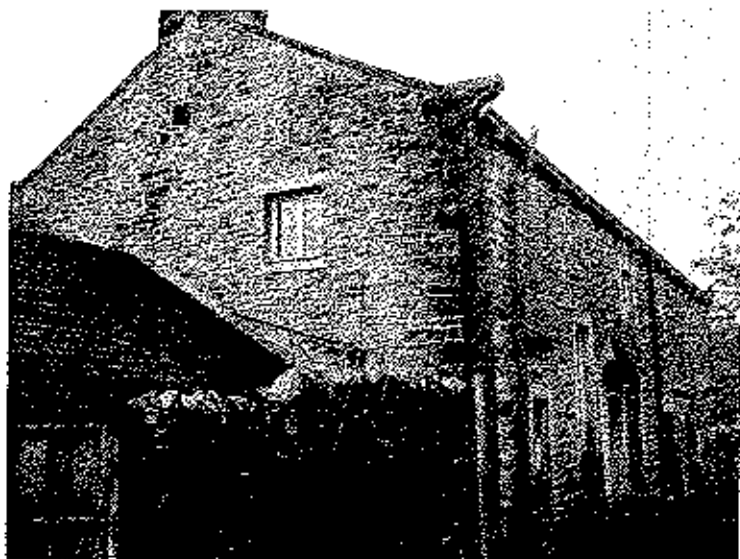
Rear / Gable Elevation - House

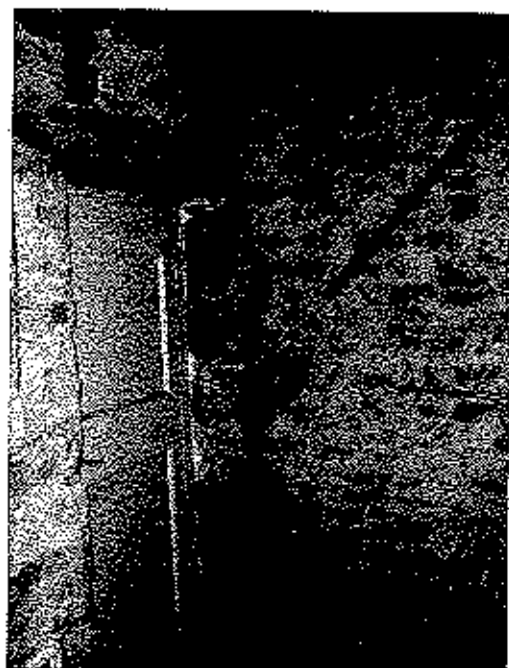
- 4.06 There is noticeable cracking within the house.
- 4.07 The cracking at the rear at ground floor level is the result of the rear wall separating from the internal walls on both sides of the kitchen.
- 4.08 The cracking to the internal walls to both the sitting room and dining room indicate past movement.
- 4.09 There is noticeable cracking at first floor level above the rear window in the stair area.
- 4.10 This appears to be as the result of lintel movement combined with lateral movement of the wall.
- 4.11 The condition of the roof structure is un-certain.  
The rafters are of variable size and condition as are the purlins.  
The main trusses have splits and shakes and are again of variable size.

Cracking / Separation - Kitchen

- 5.04 There is noticeable cracking within the house.
- 5.05 The rear wall in the kitchen has separated from the walls on both sides.
- 5.06 This may be addressed by:-

- Either i) Taking down and re-building the walls at the junctions
  - Or ii) Introducing stainless steel ties from the rear wall into the side walls and grouting with an epoxy resin.

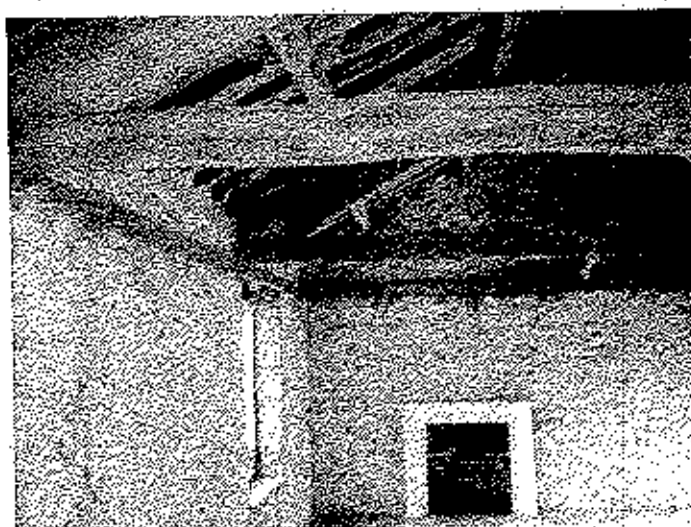
5.12 As noted the roof timbers display splits and shakes, are of variable size and condition.

Roof Members - House

5.13 We recommend that either the roof covering is removed along with the rafters and purlins.

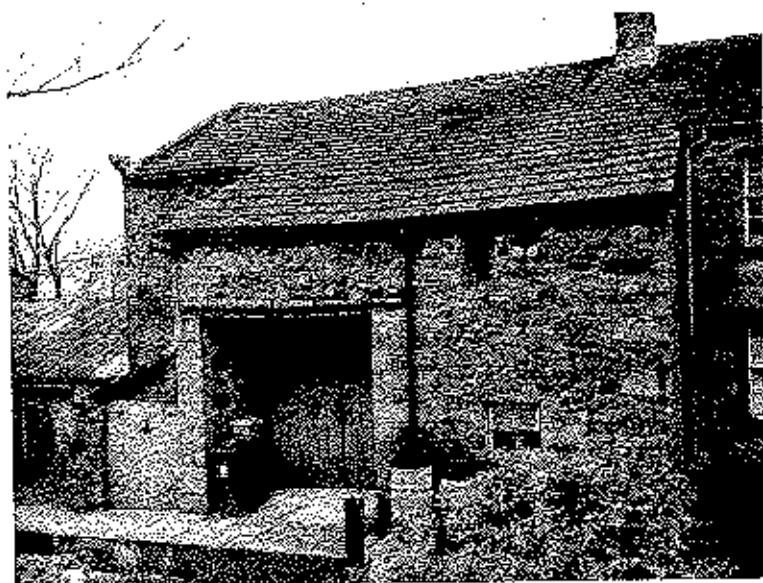
- 4.12 There is some cracking and open joints at high level on all elevations.
- 4.13 However the walls generally appear in reasonable condition.
- 4.14 As with the house the roof structure is un-certain.

Front Elevation - Barn B1

5.14 There is some cracking and open joints at high level on all elevations.

5.15 We recommend the cracking is treated as noted in 5.06.

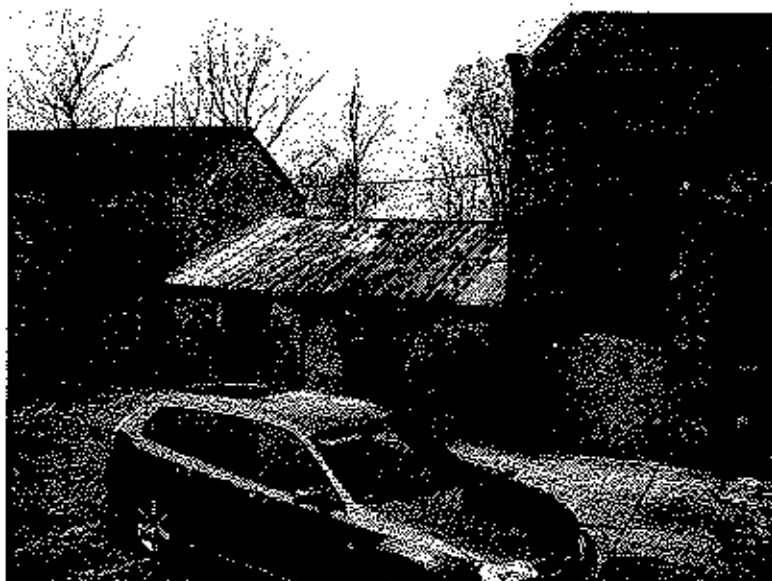
Front Elevation – Barn B2

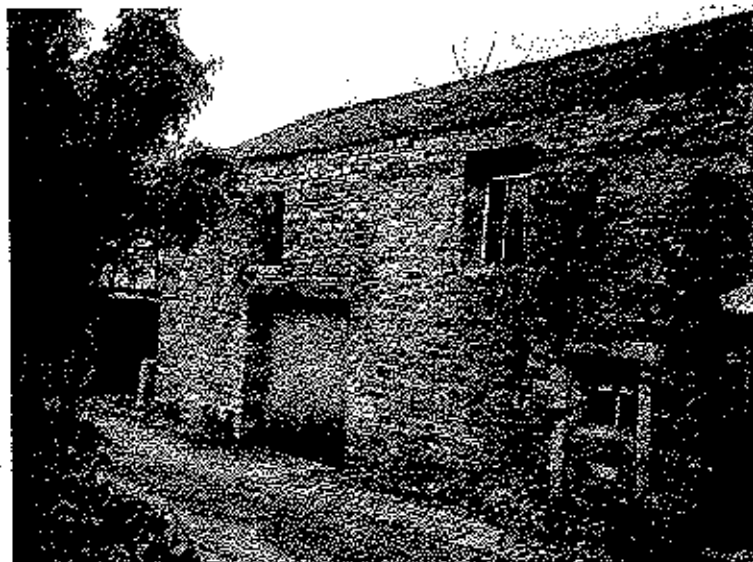
Front Elevation - Barn B3

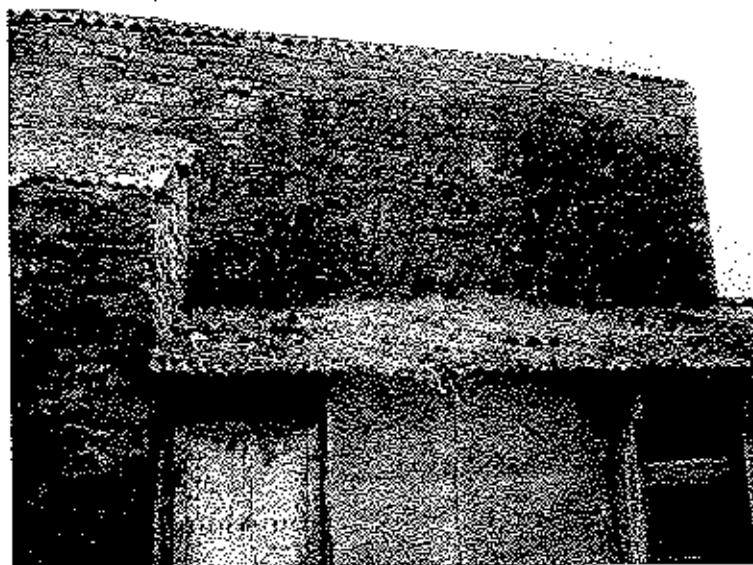
- 4.17 There is noticeable cracking internally at first floor

Rear Elevation - Barn B3

- 5.24 The internal cracks at first floor level may be treated as noted under 5.05.
- 5.25 The roof structure should be removed and replaced with either proprietary timber trusses or new purlins and rafters.

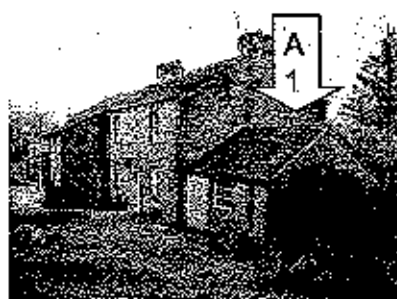
Figure 3:

There is a single storey extension on the east gable wall (shown as 'A1' in figure 3) built circa 1980; the structure has a duo-pitched rafter and purlin roof and enclosed part-boarded roof void; the stone slate roof is lined with bitumen felt. The roof void is not insulated; rodent droppings (mice and rats) are present.

- (1) extension of existing dwelling (building A) into the adjacent barn (building B);
- (2) conversion of single storey building A1 into garden-room (figure 3).
- (2) conversion of building C into garage with photo-voltaic panels in roof (figure 7).
- (3) conversion of building D into a two storey dwelling (figure 4).
- (4) renovation of building F (figure 6) including sweet chestnut cladding to front elevation.
- (5) removal of buildings E and G (figures 5 and 8).

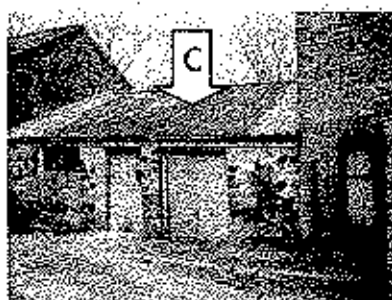
Figure 7:

A single storey shed / old shippon area (figure 7) with duo-pitched corrugated metal roof; an internal block-work wall encloses a small office area with storage cupboards; the building is cool, well-ventilated and dry; this building connects to building D.
