## **BAT SURVEY AT**

**Todber Caravan Park  
Clitheroe**

**BAT/12/1465**

# **BAT SURVEY**

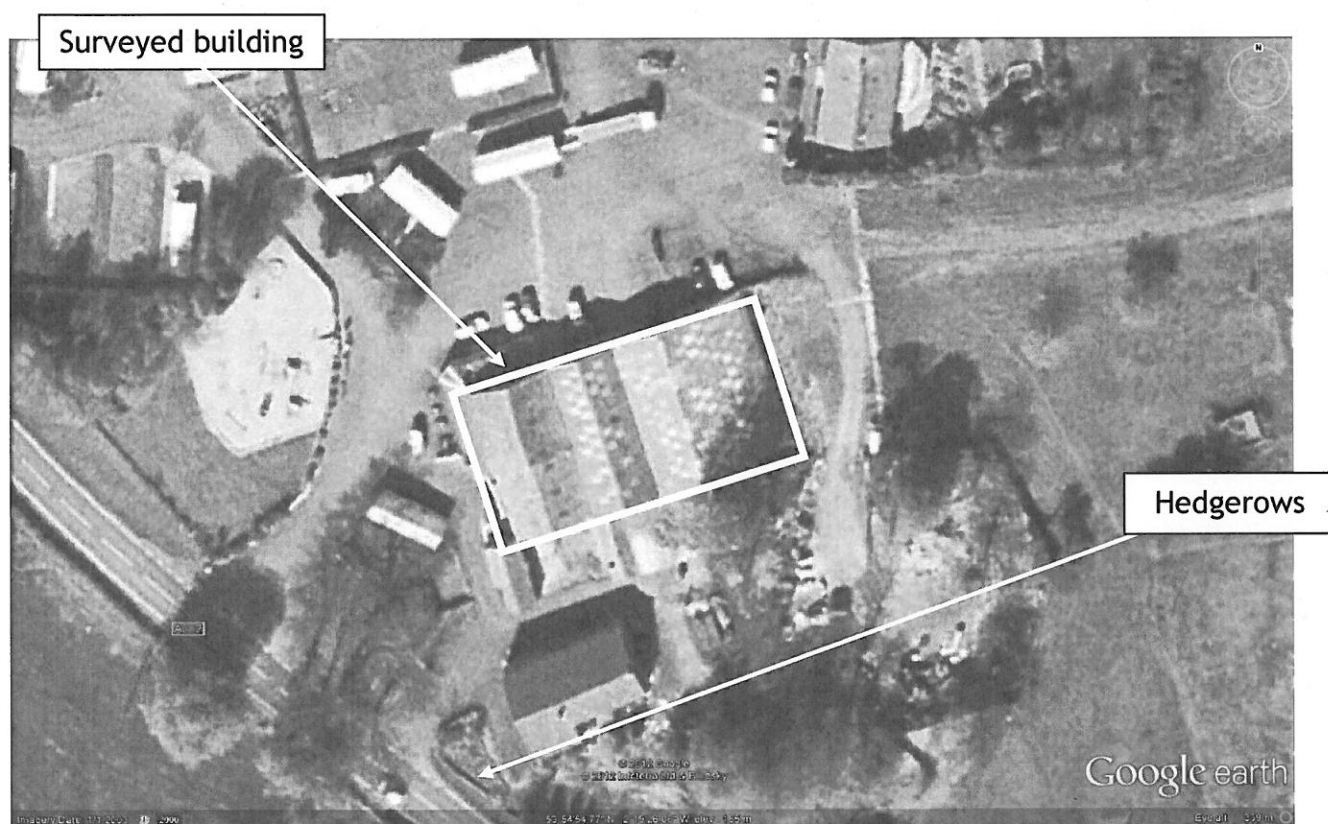
**Figure 2. Satellite Image of site**

The affected building is situated on the South Western corner of Todber Caravan Park. The main caravan area is located to the North of the building, with a narrow beck running along the Northern boundary of the caravan park. The River Ribble also flows approximately 3km to the North West of the site. The habitat corridors surrounding these becks are likely to have a high value for bats in the local area, with anecdotal accounts from site staff of bats being seen along the Northern edge of the site.

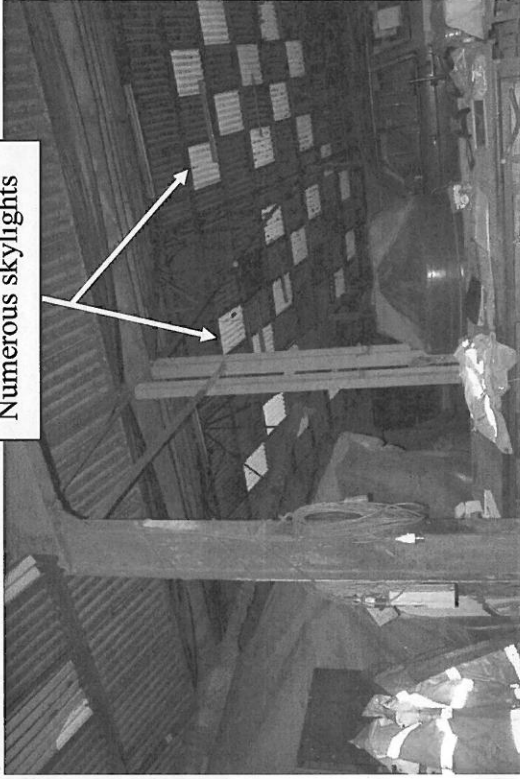
The roof is of corrugated fibre cement panel construction and is in good order. It has numerous large skylights making the internal space very light and unfavourable for bats.

Numerous skylights

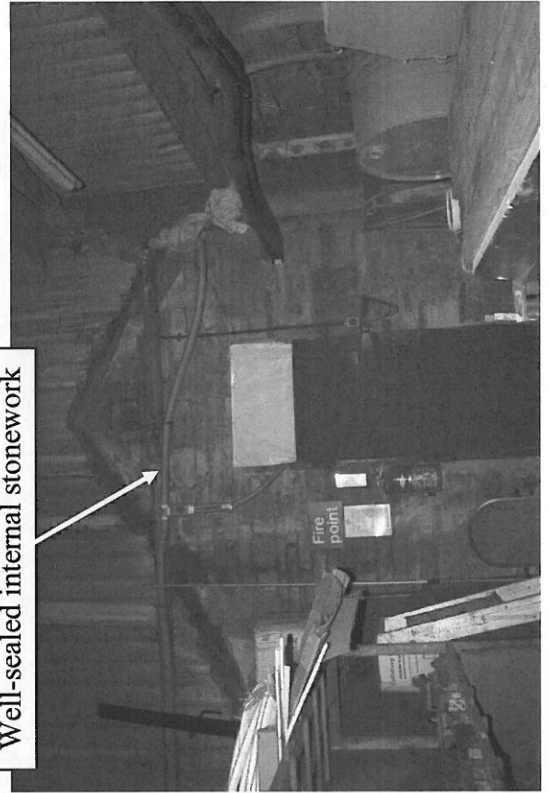
Well-sealed internal stonework
