## earthworks environmental design

Re: Daylight scoping survey (bats): High Trees, Longsight Road, Clayton-le-Dale, Blackburn, BB2 7JA

**STAGE 1**  
**ARBORICULTURAL REPORT WITH**  
**TREE CONSTRAINTS PLAN**  
**&**  
**ARBORICULTURAL IMPACT ASSESSMENT**  
**TO AID IN THE**  
**SITE DESIGN / LAYOUT**

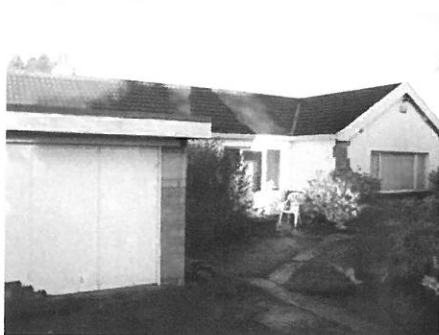
Figure 1: Front

The property is a detached bungalow (built between 1940 and 1960) with rendered brick cavity wall construction with hipped rafter-with-purlin roof and enclosed roof void. The property also has an integral garage (figure 1); there are also two out-buildings (figures 4 and 6).

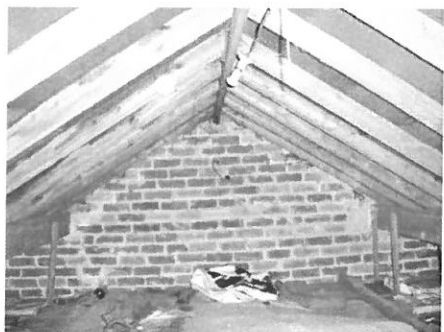
Figure 4: Roof void

The tiled roof is lined with bitumen felt and the roof void insulated with a glass fibre material laid across the ceiling joists (figures 1 to 3). There is no natural light within the roof space and the area is generally cool, dry and well-ventilated. Although there is evidence of mouse activity within the roof void, there are no signs of access by bats.

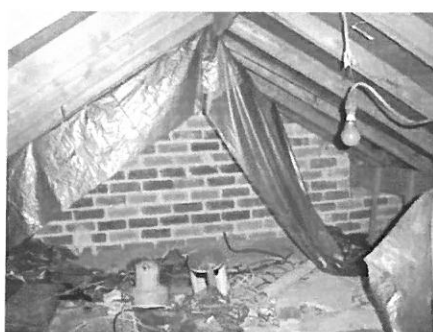
All external parts of the roof void were carefully inspected for evidence of bat droppings and other indicative signs of access by bats, none was found.

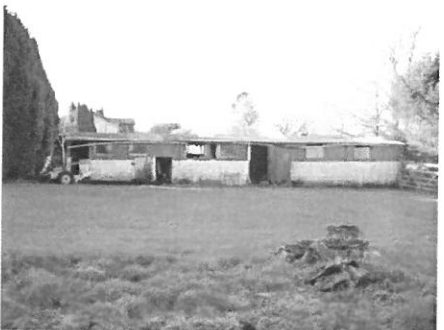
Figure 4:

(1) Poultry shed / piggery (figure 4) comprising 4 separate bays with storage and workshops. The single storey building has a concrete plinth wall; tongue and groove planking on upper walls and glazed windows; the mono-pitch roofs are under-drawn with T&G boarding and clad with corrugated metal sheets; daylight roof panels provide natural light inside the building (figure 5). The sheds are dilapidated and mostly open; internally the bays are cool, damp and draughty; although there is no evidence of roosting / feeding bats there are signs of nesting wild birds although there is no evidence of roosting or nesting barn owls at the site.

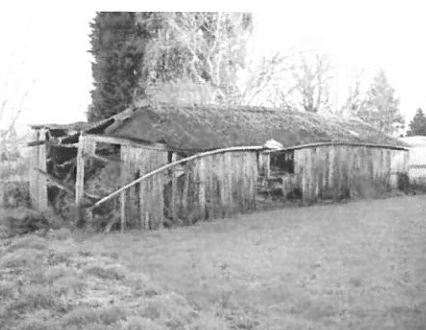
Figure 6:

(2) Storage (grain) barn (figure 6) comprising single storey shed in a dilapidated condition and heavily overgrown with brambles. The building has a timber construction with duo-pitched corrugated cement fibre roof. The structure has been used for storage and is now on verge of collapse with no safe access. The structure is cold, damp and draughty and is highly unsuitable for supporting roosting bats; although nesting birds may be present at times.
