Project Name: Elmridge Farm, Chipping		
Title: Plans to illustrate Elmridge Farm site and buildings surveyed		
Scale: NTS	Drawing No.: Figure 1	Date: Dec 2012
Reference No.: ERAP Ltd 2012_081		
<small>49a Manor Lane, Penwortham, Preston, Lancashire, PR1 0TA. Tel: 01772 750502 Fax: 01772 750503 E-mail: mail@erap.co.uk Website: www.erap.co.uk</small>

Title:
Plans to illustrate results of bat and bird surveys

Project Name:		
Elmridge Farm, Chipping		
Title: Plans to illustrate mitigation and compensation for roosting bats		
Scale: NTS	Drawing No.: Figure 3	Date: Dec 2012
Reference No.: ERAP Ltd 2012_081

Title: Plans to illustrate proposed compensatory measures for use by nesting birds

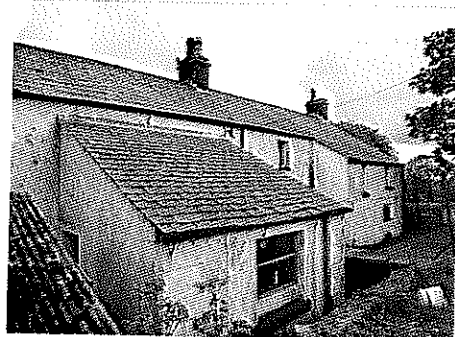
Photo A: Existing farmhouse (north elevation)

Building Reference	Brief Description	External Survey and Assessment	Internal Survey and Assessment	Dawn Re-entry Survey
Existing Farmhouse	Two storey farmhouse with white rendered elevation walls and a pitched slate covered roof.	Gaps suitable for bat access were detected in the following places: - a. At the bedding mortar beneath the ridge copings. b. At base of the chimney where the lead flashing has lifted. c. Holes in the roof where the slates have slipped. d. Holes in rotten timber soffits around porch on the south elevation. No bat droppings detected around exterior.	No underfelt or insulation present. No evidence of bat entry.	Detected single Common Pipistrelle re-entry into ROOSTS 1 and 2.
Building 1 (Barn)	Two storey stone built barn with a single storey brick built annex to the south. The buildings have pitched slate and stone tile covered roofs.	Gaps suitable for bat access were detected in the following places: - a. At the roof verge of the west facing gable (between the slates and the wall top); b. A crevice in the east elevation of the stone wall. Closer inspection confirmed that this is used by nesting birds owing to the presence of droppings; c. Around the stone lintel at the doorway on the east elevation but the gaps are heavily cobweb covered; d. Beneath the ridge copings; The remainder of the stone elevations are well pointed; no gaps suitable for bat access were detected. No bat droppings detected around exterior.	The internal walls are white washed and well-pointed; no gaps for bat access were detected on the ground or first floors. The first floor is open to the ridge internally. The pargework beneath the slates is visible; no underfelt is present. A gap at the underarch between rooms on the first floor was investigated further. No bats or droppings were detected. No bats or bat droppings detected internally.	No emergence or re-entry activity.

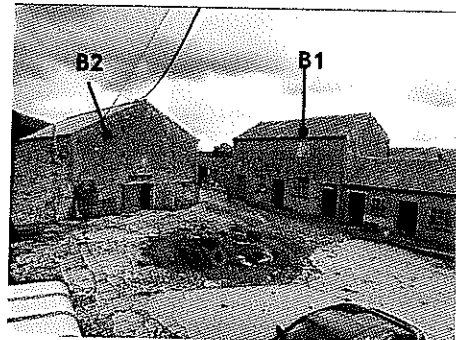
Photo C: Building 1 (north elevation) and Building 2 (west elevation)

Building 2 (Barn)	Stone barn with a corrugated sheeting roof. A hay loft is present inside.	Well pointed stone elevation walls. Keystone archway at doorway is well sealed; no gaps present. Gaps behind fascia at roof edges. Timber shed annex to east; no opportunities for roosting bats.	Mouse droppings present over floor of hayloft. Internal walls are well-pointed; no gaps for bat access. Timber roof trusses heavily cobweb covered. No mortar gaps or joints. No bats or bat droppings detected internally.	Detected single Common Pipistrelle entering ROOST 3.
Building 3 (Lean-to)	Steel framed lean to with a corrugated sheeting roof. A breeze block cattle shed section with a sloping corrugated roof is present to the west.	No gaps or opportunities for roosting bats externally. No bat droppings detected around exterior.	No gaps at timber trusses suitable for bat access. No bats or bat droppings detected internally. No opportunities present for use by roosting bats.	No emergence or re-entry activity.

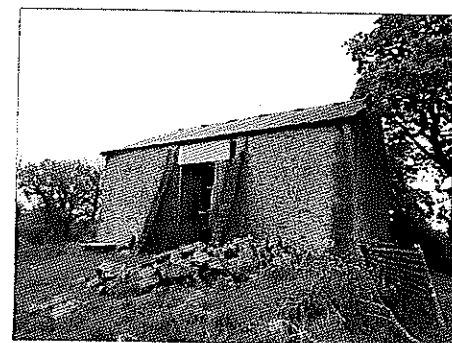
Photo F: Building 7

Building 7 (Barn)	Single storey stone barn with a corrugated sheeting roof.	Gaps behind fascia on the gable ends. Gaps at eaves which may permit bat access to the stone wall tops. No gaps at doorway lintel. No bat droppings detected around exterior.	Well sealed where the timber purlins meet the elevation walls. Timber roof trusses heavily cobweb covered. No mortar gaps or joints. No bats or bat droppings detected internally. Internal walls are well-pointed; no gaps for bat access.	No emergence or re-entry activity.

Will compensate for loss of roosting opportunity at Building 7.

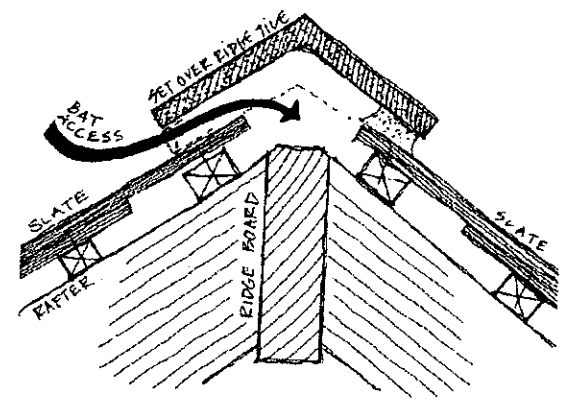
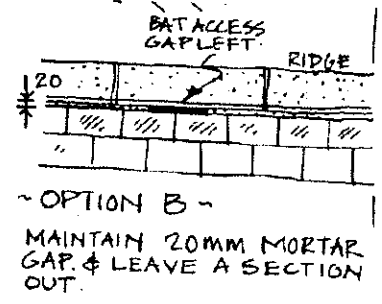
DETAIL A: Ridge Access to be installed in EIGHT positions

The void beneath the ridge coping is effectively sealed by mortar coupled with the pitch of the roof. The single gap will not permit the though passage of wind/air or ingress of water but will permit bat access into the outside shell of the building.

~ OPTION B ~
MAINTAIN 20MM MORTAR GAP & LEAVE A SECTION OUT.

Building	NEW Roost Access Point Type	Description	Number	Specification
Existing Farmhouse	A	Ridge Access: Gap (20mm high by 40mm wide) beneath ridge coping.	A1	In the same position as detected ROOST 1
			A2	Within 1 metre of the west gable end.
Converted Building 1	A	Ridge Access: Gap (20mm high by 40mm wide) beneath ridge coping.	A3	Main ridge within 1 metre of the west gable. Gap on south side.
			A4	Main ridge within 1 metre of the east gable. Gap on south side.
Converted Building 2	A	Ridge Access: Gap (20mm high by 40mm wide) beneath ridge coping.	A5	Main ridge within 1 metre of the west gable. Gap on south side.
			A6	Main ridge within 1 metre of the east gable. Gap on south side.
Converted Building 7	A	Ridge Access: Gap (20mm high by 40mm wide) beneath ridge coping.	A7	Main ridge within 1 metre of the south gable. Gap on east side.
			A8	Main ridge within 1 metre of the north gable. Gap on east side.

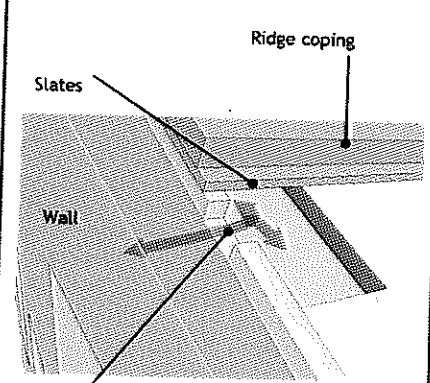
DETAIL B: GAP AT ROOF VERGE REINSTATED

Bat access/egress gap (40mm wide by 20mm high) to be created by missing a section of mortar from the roof verge.

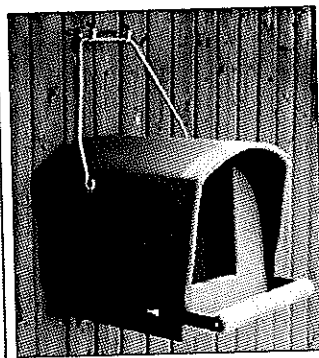
RECOMMENDED KESTREL BOX No. 28
One Kestrel box to be installed as high as possible inside the gable apex of the new farm buildings.

Free flight access to be available from exterior

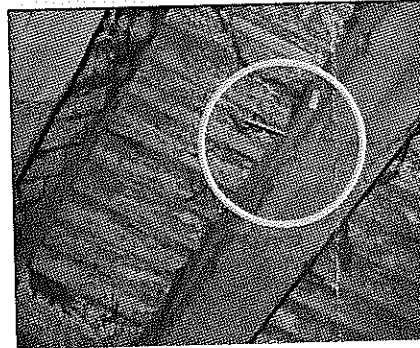
PROVISIONS FOR NESTING SWALLOW

Timber will be installed to the steel beams at the new farm buildings.

Six partially inserted nails with a 10cm long strip of timber will be inserted into the timber to leave approximately 4cm of the nail protruding to provide a starting ledge.

Free flight access into the building must be available.

This feature has been successfully used by nesting Swallow in the Woodplumpton area of Preston and will compensate for loss of nesting opportunity at Building 1.

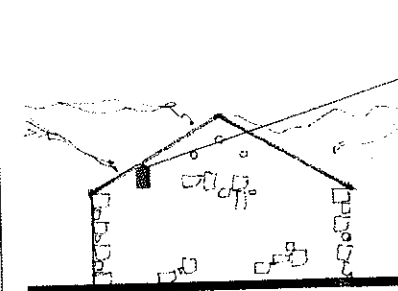
WEST ELEVATION OF DOUBLE GARAGE

One on the west elevation of the double garage

Boxes to be installed directly beneath the eaves.

The boxes will compensate for the loss of the nesting opportunity used by Starling at the Existing Farmhouse.

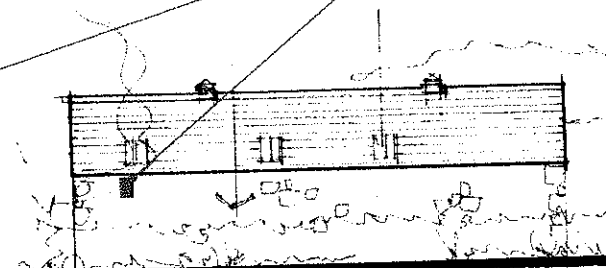
EAST ELEVATION OF TRIPLE GARAGE

One at the east elevation of the triple garage.
