## Householder Application for Planning Permission for works or extension to a dwelling. Town and Country Planning Act 1990

The works proposed includes alterations to the existing building and a proposed garden room to the South West Elevation of the existing dwelling. The existing building requires roof repairs and alterations to upgrade the fabric, improve heat retention and create more habitable space on the first floor. We propose the removal of the two existing 'hipped' roofs and dormer windows on the South East Elevation with amendments to the roof structure and ridgeline to be extended out over a new wall built off the existing to form a pike gable end. This also applies to the current 'lean to' roof and dormer window on both the North East and South West Elevations to allow greater head height internally. Other window alterations are proposed to the South East and North East elevations at ground floor level in order to accommodate internal changes and views out. In addition we propose restoring the original chimney full height. The access to the patio on the North West elevation is to be extended with a ramp and slightly raised around the existing dwelling and new garden r

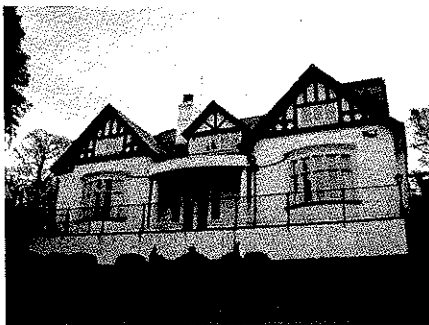
Figure 1: Front elevation

The roof structure is complex; there are also four dormer windows with flat bitumen roofs (figures 1 to 5).

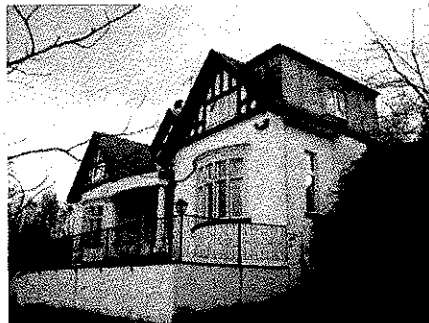
Figure 4:

The proposed works include a building extension to the south-west elevation (figure 4) and re-roofing of the property in addition to modifications to existing dormer features, requiring some disturbance to existing voids.
