Application for Planning Permission. Town and Country Planning Act 1990

Barn at Eatough's Farm, Fleet Street Lane, Ribchester. PR3 3XE

Heritage Statement to Support Planning Application

321130141P
WILDLIFE SURVEY FOR BATS AND OWLS

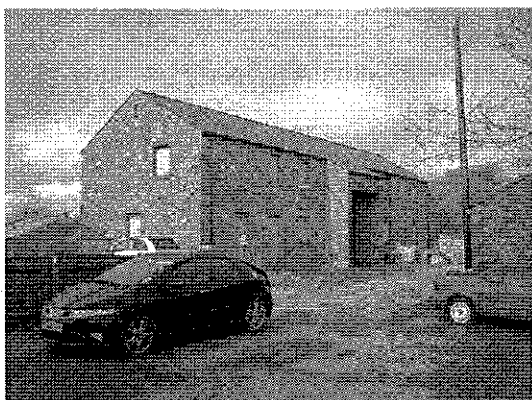
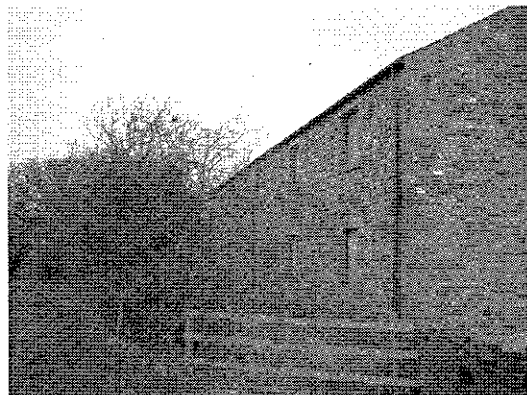
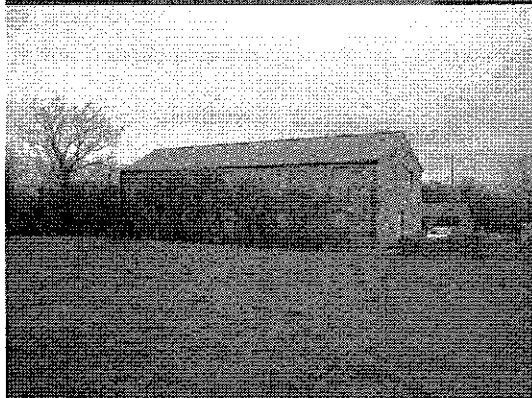
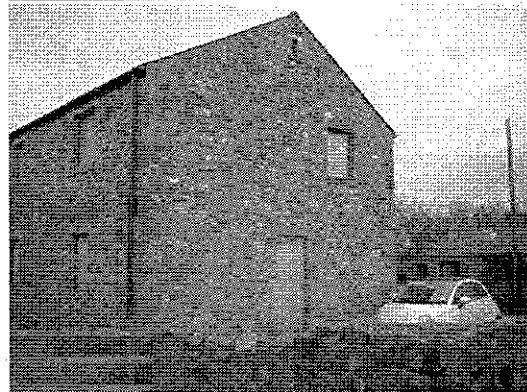
Photographs of the Barn

The barn is constructed from local, natural stone under a blue slate roof. It is of a simple design, typical of barns throughout the area, with a dual pitched roof extending at one side over a protruding section containing the full-height barn door opening. Other than the charm of its simplicity, there are no features worthy of note.

There is evidence that the Barn had a Shippon attached to its South facing gable wall, but which now only remains as a low-level wall and foundations.

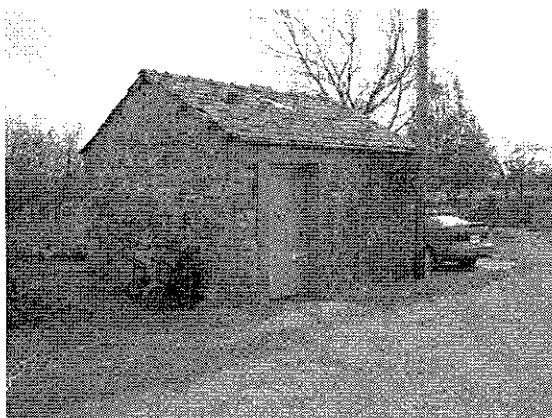
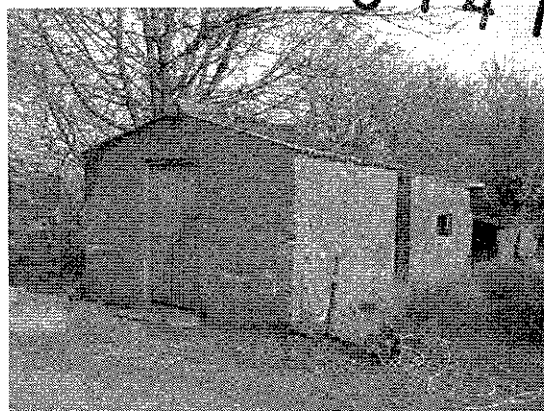
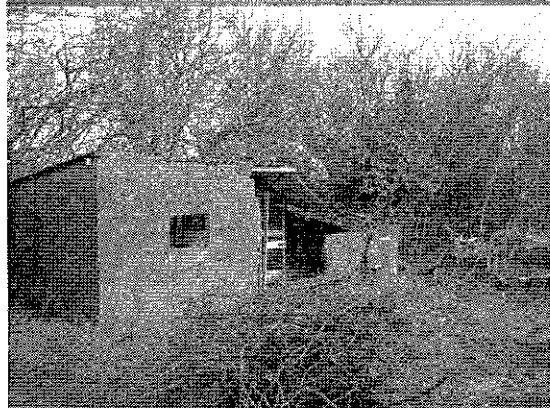
Photographs of the Outbuildings

The 3 detached outbuildings are in various states of repair ranging from derelict to useable.
