# earthworks environmental design

3 April 2012

Job ref: B 1125

Re: Daylight scoping survey (bats): Shay Cross, Old Back Lane, Wiswell, Clitheroe. BB7 9BS

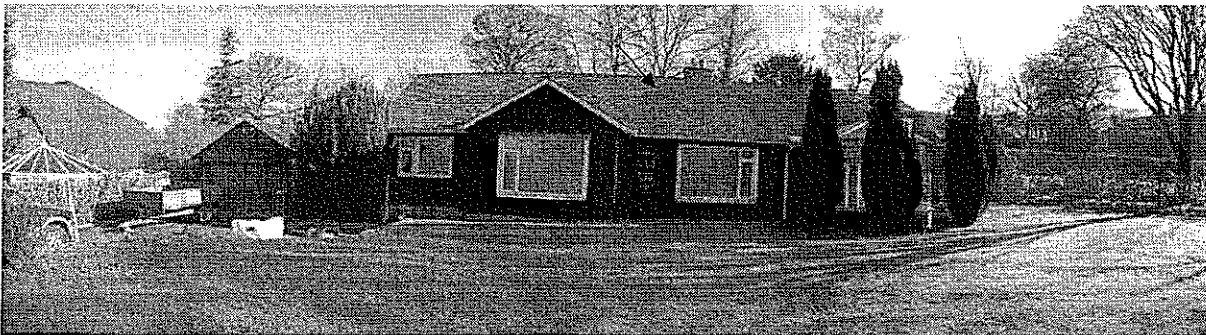
Figure 1: Front elevation (south)

An adjacent detached double garage (figure 1 and 6) has a similar construction to the bungalow; the post and truss frame supports a shingle roof (unlined – figure 7). The garage has timber sliding doors to the front and a small rear door and two glazed windows providing some natural light. The tongue-and-groove walls and timber soffits are well-sealed and secure. The building is open to the eaves and there are no enclosed roof voids. The garage is unused and currently empty and there is no evidence of bat activity within any part of the building.

There is a single dislodged shingle below the ridge, approximately 1200mm to the left of the chimney stack on the front roof pitch, (shown by arrow in figure 1).
