## BAT & BARN OWL SURVEY

The Moorcock Inn, Waddington

# **BAT & BARN OWL SURVEY**

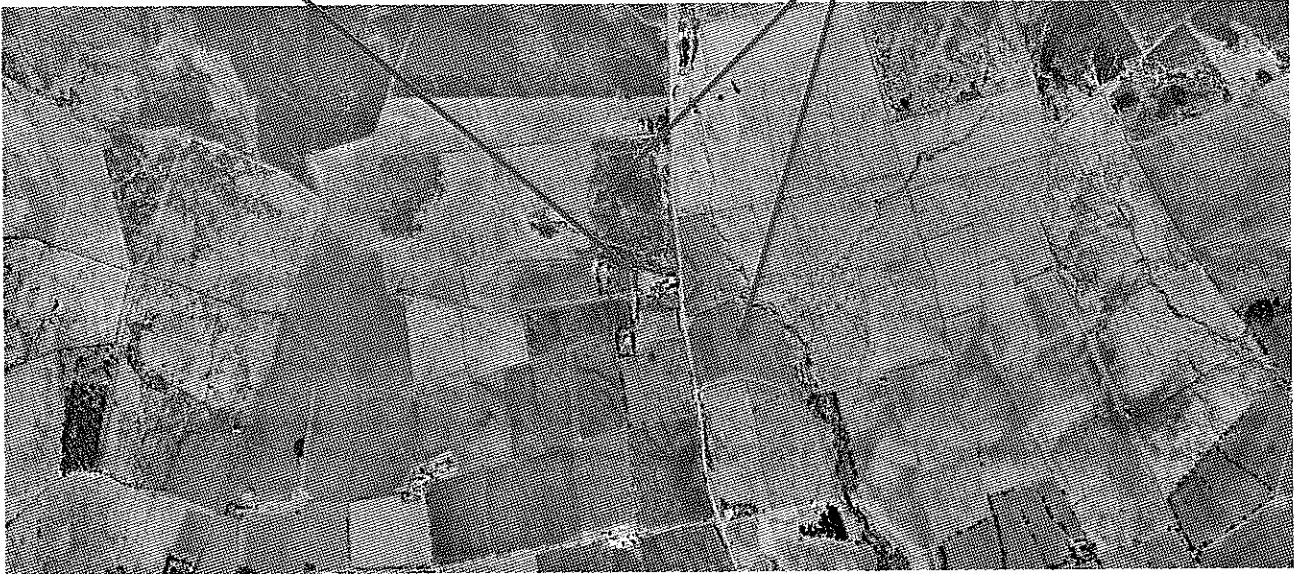
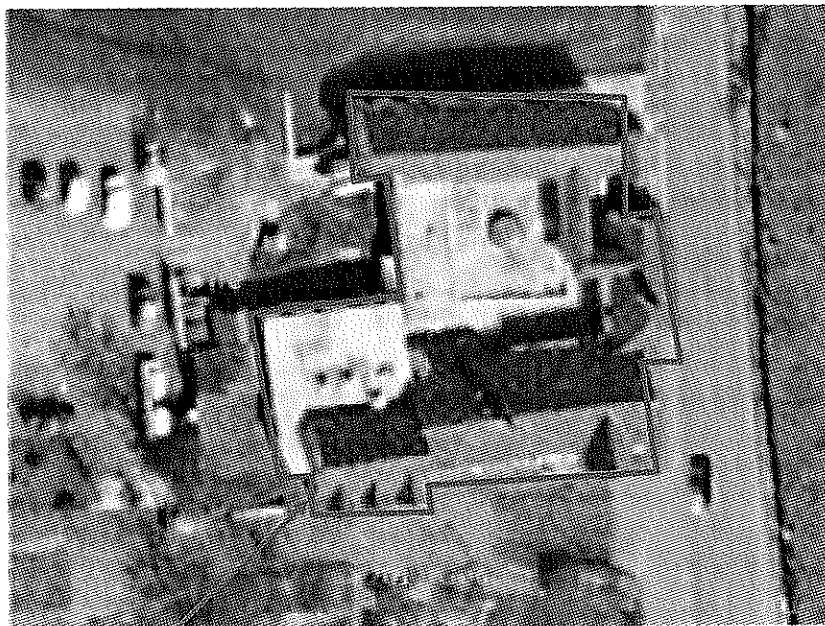
Satellite Image of surrounding area

The site lies in a remote rural area

The site is surrounded by exposed pasture fields

Surveyed building

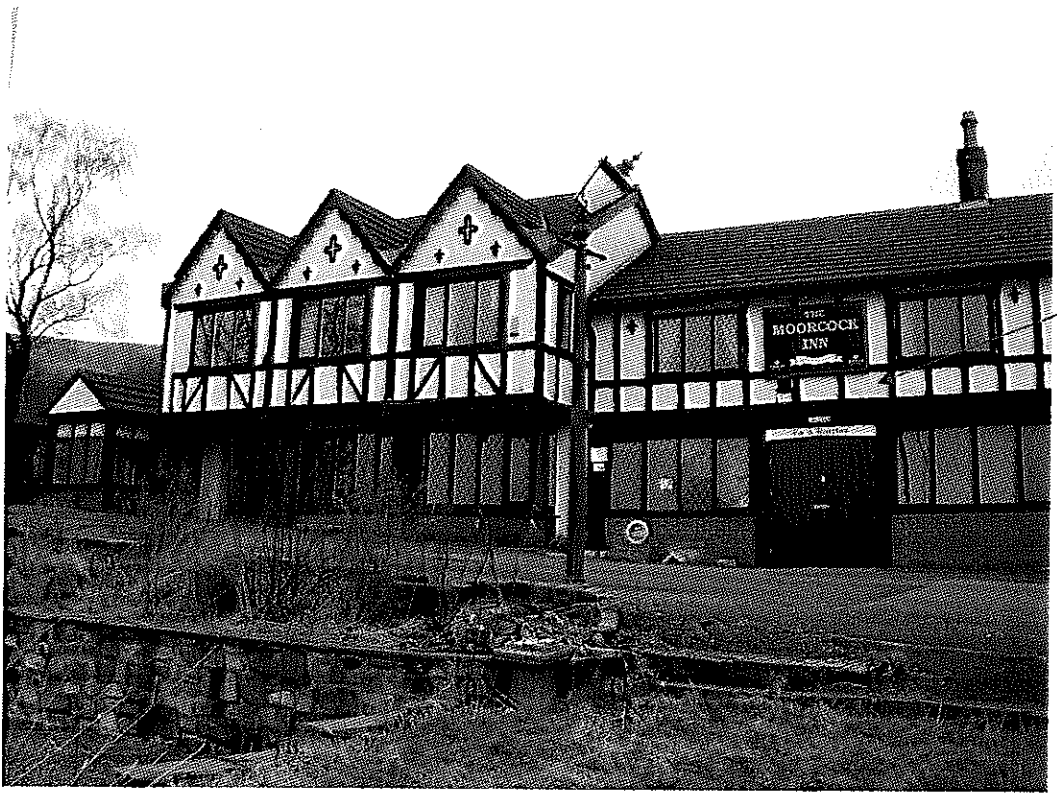
Building external - Southern elevation

Rendered walls  
in excellent  
condition

The building is made from rendered block and has been painted. The walls are in excellent condition with no structural cracks or crevices on any elevation. The chimneys are made from brick and are fully pointed. The eaves of the building are generally well sealed however there are two areas of exception. These can be found on the Eastern elevation overlooking the road and one small area on the Southern elevation above the front door.

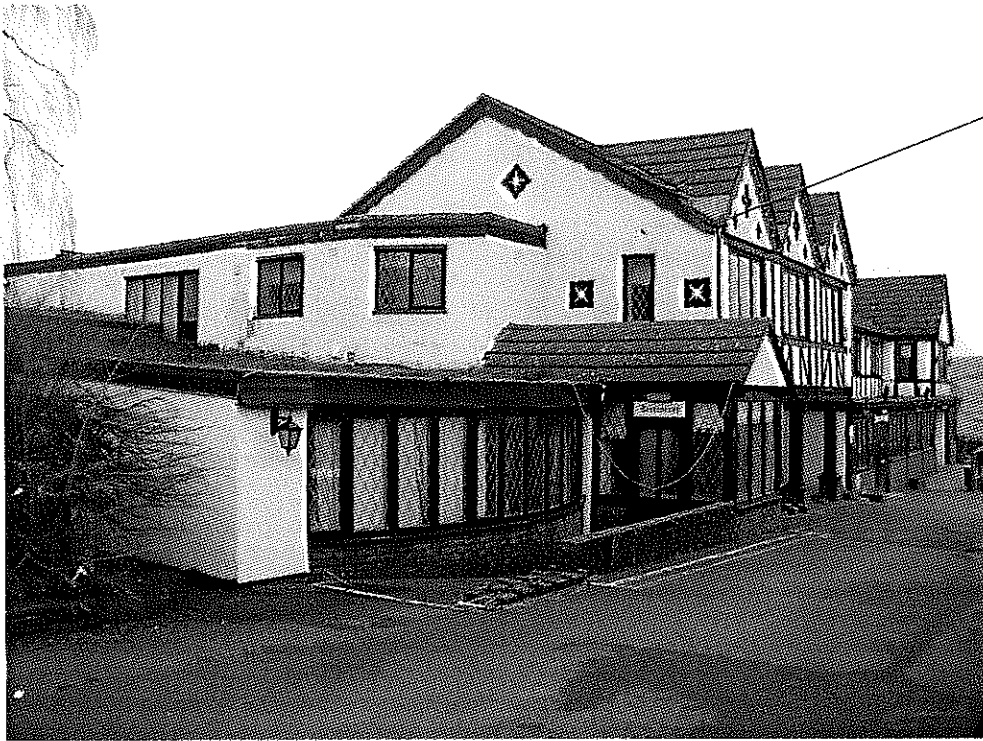
Building external - Western elevation

Damaged barge board  
on SE corner of  
building

One area of barge boards has suffered from damage and has broken on the South Eastern corner of the building. The gap behind this board was found to be empty on inspection with no previous signs of use by bats.

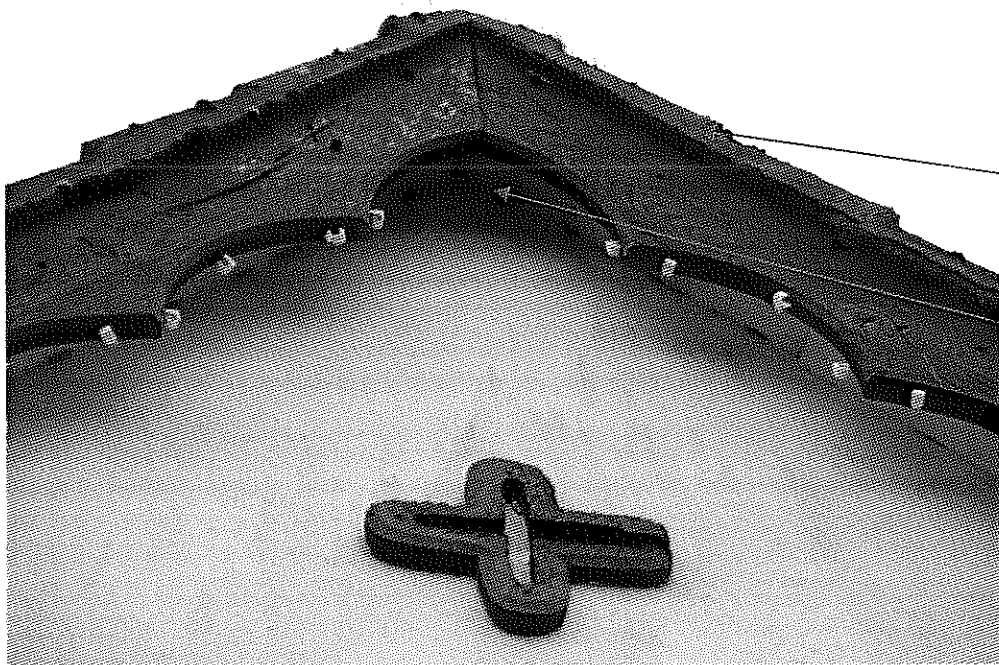
Building external - Gable wall apex

Roof verges well  
mortared

Gable apexes sealed

These areas had a slight gap behind the soffit boards but were found to be empty on close inspection. No bats or past evidence could be found in or around the holes (e.g. droppings, urine staining, grease marks etc). The barge and soffit boards were found to be in excellent condition elsewhere and sit tight to the wall surface. The gable wall apexes are all sealed.

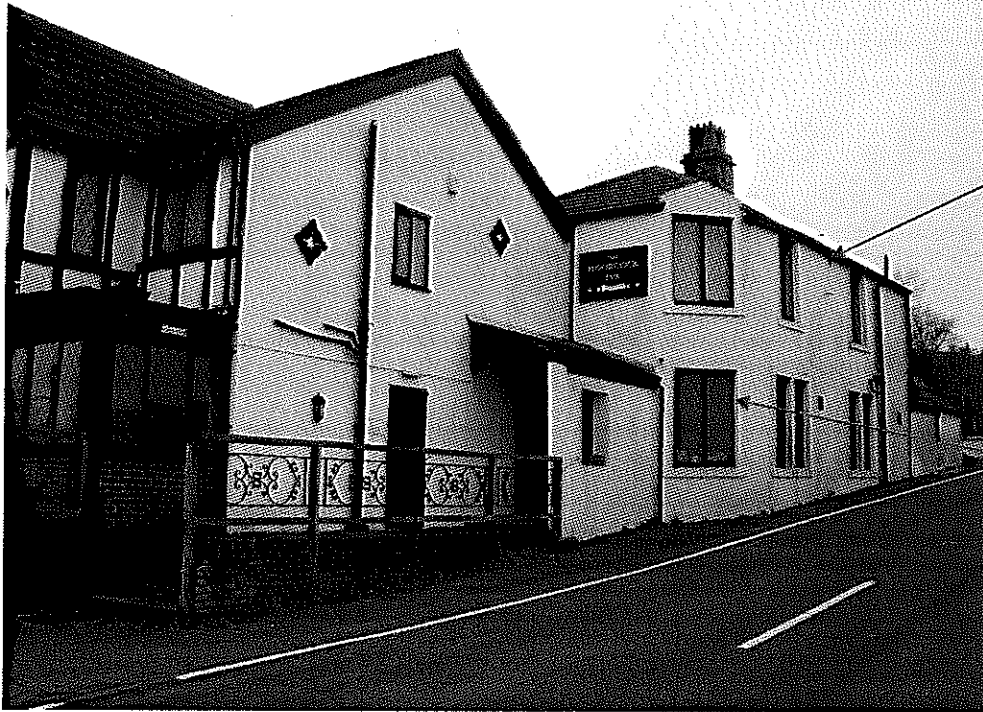
Building external - Eastern elevation

Eastern elevation gap along the eaves

Window and door frames all sealed

All window and door frames of the building were found to be fully sealed with no gaps or crevices.

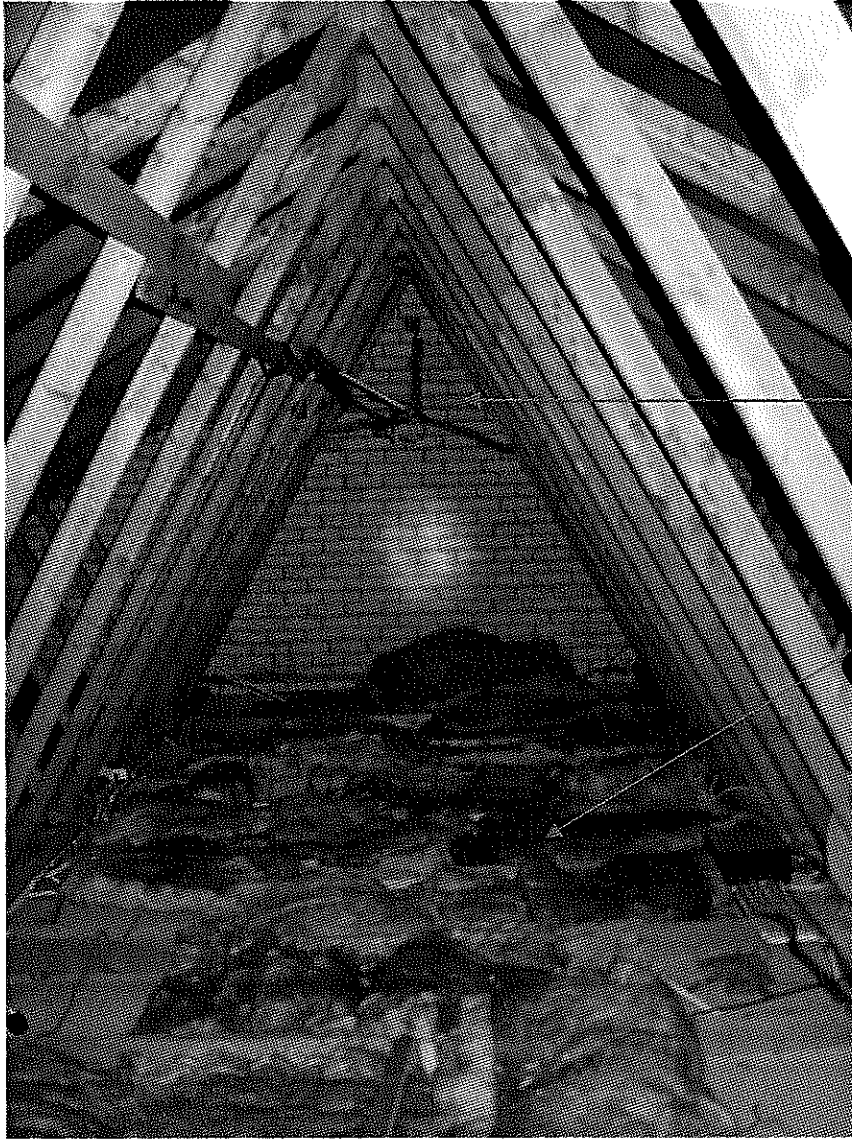
Building internal - Roof void

Voids fully sealed and inaccessible to bats

No evidence of bat droppings, prey items, urine staining etc in any of the voids

Internally the pitched roof voids were all found to be extremely well sealed from the outside. The voids are well insulated and in many cases boarded. The gable ends and eaves were sealed up to the roof lining. No evidence of bats could be found in any void, but mouse droppings and chewed materials were found in one area.
