**BAT SURVEY**

Land adjacent to Manor Barn  
Off Back Lane  
Rimington

**Demolition of a derelict shippon.**

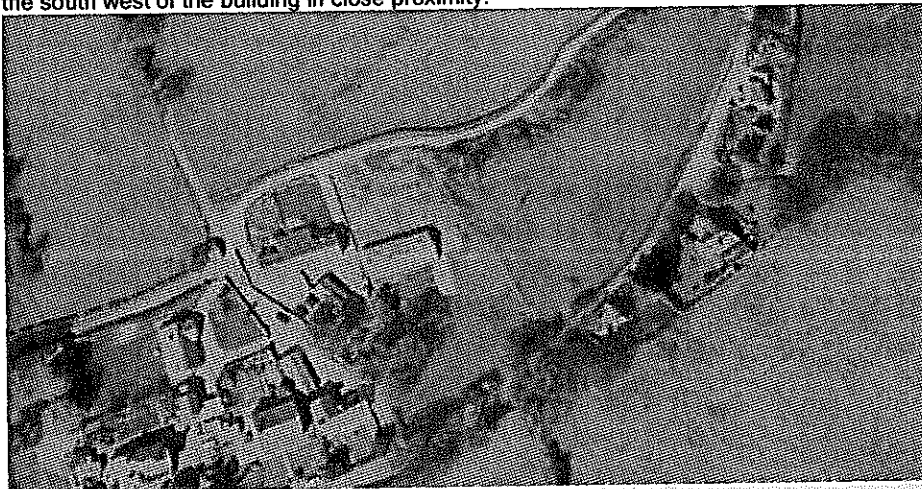
COMMENTS: Both Back and Rimington lane are lined with mature trees/ hedge. There are a group of trees to the south west of the building in close proximity.

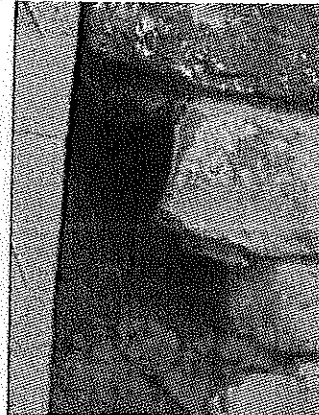
COMMENTS: The pointing in the stone and brick walls and the render is in reasonable condition with no access points for bats, however there is a large crevice in the stone wall section (see picture below).

Crevice in stone wall

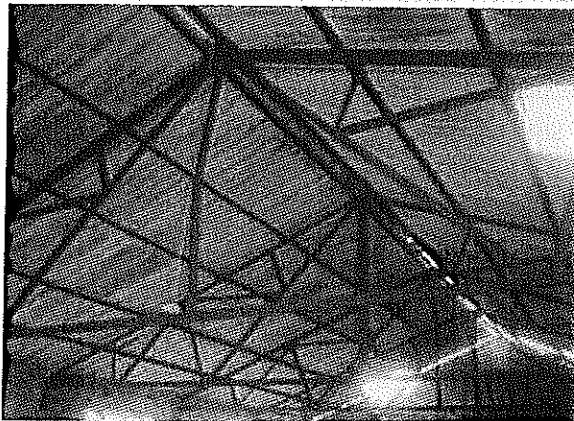
COMMENTS: There is no enclosed roof space. The roof is supported by steel trusses and purlins.

COMMENTS: The roof light opening with no glazing provides access as do the large gaps at ridge and eaves level (as illustrated above)

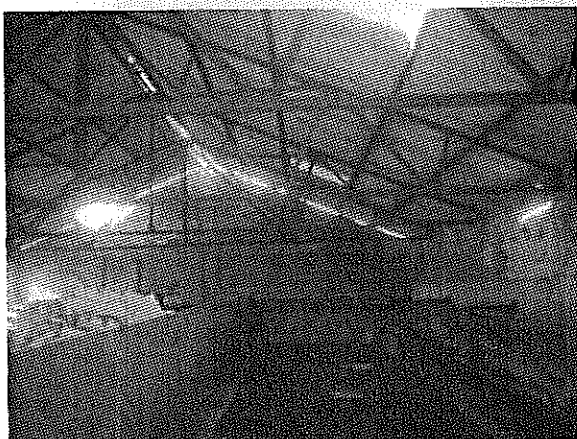
COMMENTS: None of the above where found.

The interior of this building is draughty due to the exceptional number of openings in it. It provides very little protection from the elements and it lacks any cracks, crevices or any shelter suitable for bat hibernation or roosting.
