# earthworks environmental design

Job ref: B 1310

Re: Protected Species Survey: 2 Whalley Road, Langho, Lancashire. BB6 8EJ

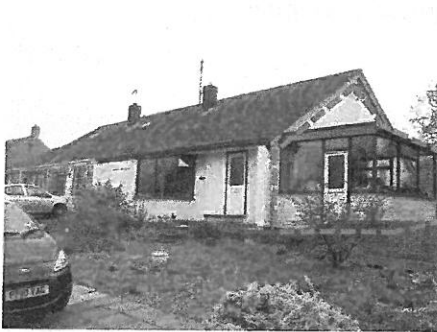
Figure 1: front / SW side elevation

The property is a single storey semi-detached dwelling with brick and block cavity wall construction and duo-pitched tiled roof with enclosed roof void. There is an attached sun lounge with flat bitumen roof on the south-west gable wall (outlined in figure 1) and also a small lean-to conservatory with mono - pitch laminate roof at the rear (figure 3).

It is understood the proposed building extension (to accommodate, kitchen, bathroom and lounge) at the south-west gable end will require removal of the existing single storey sun-lounge (located by red broken line in figure 1); additionally an existing garage (figure 2) will be converted into a bedroom.

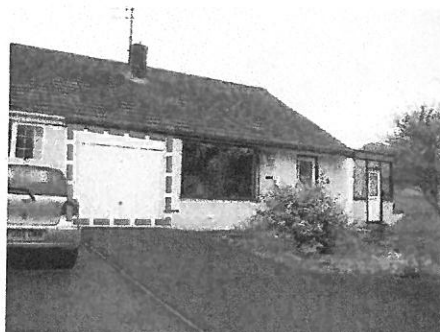
Figure 2:

There is a single garage on the front elevation (figure 2) with an 'up-and-over' door and well-sealed fascias.

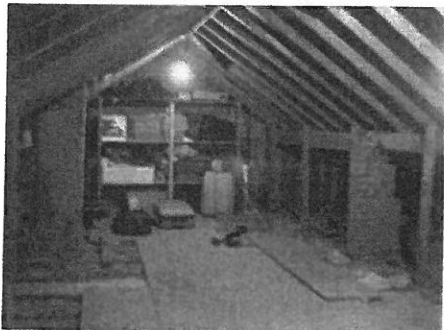
Figure 4: roof void

The roof has a rafter with purlin construction and is boarded for access and storage (figure 4); the concrete tiled roof is lined with bitumastic felt and the void insulated with glass fibre and rock-wool materials between the ceiling joists (figure 6). The roof void is dry, cool and well-ventilated and there is no natural light.

The roof void was carefully inspected for the presence of bat droppings and other indicative signs of bats; none were found. Several small mammal droppings throughout the void indicate mouse activity only.

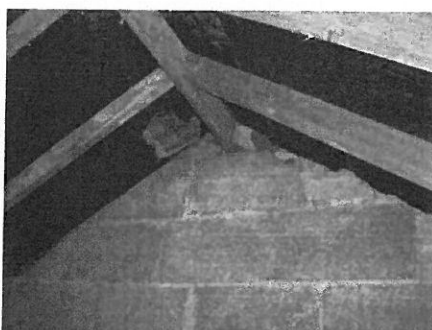
Figure 5: south-west gable apex wall

Externally, the property is relatively well-sealed; the south-west gable wall has PVC cladding and fascia-soffits are fully secure. External features including roof verges, ridge tiles and lead work flashings are secure.
