## **Storage Outbuilding at Low Farm, Ribchester Road, Clayton-le-dale, Blackburn, BB1 9EE**

### **Bat Survey, Plus Barn Owl & Breeding Bird Assessment**

**May 2013**  
RB-13-74

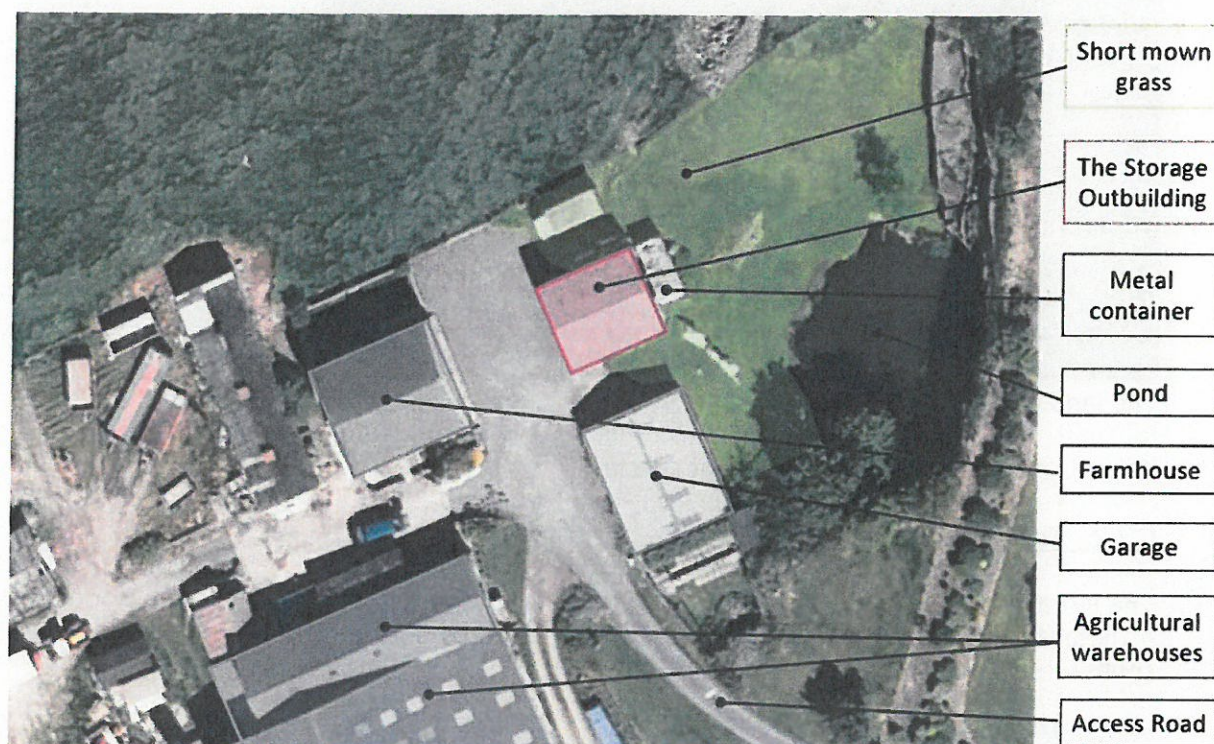
**Fig. C.7.1: Labelled aerial photograph of the building & its surrounds**

As shown, the building is situated north-east of the farmhouse, plus north of a garage and north-east of agricultural warehouse buildings. The access track into the farm is from the south and to facilitate vehicular access into the outbuilding there is hard-standing alongside the south-west gable end and also alongside half of the south-east elevation.

Adjacent to the north-eastern gable end there is a metal storage container, but as labelled on **Fig. C.7.1**, the container shown at the north-west side of the building is no longer present.

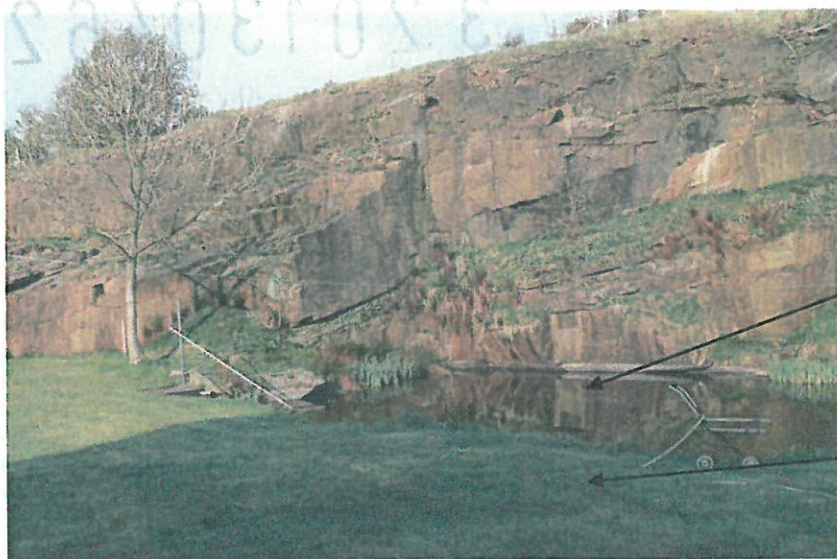
**Photo. 1**

The ground composition to the north-west and north-east of the building comprises short-mown grassland and localised neat storage of concrete slabs on one pallet adjacent to the north-west elevation. To the east, the short grassland leads to a pond, which is illustrated in **Photo. 1**. As shown, the pond is bound by a small old quarry face on its east side. There is also a small cluster of trees adjacent to its south side, making it a very enclosed and sheltered feature.

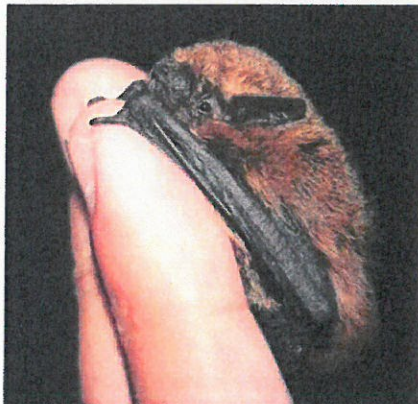
Fully grown Common pipistrelle bat

- Workers are to be alert for the presence of bats, and/or any accumulations of bat droppings, underneath the features that they are stripping. For guidance, the following photographs show a Common pipistrelle bat (the species that is most likely to be encountered) and an accumulation of bat droppings.

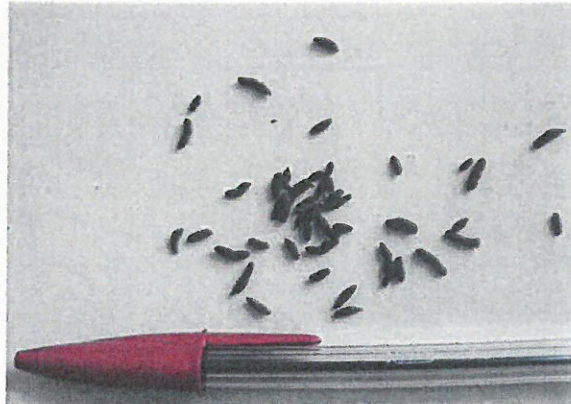
Pipistrelle bat droppings, which look like mouse droppings, but crumble to dust when squashed between the fingers (comprising tiny, glistening bits of insect wings etc.)

- If a bat (or an accumulation of bat droppings) is discovered at any time during the roof removal, work is to temporarily cease whilst an experienced bat ecologist is contacted for guidance and assistance. This can be the consultant who undertook the initial survey (Ribble Ecology: 01772 879545), any other licensed bat worker, or the Bat Conservation Trust (BCT) helpline (0845 1300 228).
- If it is necessary to capture a bat to remove it to safety, this should be undertaken with gloves or a light cloth, capturing the bat and containing it whilst the advice of the bat worker is sought. Thereafter, following the on-site advice of the bat worker will ensure there is no breach of the legislative protection afforded to roosting bats.
