BAT SURVEY

MERRYBENT HILL FARM  
CATLOW ROAD  
SLAIDBURN

DATE AND TIME OF VISIT  
20<sup>TH</sup> NOV 2012

BAT SURVEY  
AT

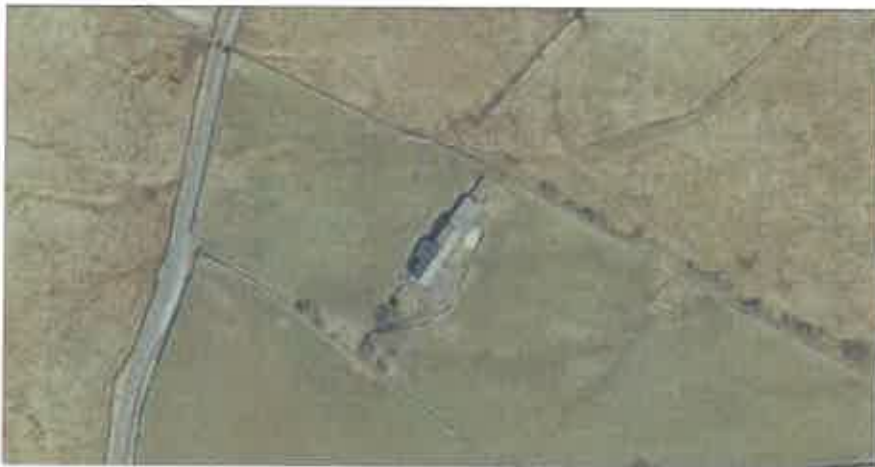
COMMENTS: The farm is located approx 5 miles to the north of Slaidburn just off Catlow road, it is a remote upland farmstead surrounded by agricultural land.

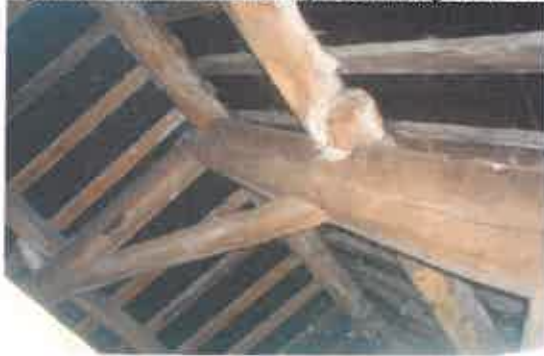
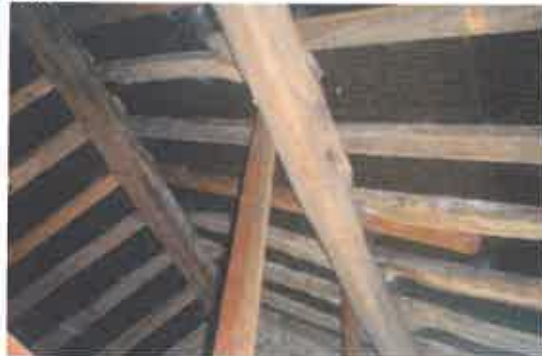
COMMENTS: The house roof space is enclosed with a ceiling, and it was inspected from 3 separate hatches (it was not safe to enter the roof space). The timbers are original but at some time the roof has been felted and some rafters replaced. As can be seen in the photograph there is an exceptional amount of cob webs in the roof space. Although close inspection was not possible it does not appear that bats have used this roof space and no signs that bats were currently hibernating could be found.

The farmhouse roof voids

It is recommended that any re-roofing should be carried out during the autumn and winter months when bats are inactive and it is highly unlikely that any bats are present in the building.

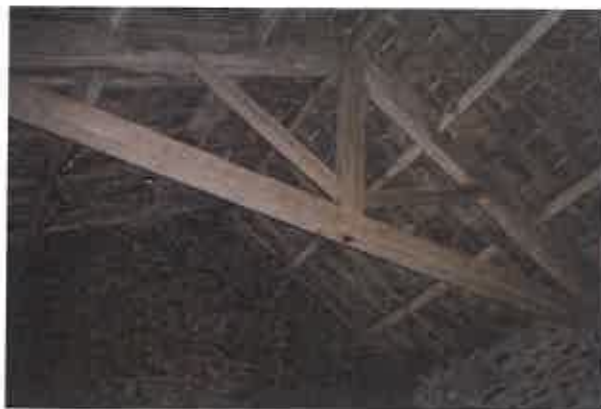
The barn roof void

The barn roof space is not enclosed, it appears to have original roof timbers which are in reasonable condition there is no felt in this section of roof the area is damp and draughty.  
The store roof space is also open to the underside and although there is no water ingress the area is damp and draughty.

COMMENTS: The farmhouse roof slates are in reasonable condition, although some loss of Lead around the chimney has lead to some deterioration at ridge level. The barn ridge stones are in poor condition leading to substantial water ingress. The corrugated roof covering on the store with plastic roof lights is in good condition.

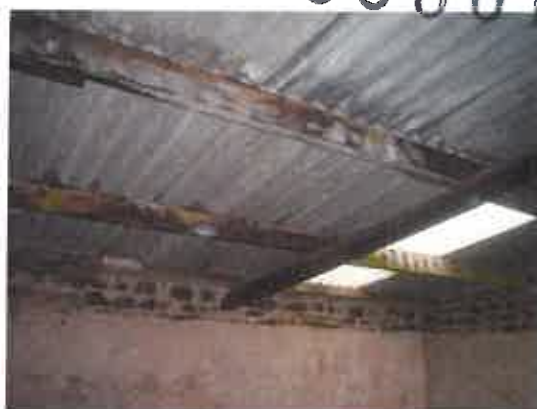
Machinery/cattle store roof.

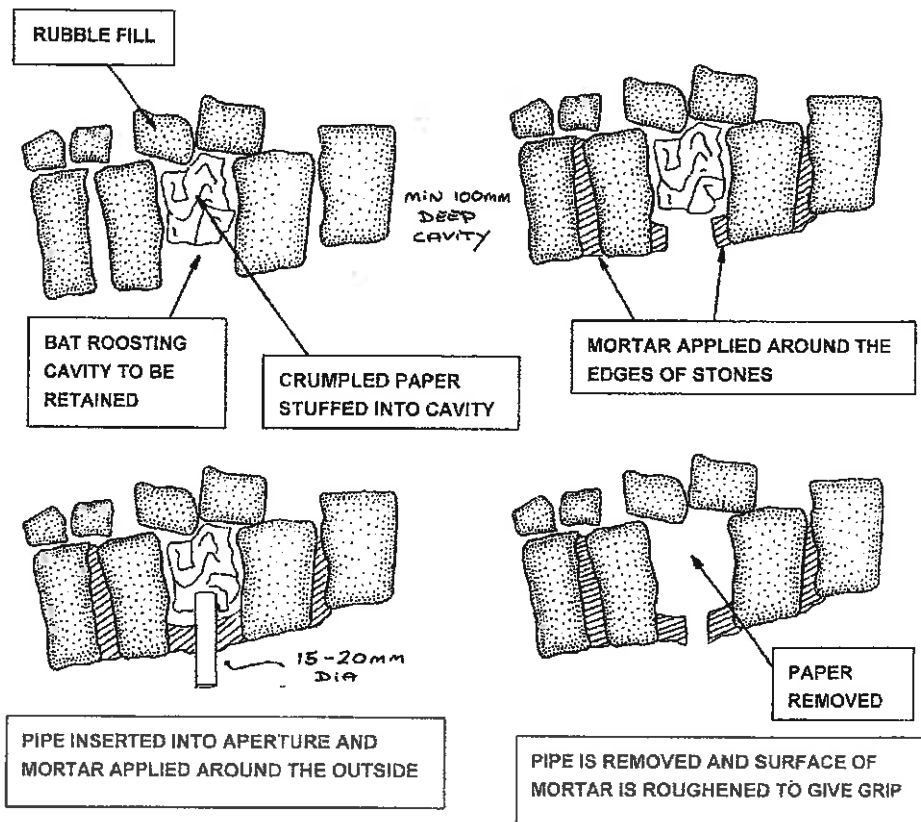
## Retaining a cavity

- Gaps formed at the eaves to allow access to the roof void. See attached illustration.
- Areas of pointing to be omitted forming suitable roosting crevices. See attached illustration.

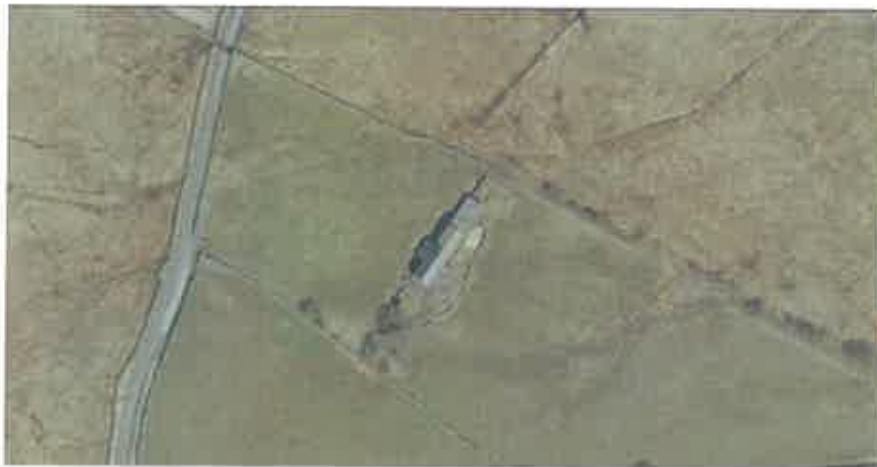
COMMENTS: The farm is located approx 5 miles to the north of Slaidburn just off Catlow road, it is a remote upland farmstead surrounded by agricultural land.

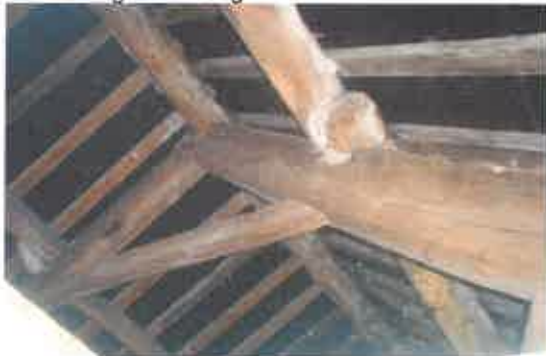
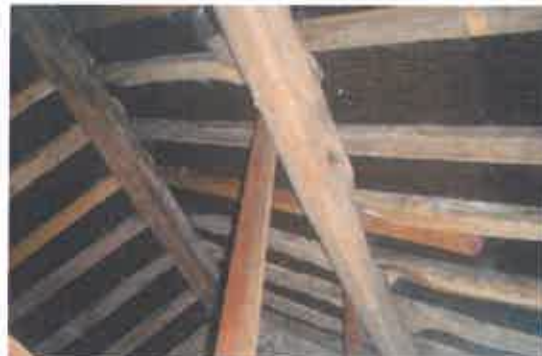
COMMENTS: The house roof space is enclosed with a ceiling, and it was inspected from 3 separate hatches (it was not safe to enter the roof space). The timbers are original but at some time the roof has been felted and some rafters replaced. As can be seen in the photograph there is an exceptional amount of cob webs in the roof space. Although close inspection was not possible it does not appear that bats have used this roof space for hibernating or roosting.

The farmhouse roof voids

It is recommended that any re-roofing should be carried out during September - October autumn and winter months as the buildings are not used for hibernation and bats generally are inactive.

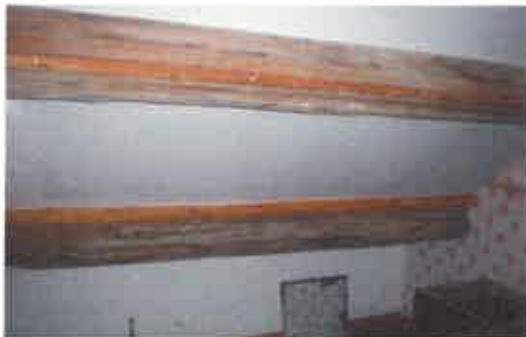
The roof space in the cat slide roof.

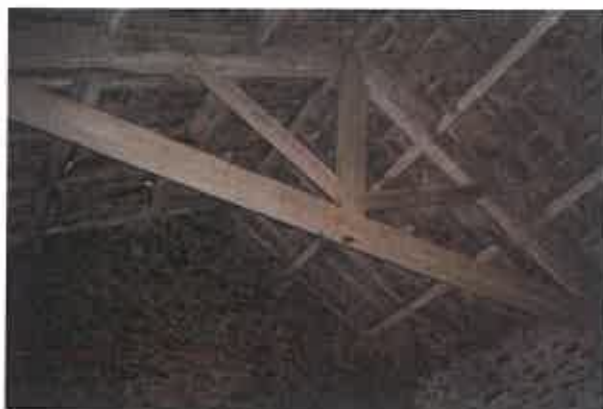
The barn roof void

The barn roof space is not enclosed, it appears to have original roof timbers which are in reasonable condition there is no felt in this section of roof the area is damp and draughty.

COMMENTS: The farmhouse roof slates are in reasonable condition, although some loss of Lead around the chimney has lead to some deterioration at ridge level. The barn ridge stones are in poor condition leading to substantial water ingress. The corrugated roof covering on the store with plastic roof lights is in good condition.

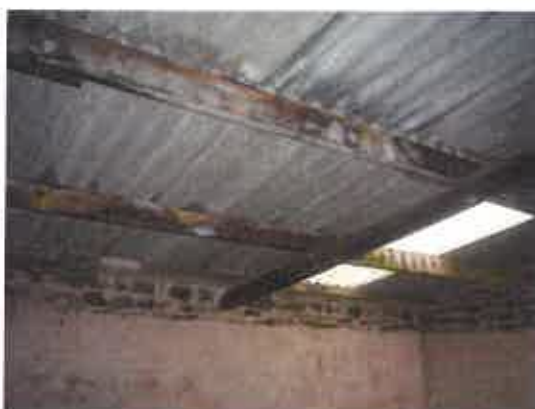
Machinery/cattle store roof.

The store roof space is also open to the underside and although there is no water ingress the area is damp and draughty.

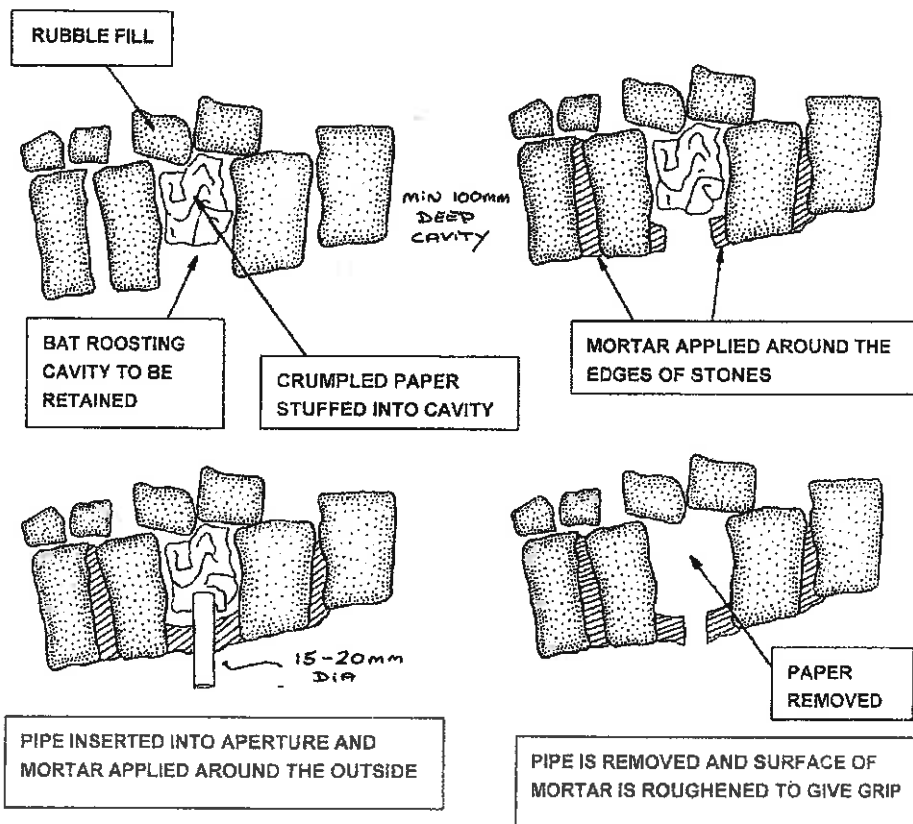
## Retaining a cavity

- Bat tubes into the walls of the south east elevation.
- Bat slates to be installed to allow Pipistrelle to roost between the felt and slate.
- Gaps formed at the eaves to allow access to the roof void. See attached illustration.
- Areas of pointing to be omitted forming suitable roosting crevices. See attached illustration.
