**Cocklick End Farm, Slaidburn**

*Further Bat and Barn Owl Surveys*

July 2012

**Project No & Title:** BOW0020/083 Cocklick End - Further Bat and Barn Owl Surveys

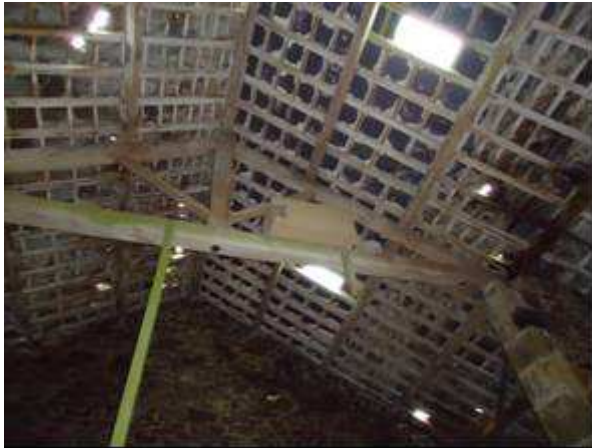
**Image 1 – Interior of the barn, showing the roof structure and location of the barn owl nesting box.**

- 3.2. Internally the barn is double height with a tiled roof on timber batons, beams and trusses. Mortar work is present between the tiles; some of which has failed leaving gaps between the tiles in which bats could roost or access the barn. The roof is not lined. The internal walls are stone built with the mortar work that is in moderate condition. Gaps and cracks are present between the stones where the mortar has failed. The walls are partially lime rendered. Opportunities exist for bats such as brown long eared bats and pipistrelle bats to roost between the timber beams and roof tiles, at the top of the walls and within crevices in the stone work of the walls. Cavities in the walls (ventilation holes) have been used by nesting birds; although they were not active at the time of the survey, large piles of debris on the floor below these nest sites indicate that corvids may have used the nests.

- 3.3. A barn owl nest box is present within the barn and evidence from the presence of feathers, splashes and pellets on and beneath the box suggest that barn owls have or currently use the box.

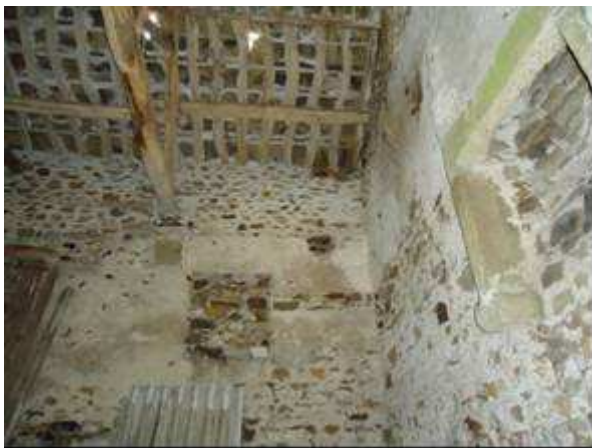
**Image 2 – Partially lime rendered walls and mortar work in good condition.**

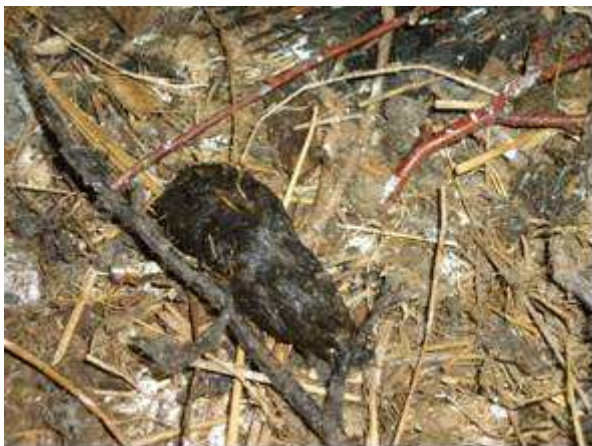
**Image 3 – Fresh barn owl pellet beneath the barn owl box.**

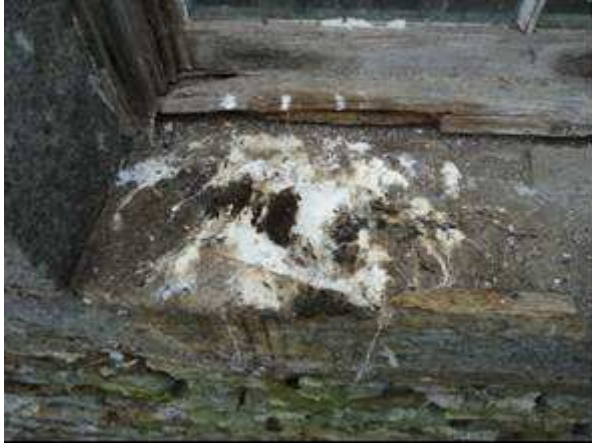
**Image 4 – Splashes and pellets on first floor window ledge of house.**

- 3.5. Barn owl pellets were found on the window ledge of the window that was used to access the first floor for inspection. The location of the pellets indicated that the owl perches on the broken window frame and the age of the pellets suggest that this activity is not recent.

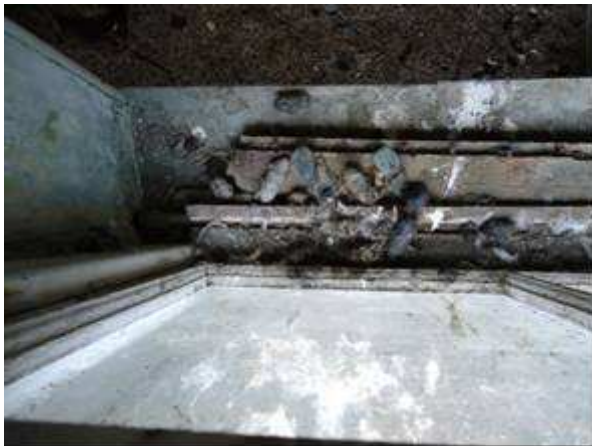
**Image 5 – Splashes and pellets on first floor window ledge of the house.**

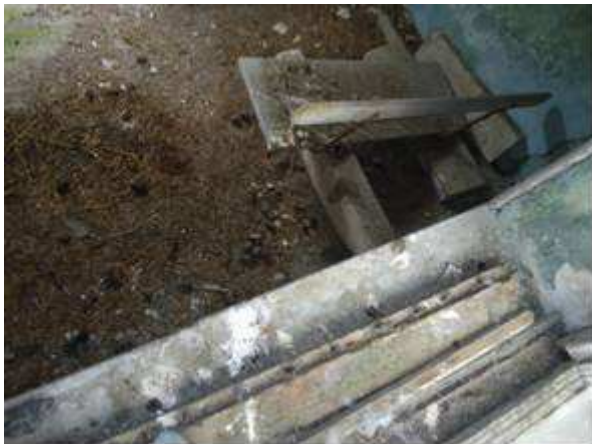
**Image 6 – Field signs of barn owl across the first floor level of the house.**

4.10 It was confirmed during the bat surveys that barn owls are breeding within the barn. Field signs of barn owl within the building suggest that it has been used by barn owls for a significant length of time. Within the barn and house white splashes, feathers, pellets and prey remains were all observed. Owl pellets were found outside the barn beneath a ledge located in the apex of the north eastern elevation. A barn owl was observed to emerge from the barn at dusk and barn owl chicks were sighted in the barn owl nest box.

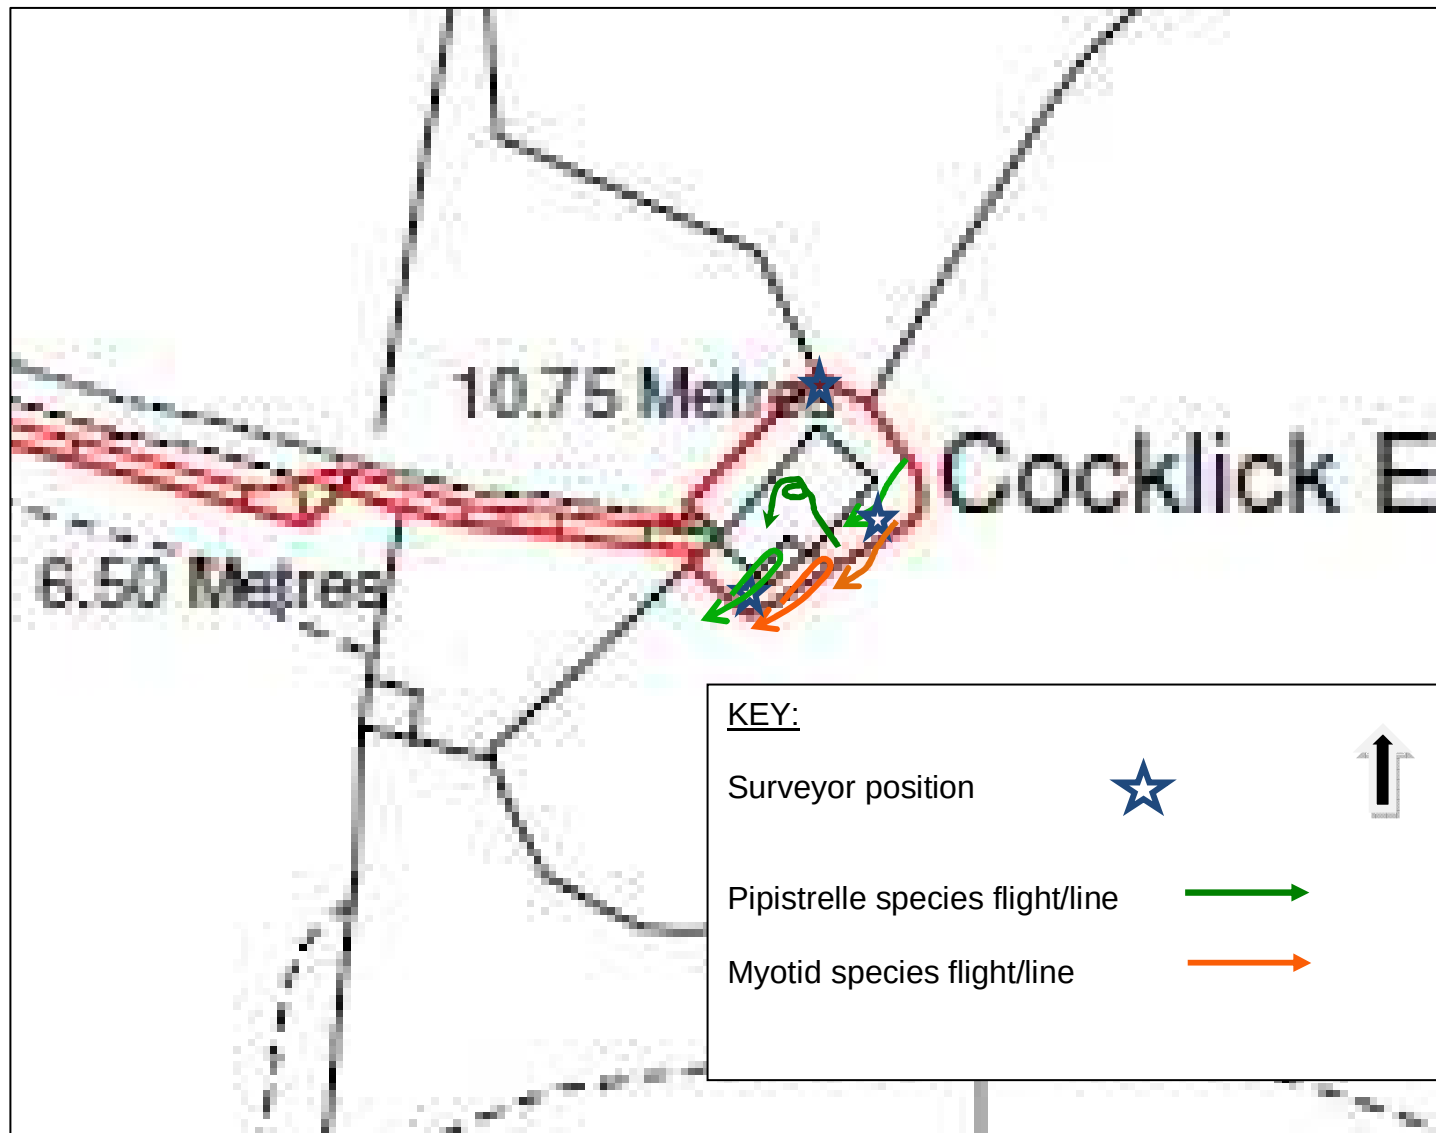
## Dawn Return Survey Results

- 3.10. Three surveyors were positioned around the barn, at the northern and southern corners and opposite the main entrance to the barn. The first bat heard was a common pipistrelle at 03:21 flying along the north western elevation. Two *Myotis* bats were heard but not seen along the south eastern elevation at 03:36 and 03:38 and a common pipistrelle was seen in front of the house at 03:40. Finally a pipistrelle bat was seen entering the barn at 03:53. It was not observed to leave the barn. No further bats were observed during the survey.
