# **COCKLICK END FARMHOUSE FOREST OF BOWLAND LANCASHIRE HERITAGE STATEMENT**

**September 2012**

**PETER DE FIGUEIREDO  
HISTORIC BUILDINGS ADVISER**

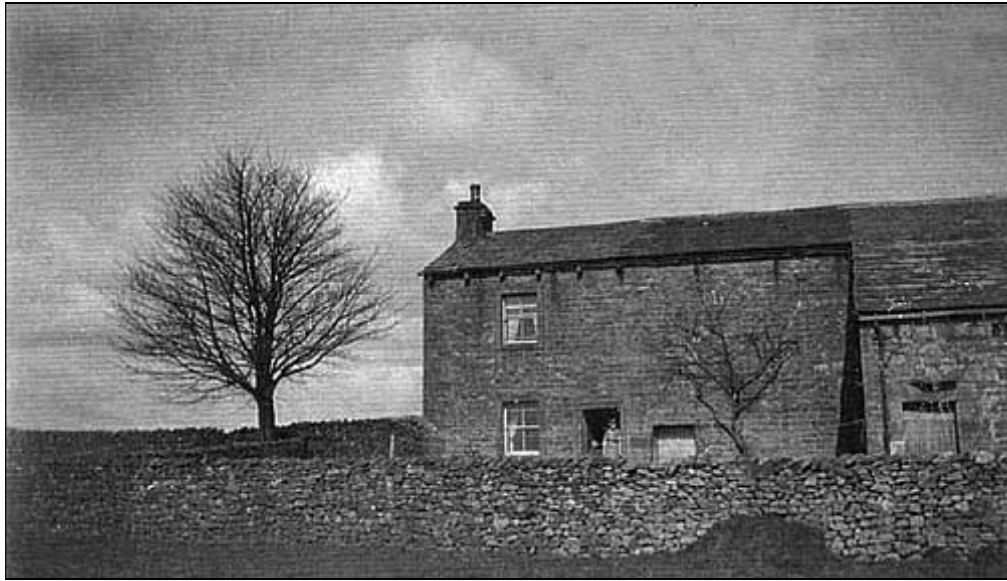
*Photograph of rear elevation taken before closure of the farmhouse, possibly 1950s, from the late May Jackson collection ([www.dalehead.org/cocklick\\_end.htm](http://www.dalehead.org/cocklick_end.htm))*

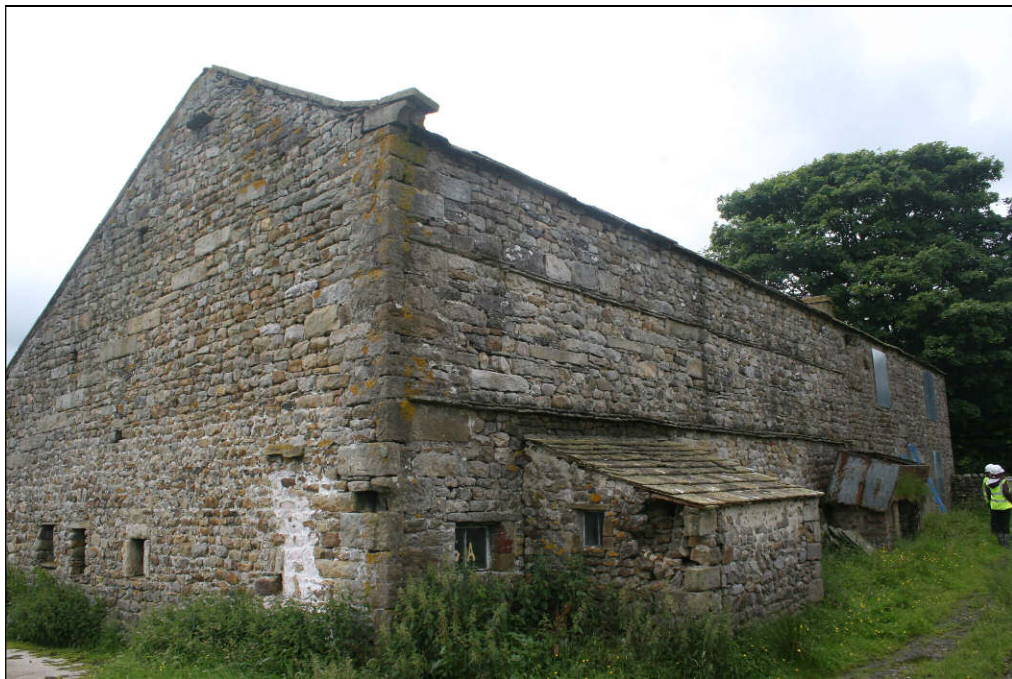
*Front and side elevation to barn*

- 3.1 The farmhouse and barn at Cocklick End form a single linear arrangement, with a common frontage line, and continuous ridge for the full length of the building. The barn projects out on the southeast side with an outshot or cat-slide roof covering the entrance. The entrance to the house is on the northwest side. The walls are built of gritstone rubble, roughly laid to courses, but using random sized stones, and the roof is of stone slates. Dressed stone is used for quoins, lintels, sills and for a prominent kneeler at the southeast corner of the barn.

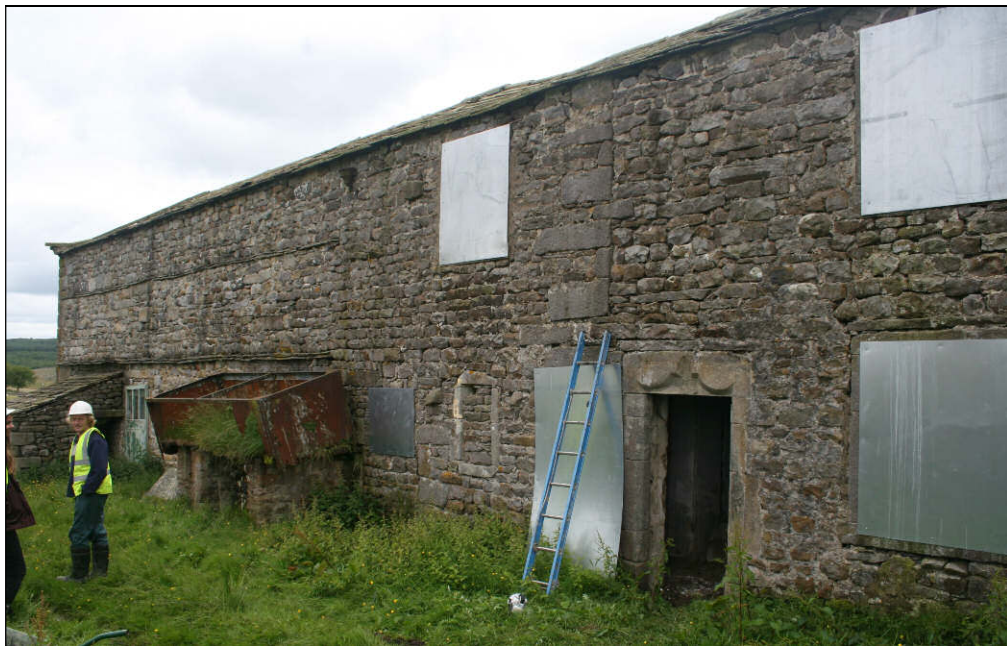
*Front elevation, showing earliest phase to the left of present entrance to the house*

- 3.2 Close examination of the fabric reveals that the earliest part of the building is the central unit, which extends from the line of the party wall between the house and barn to the stack of massive quoin blocks immediately left of the present entrance to the house. This unit contains a single room open to the roof, where the first floor has collapsed. At what was upper floor level is a fireplace with a stone surround that projects into the room and a tapering chimney stack above. The roof retains its original purlins and rafters of oak, supported on a central truss, which has been modified by the insertion of a King Post.

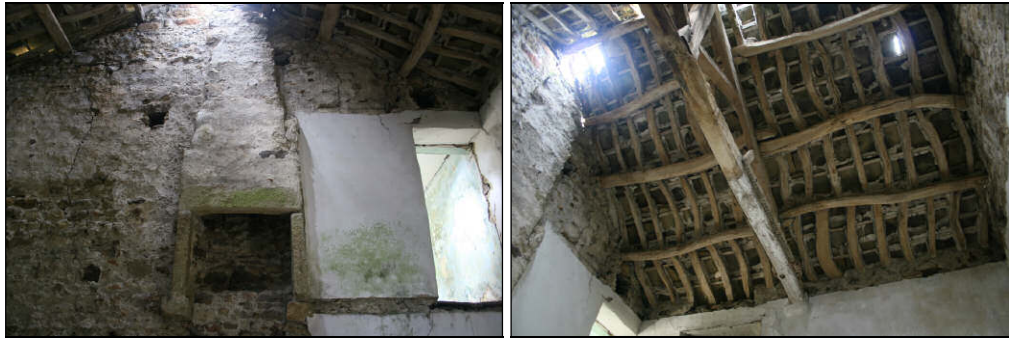
*Interior of central unit showing first floor fireplace and roof*

- 3.3 The character of this central space suggests that it was originally a barn, for there is no sign of a fireplace on the ground floor, and the fireplace at first floor level must have been inserted later. There are blocked doorways at front and rear, and it is possible that the doorcase with the fine inscribed lintel dated 1727 was originally in one of these openings. If this was the case, it is more likely that it was situated on the other side, for the blocked doorway at the present front of the house has quoins, which are not compatible with the form of the moulded stone doorcase and lintel. Considered stylistically, the central unit could date from the early 18<sup>th</sup> century, and is compatible with the date 1727.

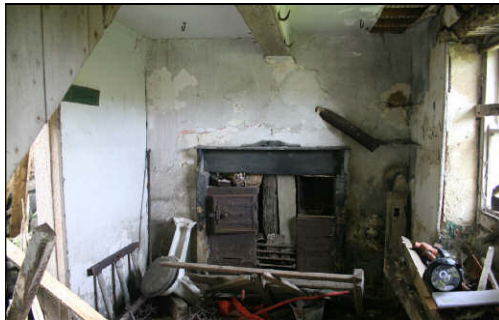
*Kitchen with range and meat hooks*

- 3.4 The southwest end of the house is a later extension. It contains a kitchen with a Victorian cast iron range and a room to the rear. A staircase leading to the upper floor has two stone treads at the base with timber treads above, and plain square balusters and handrail. The roof and first floor of the rear part have collapsed, but a stone fireplace surround with an early 19<sup>th</sup> century cast iron grate with Gothick-arched fireback remains at first floor level.

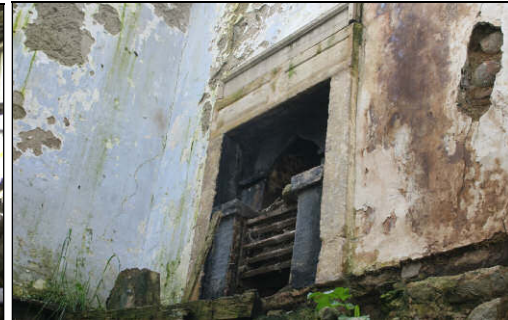
*Stone fireplace at first floor level*

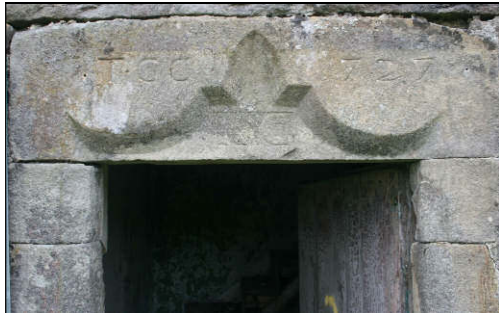
*Inscribed lintel on house with date 1727*

- 2.6 The lintel over the doorway to the farmhouse at Cocklick End has a date of 1727, while the barn has a datestone of 1827. These dates relate to different stages of construction, though the building analysis described in Section 3 of this report shows that the process of development was more complex than the datestones alone suggest.

- 3.5 The later extension probably dates from the early 19<sup>th</sup> century, and may be contemporary with the barn which is dated 1827. The doorcase and stone lintel with the inscription TGC and date 1727 was presumably incorporated into the extension when it was built.

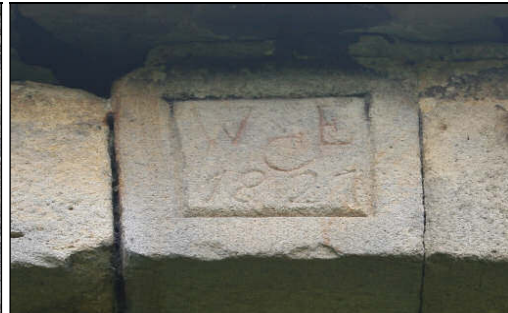
*Inscribed lintel on barn with date 1827*

- 3.6 The barn is of the combination type, in which shelter for animals is combined with crop storage under one roof. Dating from 1827 with the initials WEC, the barn was built as an extension to the earlier house, continuing the same eaves line on the northwest side and a common ridge line, but taking advantage of the slope of the land to create a higher space within.

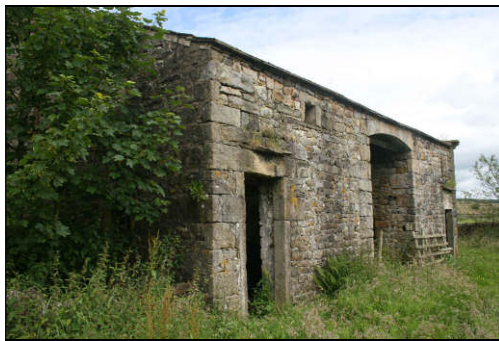
*Entrance facade to barn*

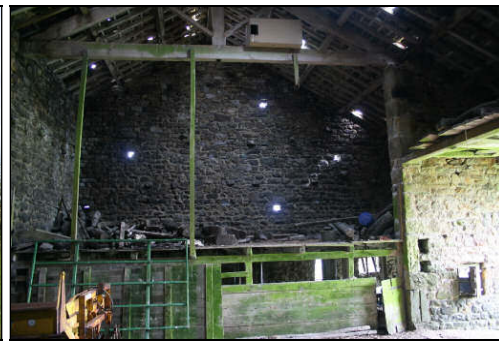
*Barn interior with cart entrance to right*

- 3.7 The large cart entry led into the threshing floor, with the area on the left and the area above the cow pens to the right used for storing hay, threshed straw and other crops grown on the farm. Threshing took place during the winter months and involved the use of a flail, generally carried out by a team of two men, the straw residue being lifted to one side and the ears being winnowed by natural draughts between the cart entry and the doorway opposite.

- 3.8 The entrance passageway gave protection in inclement weather, while the height of the threshing area provided light and air for the work of winnowing the husks from the ears of grain. Air vents are created by leaving out odd stones in the external walls to prevent the crops inside from becoming damp or mouldy. The threshing floor is paved with river cobbles and stone blocks. Originally, there would have been a separation from the storage bays with bracing to keep the loose crops or straw from falling onto the threshing floor.

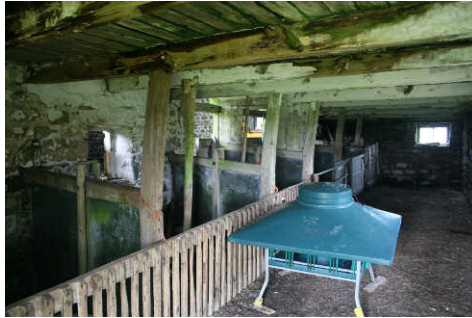
*Cattle pens*

- 3.12 The external doorway to the right of the cart entry leads into a passageway giving access to a range of cattle pens, each divided by timber posts and rails with slate infill panels. Originally the cattle would have been tethered whilst they were in the building, tail on to the access and manure passage, and fed from timber feeding boxes filled from the threshing floor.

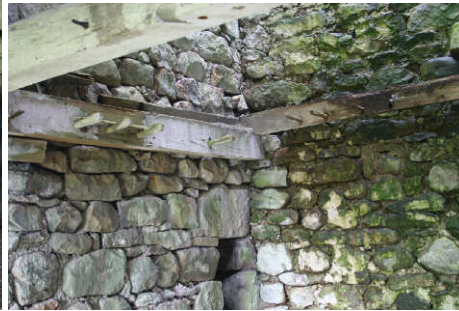
*Loose box or implement storage area*

- 3.15 The doorway to the left of the cart entrance leads into a space which probably served as a loose box and also perhaps for implement storage. Looseboxes allowed an animal to move about, and were intended for calves, sick animals, a bull or a cow about to calve. Timber pegs on the walls within were probably for hanging halters, tack or ropes.
