**STATEMENT OF SIGNIFICANCE  
Including Heritage Impact Assessment  
Sawley Lodge  
Sawley  
Lancashire  
BB7 4LF**

For Issue 20 August 2013

jubb&jubb  
CHARTERED SURVEYORS  
HISTORIC ENVIRONMENT ADVISERS

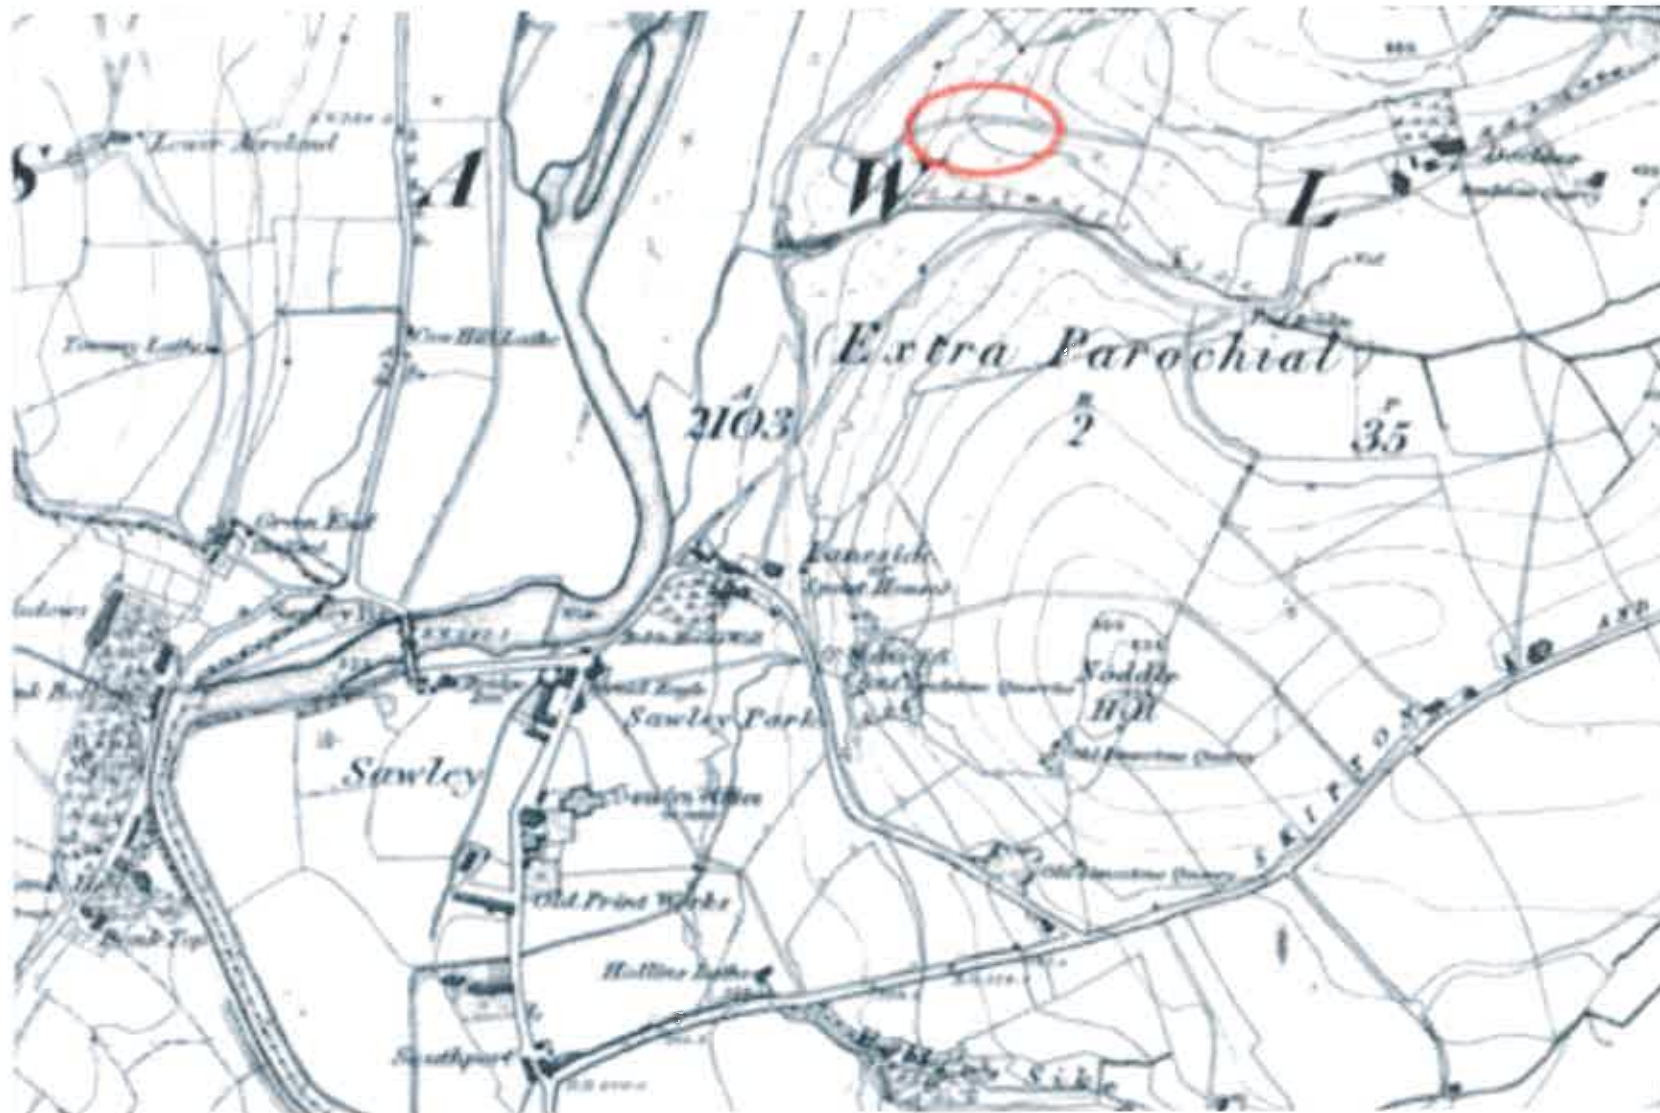
Ordnance Survey Extract 1847

- 2.1 The 1847 Ordnance Survey map records no building on this site, and the contours show that levelling of the site did not occur until after 1847.
- 2.2 The 1886 map shows the lodge building extending to most of its current footprint although the outbuildings (glasshouse, stable block, sheds and plant housings) are not recorded. This concurs with physical examination, which recorded a hopper head dated 1882 on the inner east wing of the building. There is evidence however, that the 1882 extents of the building may overlay an earlier building thought to date from after 1850 (ref Appendix C).

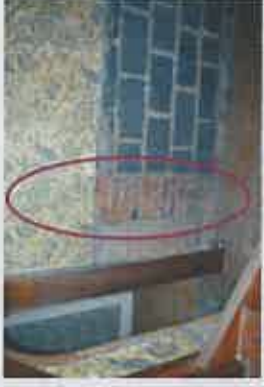
Sawley Lodge - Phasing Diagram

- 2.3 Physical evidence for the earlier building (after 1850 but before 1882) is very scant. A small section of brickwork, revealed abutting a modern cinder-block wall is thought to be the last scrap of the rear external wall of 'Block A' (see footprint analysis at Appendix D).

Possible footprint as built - no fabric remains other than a scrap of wall at —

Scrap of wall - after 1850 but possibly pre-1882
