HABIT REPORT

PROJECT: 25 LONGWORTH ROAD
LOCATION: BILLINGTON,
BB7 9TP
CLIENT: ANDREW READ

OUTLINE BRIEF: LOFT CONVERSION AND DORMER WINDOW
TO THE REAR OF THE PROPERTY

Initial Assessment Bat Survey

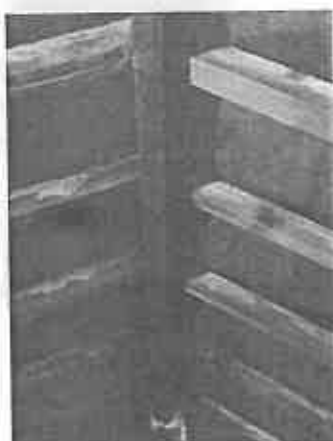
RIDGE (INTERNAL)

The loft space has been inspected on several occasions by myself and the client with no evidence of activity within the roof space this includes the usual signs of smells and animal waste.

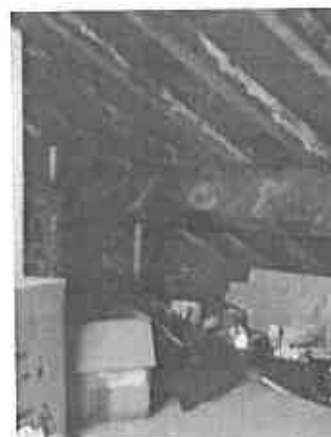
GENERAL INTERNAL

Currently the loft space of the above property is a sealed space used and accessed regularly by the client for storage of possessions. There are no overhanging eaves to either elevation of the property with a box gutter to the front of the property and a flush fitting fascia board to the rear, restricting any access into the loft space.

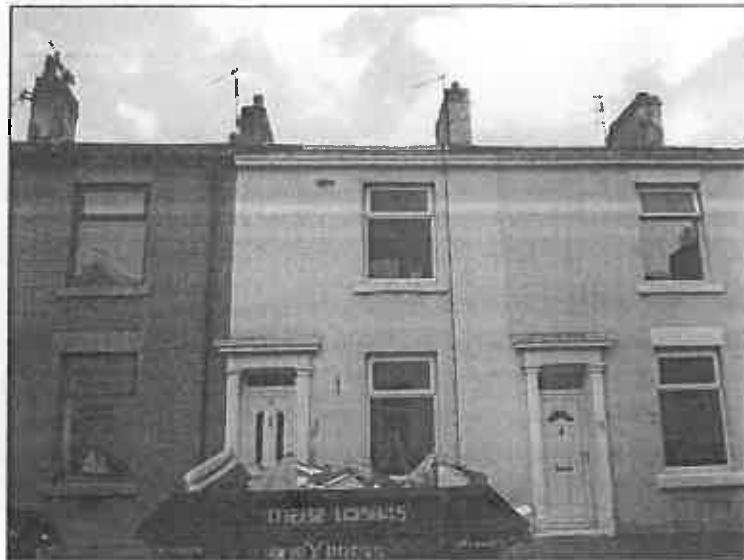
Figure 1: North elevation.

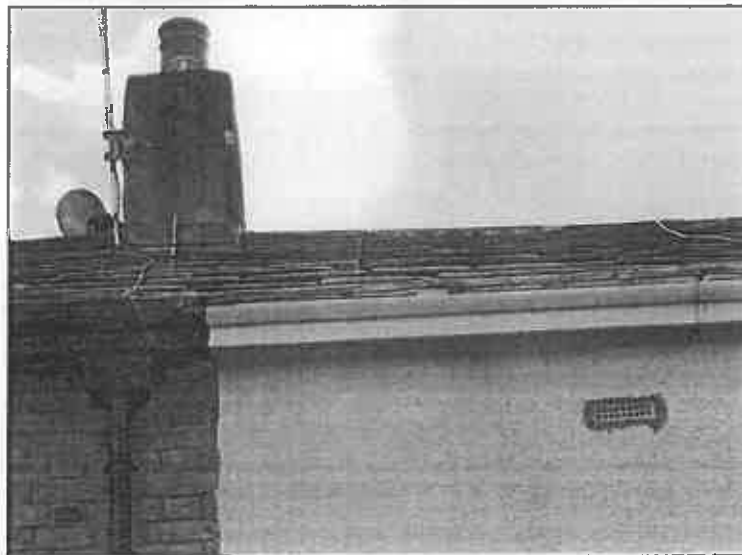
The client is applying for planning permission to build a dormer at the rear of the property (southern elevation). The northern side of the loft space has been converted to form a storage area and the roof has been boarded internally. Therefore, the gaps in the slates which provide suitable roosting features for bats on the northern elevation have been retained. Given the retention of suitable roosting features on the northern elevation and no evidence of use by bats being located within the roof structure on the southern elevation, it is therefore considered that works can continue without the need for further surveys. The site provides moderate habitat value due to the gaps in the slates and its close proximity to woodland and open water. This habitat value will be retained when the works have been completed due to the retention of the gaps in the slates within the roof structure on the northern elevation. Further gaps in slates were noted within the roof structures of adjacent properties on both sides of Longworth Road providing several roosting opportunities for the bats recorded in the area.

Figure 2: Gaps in slates – suitable roosting features that have been retained (northern elevation).

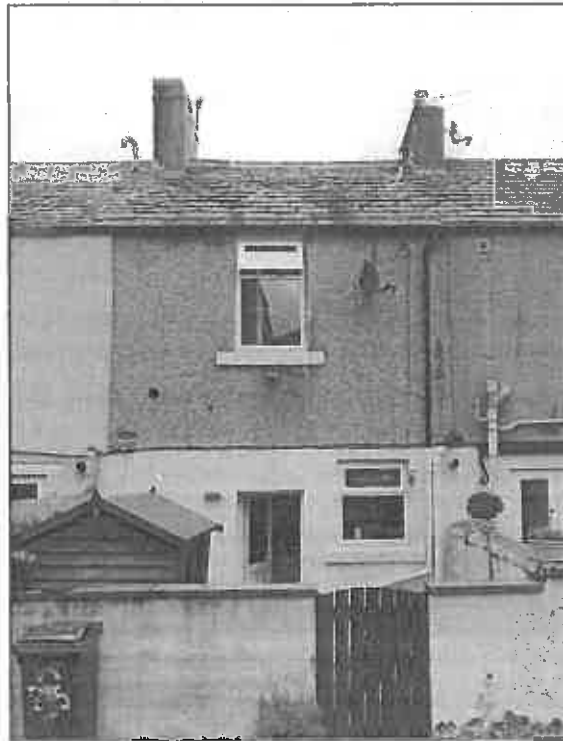
Figure 4: Southern elevation.

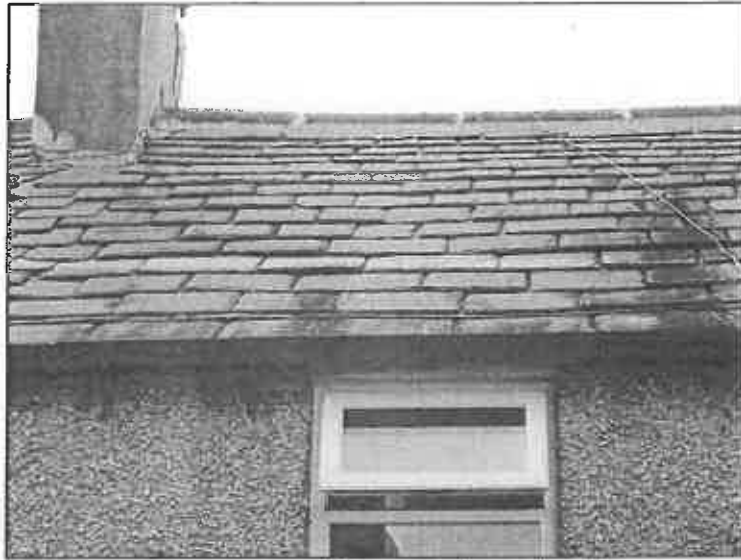
Reference Number	Habitat Value Table 2 Refers	Description of Roosting Features Access to Roosting Features	Confirmation of Bat Presence
B1	Moderate Habitat Value	<p>A two storey brick built and rendered mid-terrace property with a pitched slate tiled roof. Windows and doors are UPVC framed and tight fitting.</p> <p>Internally renovation work has begun and the loft space is being converted. The northern side of the loft has been converted to form a storage area and the roof has been boarded.</p> <p>The roof is felt lined on the southern side of the property and the felt is tight fitting with no tears.</p> <p>Externally several gaps are visible between the slates on the north and south elevations.</p>	<p>Permission was granted by the client the cut holes in the felt lining on the southern side of the property in order to complete a full inspection.</p> <p>A hole was cut in each 0.5m² of felt across the entire roof structure on the southern side and each section was inspected with an endoscope. Daylight was visible through the gaps in the slates that had been noted externally.</p> <p>No evidence of bats could be located between the felt and slates across the entire southern roof structure indicating that this section of the roof is not being used by bats.</p>

Figure 5: Gaps in slates on southern elevation.

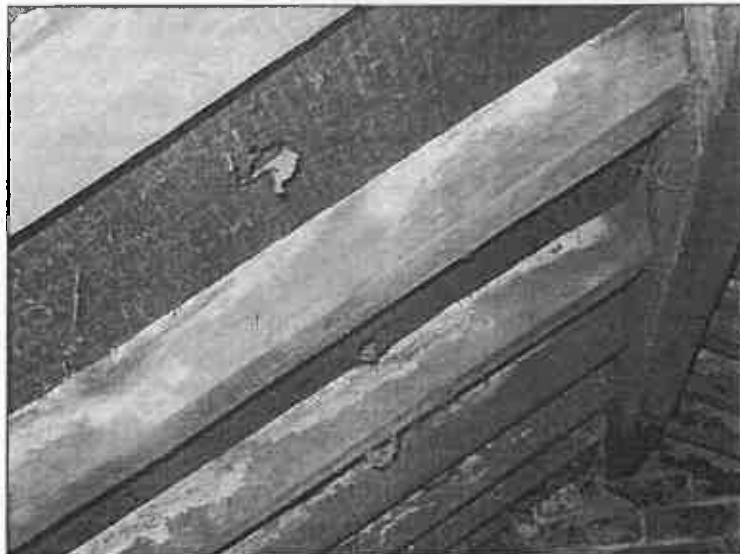
Figure 6: Southern elevation interior – example of holes cut in felt lining to complete thorough endoscope inspection, no evidence found.

Reference	Specification for Surveys ²	Seasonality for Emergence Surveys
B1	No further surveys.	<p>Optimal: Mid May to August inclusive.</p> <p>Sub-optimal: May to September inclusive - will require a greater survey effort and justification.</p>
