BAT SURVEY

**GREENBANKS BUNGALOW
GREEN LANE
GRINDLETON**

**DATE AND TIME OF VISIT
25TH March 2014 3.00pm**

EXTEND THE PITCHED ROOF OVER THE EXISTING FLAT ROOFED KITCHEN AND CONVERT THE EXISTING ROOF SPACE TO INCREASE THE EXISTING FIRST FLOOR BEDROOM ACCOMMODATION.

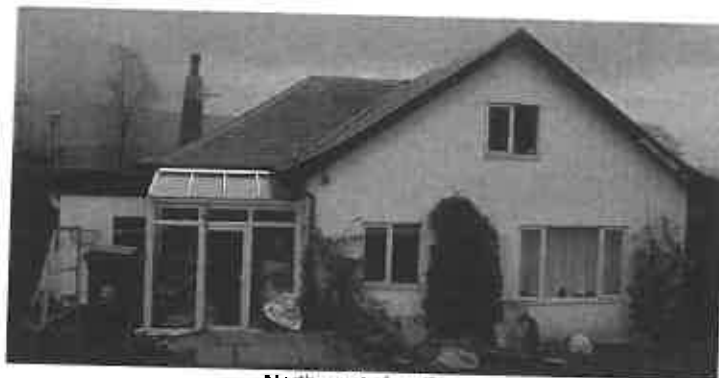
North west elevation

COMMENTS: The property is a detached Bungalow with detached garage.. the original bungalow was built in the 1920's, it has subsequently been extended with the latest flat roof kitchen extension being added in the 1980's.

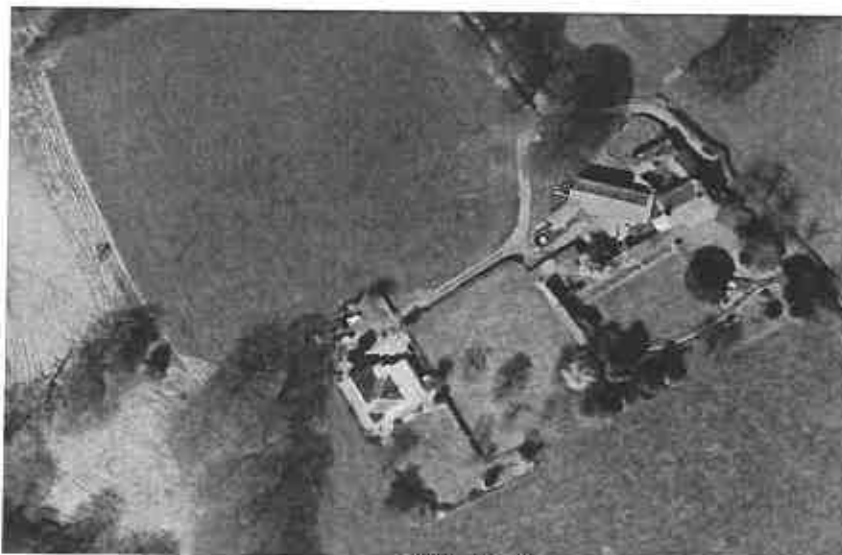
COMMENTS: To the west of the garden 'West clough brook' flows in a north to south direction in a ravine with densely wooded banks. The large area of trees extend towards the North forming extensive foraging and roosting habitat for bats. The fields surrounding the house are boarded with hedges and trees.

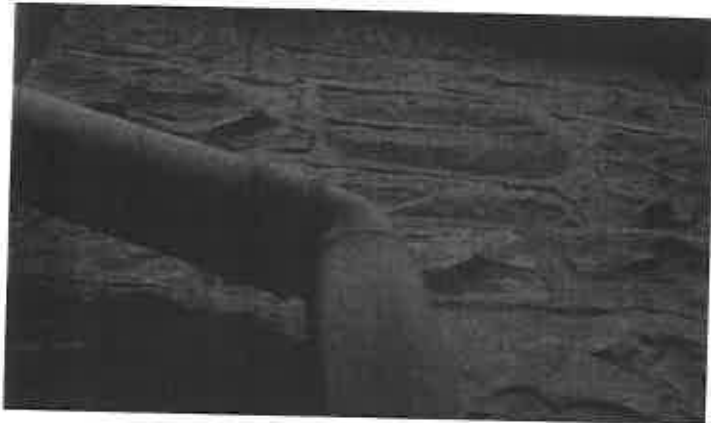
Stone wall

COMMENTS: The walls are a combination of mainly white painted render to the most recent additions with the south east elevation being partially natural stone with strap pointing. The south west and south east elevation (the oldest section) have a rough render finish .

COMMENTS: All the walls are in good condition with no access points or cracks or crevices.

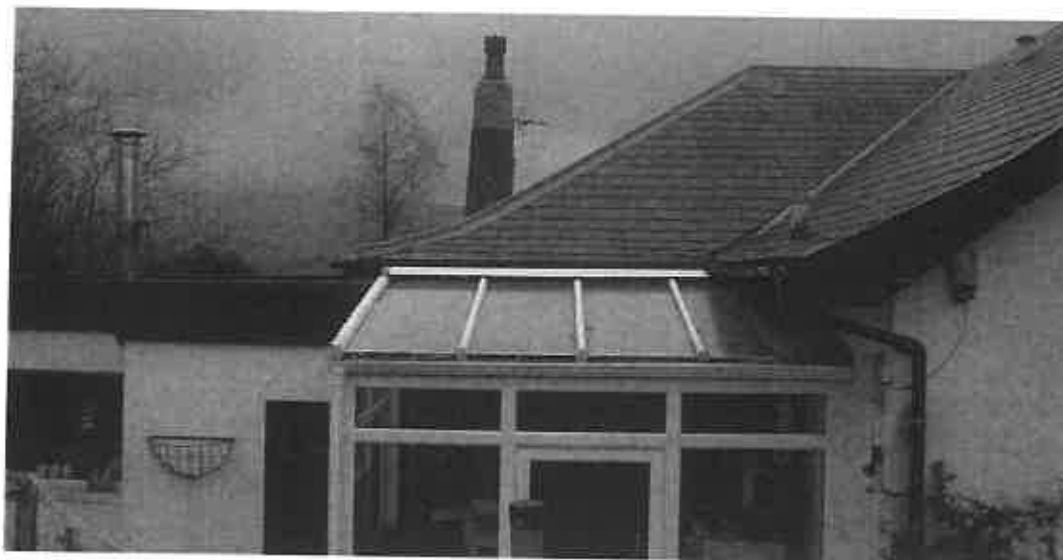
COMMENTS: The main roof is pitched and hipped with a blue slate finish there are overhangs to the eaves and gables which are boarded to the underside. The kitchen has a flat roof with a felt finish, the fascias to the perimeter project slightly from the wall . There is a fully glazed porch to the North west elevation and a glazed lean to south east elevation.

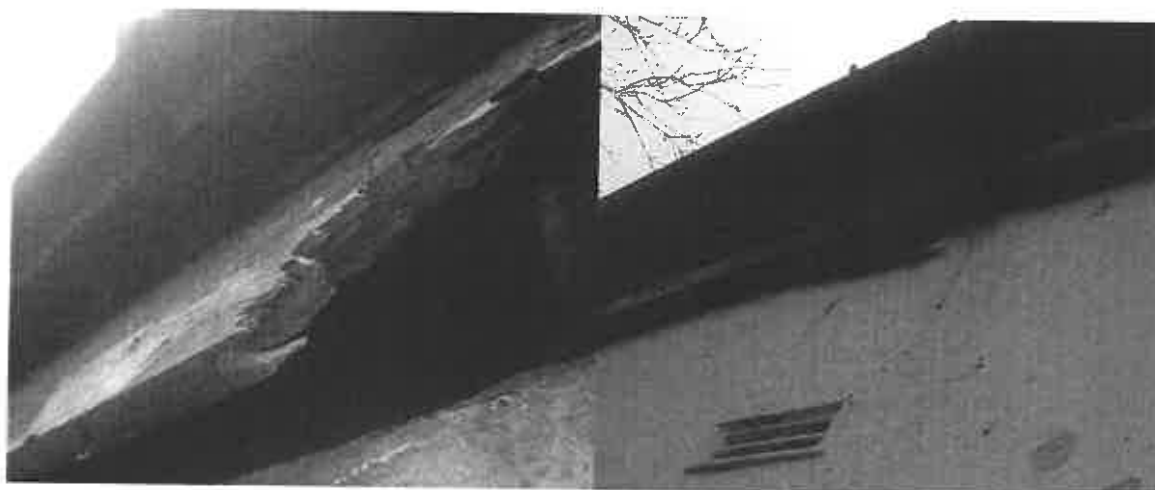
COMMENTS: The tiles are tight fitting with no significant cracks or crevices. The lead work is also in good condition and does not form any crevices. The overhangs are mostly tight fitting with some gaps suitable for bat ingress, there was some evidence of staining at the entrance of the gap with some dried grass visible this opening was closely inspected internally no bats were found, it is likely that the recess has been used by birds or squirrels (there is history of squirrels using the building).

COMMENTS: It was not necessary to use the bat detector during the survey as it was undertaken during the hibernation period. The path surrounding the building were examined for droppings and staining evidence, none was found with the exception of some wall staining near the fascia access point.

However due to the fact that the house is located in a prime foraging location and staining at the entrance of the soffit crevice was evident i would recommend that an emergence survey be carried out mid to late April to clarify what is using the crevice and determine if any bat mitigation is required.

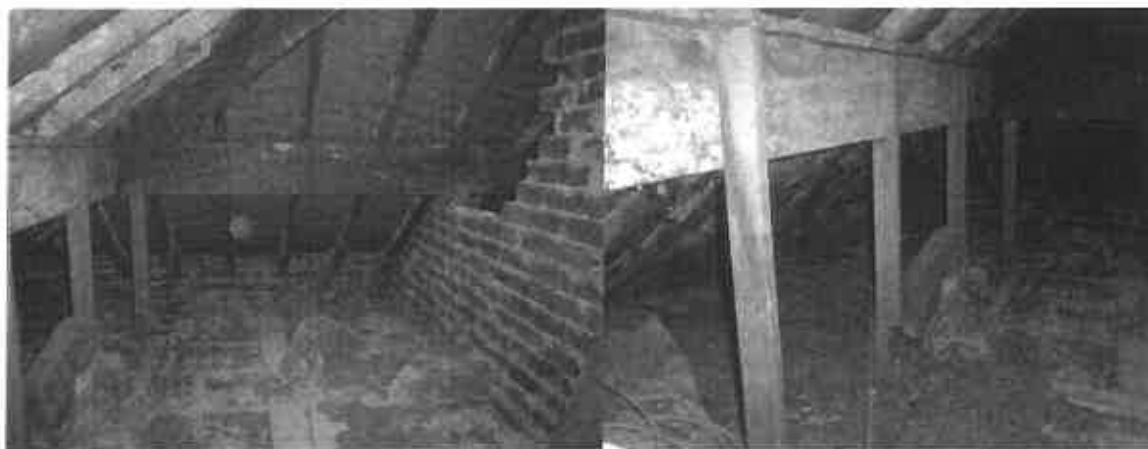
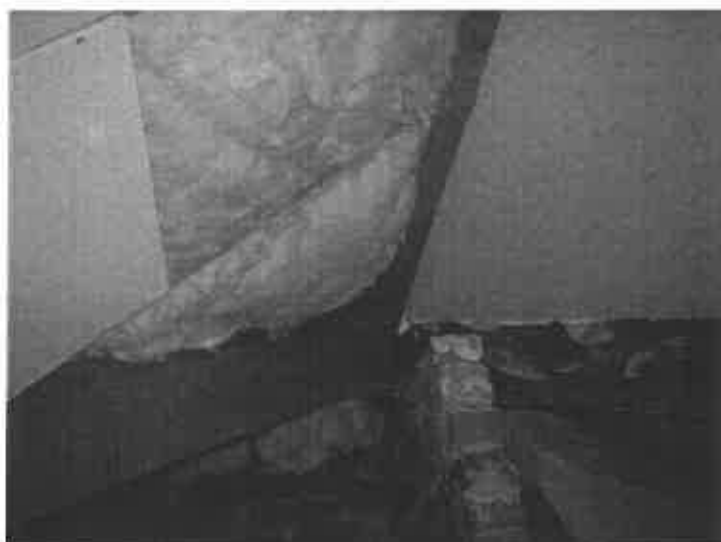
COMMENTS: The roof space is accessed via a staircase the more recent sections of the building having the roof void already used as living accommodation. The remainder of the roof space is accessible via doors from the landing, The area consists of a section which has a boarded floor and the rafters have been lined out with plasterboard and is currently being used for storage. Leading off this section are two further voids which are divided by brick walls. The timber purlins and rafters are in good condition with no cracks or gaps. The felt is also in good condition providing no roosting habitat for bats.

COMMENTS: The house is inhabited so the internal inspection was limited to the roof space. None of the above evidence was found inside the building.
