BAT SURVEY AT

Lane Ends Barn, Blackburn

1. EXECUTIVE SUMMARY

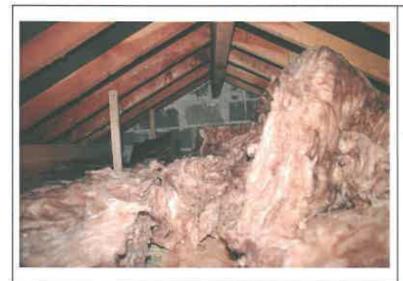
Photograph Notes The garden onto which the extension will go is disturbed and open. No trees will be lost The walls and eaves are very well sealed and offer no potential for roosting bats Solar panels further block what is already a very well-sealed roof on the West elevation

The roof voids are very clean
