BAT SURVEY

12 Bracken Hey
Clitheroe
Map ref: SD 753424

DATE AND TIME OF VISIT
25th June 2014 9.30 - 10.15pm

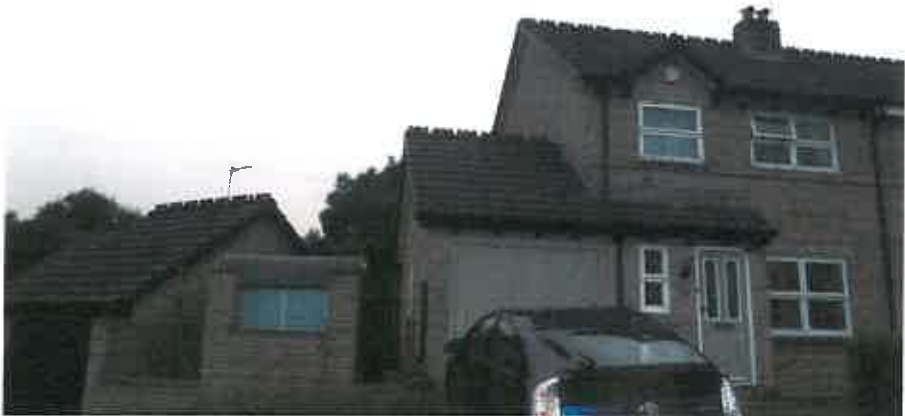
Front elevation

COMMENTS: The house is a semi detached property with a single storey garage attached to the side and a further detached garage to the north in the garden. The house dates from the early 1990's.

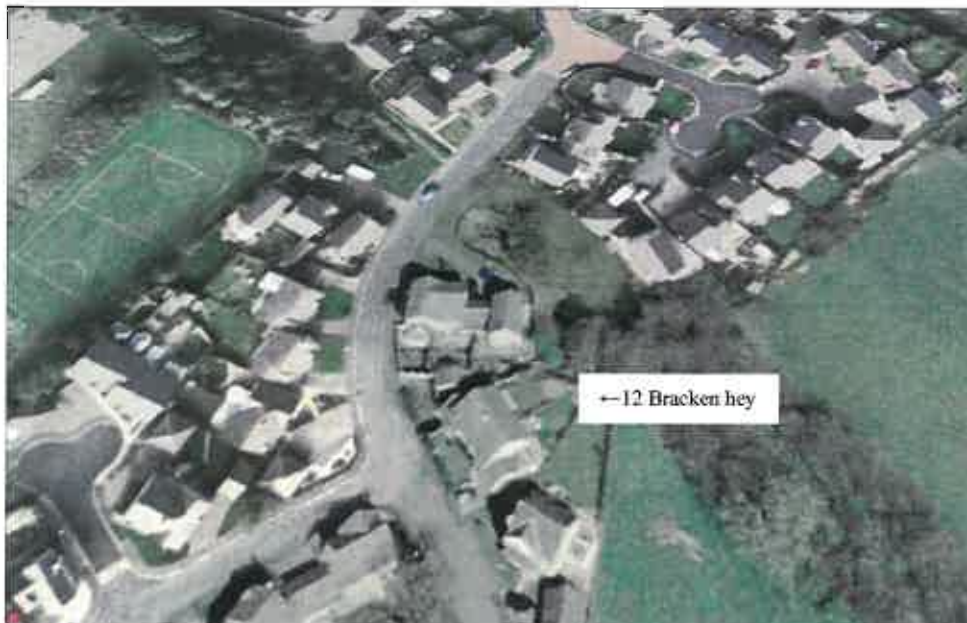
COMMENTS: The rear garden abuts a small brook which is densely lined with trees. Gardens surround the houses. There is medium level foraging potential in the trees to the rear of the property.

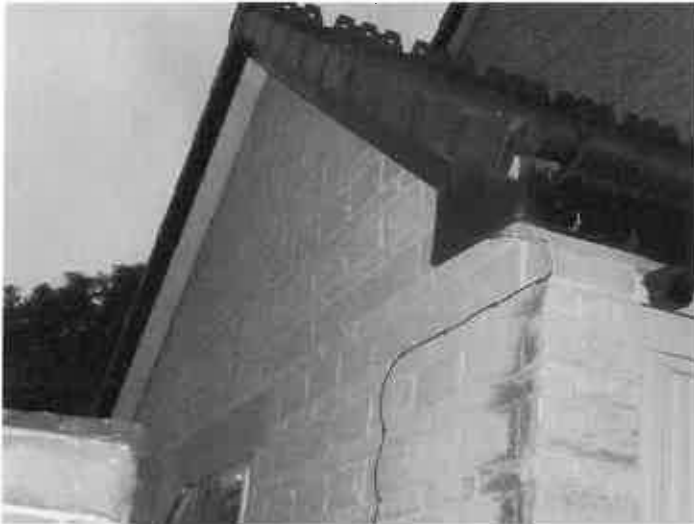
COMMENTS: The walls are stone.

COMMENTS: No cracks or crevices in the walls

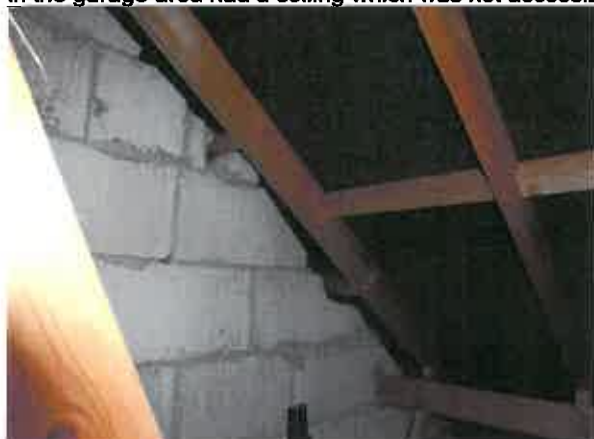
COMMENTS: It was possible to access the main roof which was used for storage and a full inspection was carried out. The felt was in good condition and insulation quilt was laid between the ceiling joists. The roof space in the garage area had a ceiling which was not accessible for inspection.
