## **Preliminary Bat Survey Report for**

**25 Watt Street,  
Sabden**

**Survey Date: 10/7/14      Report Date: 11/7/14**

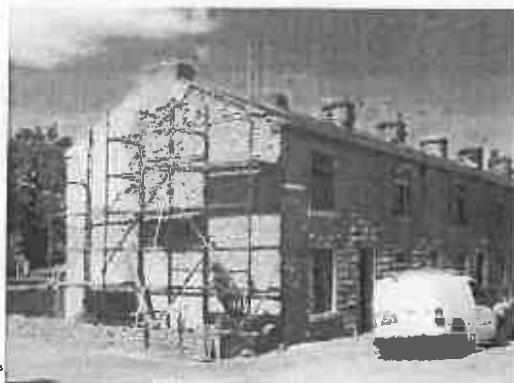
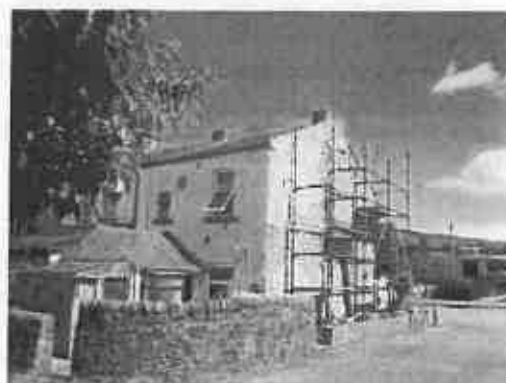
This is an end stone terraced house:

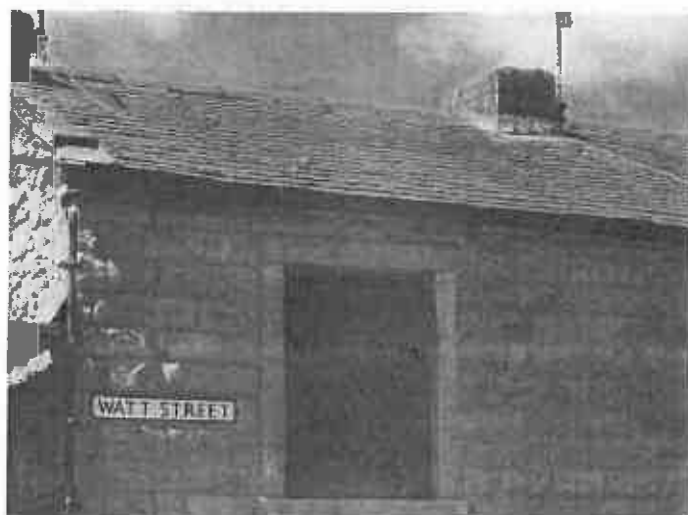
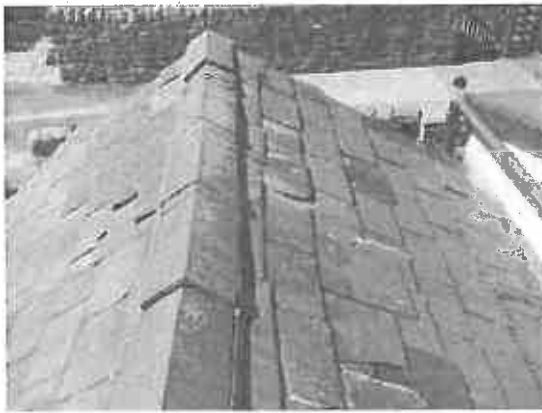
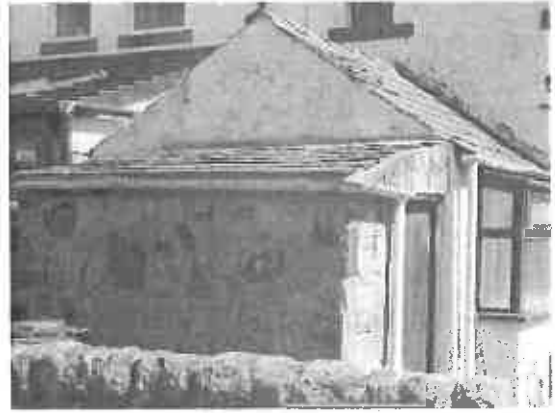
In addition there are gaps under roof slates on the house and rear annexes:

I understand the property will not be re-roofed, though the extension will require the demolition of the annexes and the new roof will need to be tied into the old. Roosting potential under the annexe roof slates will be lost. Although these gaps may never be used and the losses probably wont be significant, it would be good practice to recreate some replacement gaps under roof-slates on the extension. See Appendix 1. This would however require the use of traditional bitumastic felt as a lining material as breathable membrane can be lethal to bats.

Ensure roof slates are removed by hand with care. If a bat or droppings that may have come from a bat are found work **must** stop immediately. There is a legal obligation to do this. As far as practicable the feature that was sheltering the bat/s should be replaced. Further advice **must** then be sought from the bat consultant before work continues.

Consider providing continued bat access under roof-slates on the extension, avoiding the use of breathable membrane. See Appendix 1. (Wherever access is provided for bats, it must be ensured that bitumastic felt is used to separate the potential bat roosting area from any breathable membrane used. It must be secured in such a way that bats cannot enter between the two layers. The reason is that it is now known that breathable membrane represents a serious threat to bats as their claws loosen the fibres allowing them to become fatally entangled, destroying the integrity of the membrane in the process.)

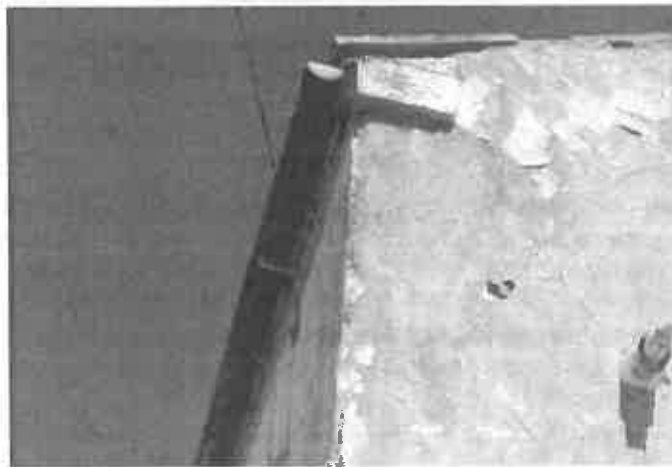
**There is also a gap behind the rear fascia board:**

There was no evidence at this visit to suggest roosting by bats but there are gaps under roof slates and behind a soffit, as well as into the gable wall where render has recently been removed.

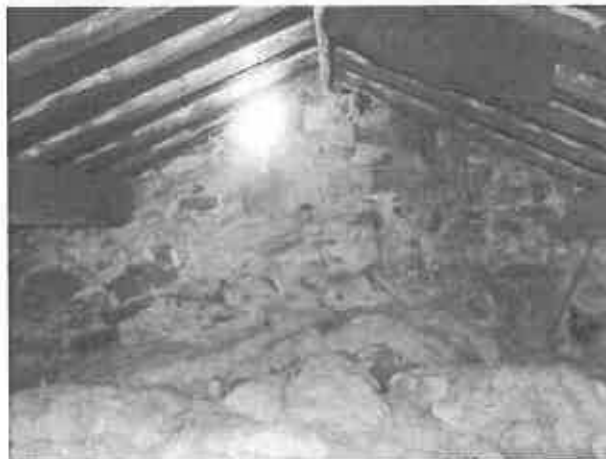
**The loft is small and the roof has been lined with bitumastic felt:**

It well insulated with material that was laid at least a year ago, probably longer. The loft was difficult to move around but could be seen well with the aid of torch and binoculars. No evidence of roosting was found though daylight was visible at the front corner eaves and a large flap of bitumastic felt was hanging down suggesting access may be possible from the roof.

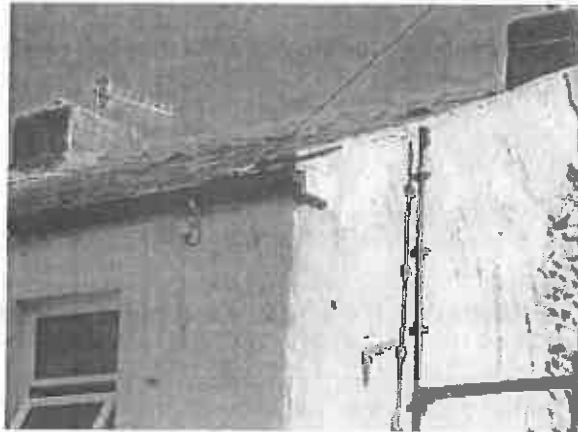
Flaps of felt could also be seen flapping:

Their function was uncertain.

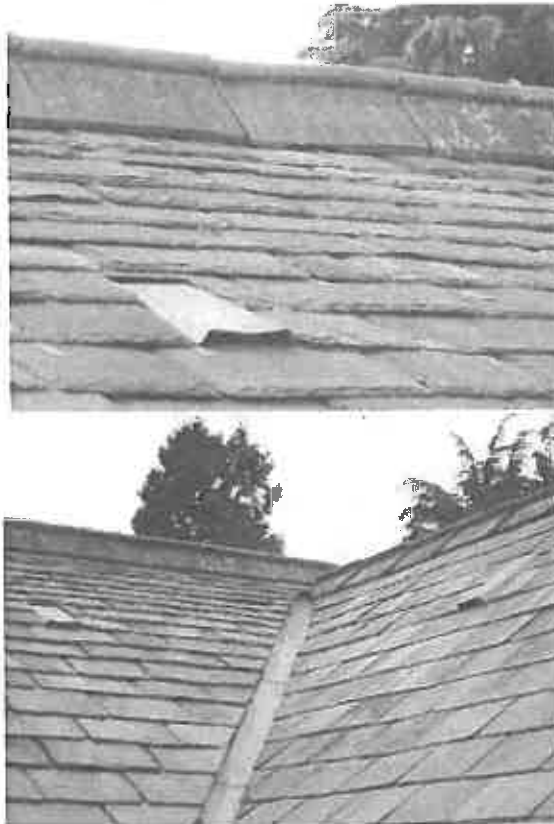
**Examples of provision of bat access under roof slates:**

Access under slates is best provided close to gable edges and just below the ridge.

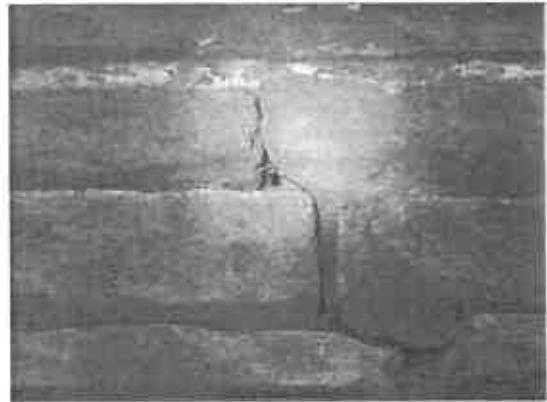
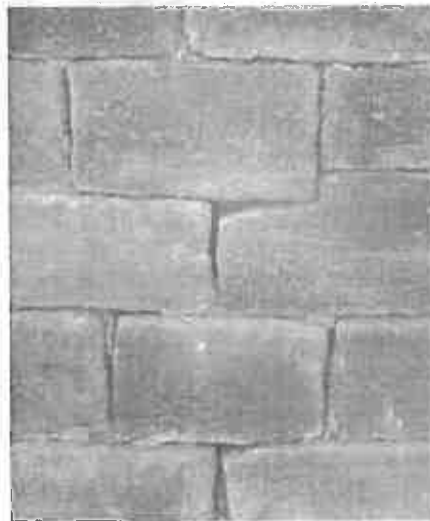
## Appendix 2 – bat access into walls

**Examples of appropriate openings into walls for bats.**

Retain bat access into the gable wall via one of the methods illustrated in Appendices 2 and 3.

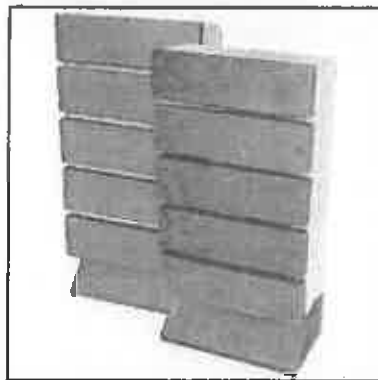
#### EcoSurv Habibat

"Designed to be built into an exterior wall and is available in a variety of faces to match the building. Standard facings of red or blue brick - ideal for new builds - are normally available from stock, or boxes can be made to your specific requirements with a face of brick, stone, timber, or plain (for rendering). Supplied unpointed."

Brick example of Ecosurv Habibat. Can also be faced with stone.

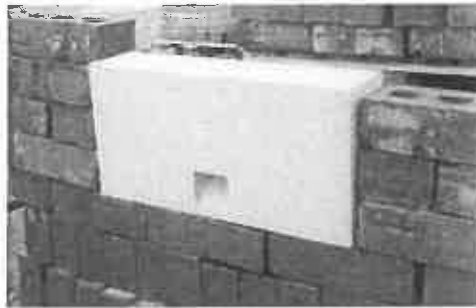
**Forticrete**

**Above and below - standard colours available. Others available to order**

**"Forticrete's boxes have been designed to be fitted to your property easily. Suitable for new build construction or renovation work where there is a requirement to provide a habitat for Pipistrelle bats."**
