Building Record

Barn at

Elmridge Farm, Elmridge Lane

June 2014

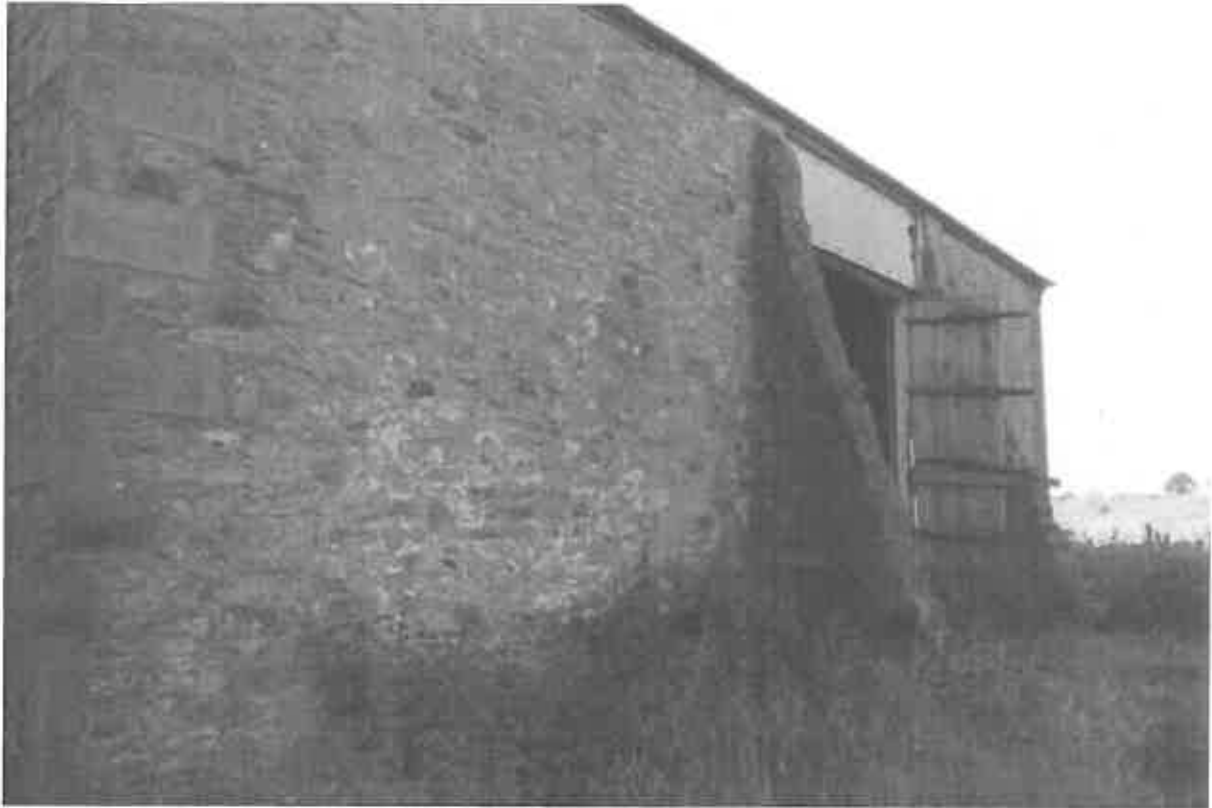
Figure 20 – The buttresses to the cart entrance

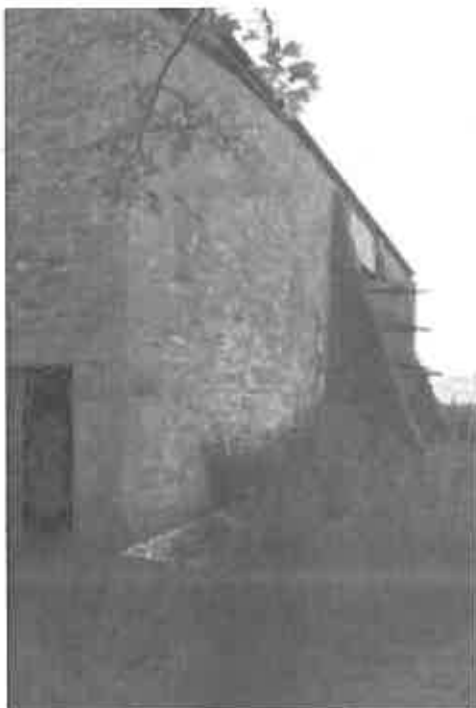
Figure 23 A view along the north east elevation showing the quoin detail to the corner.

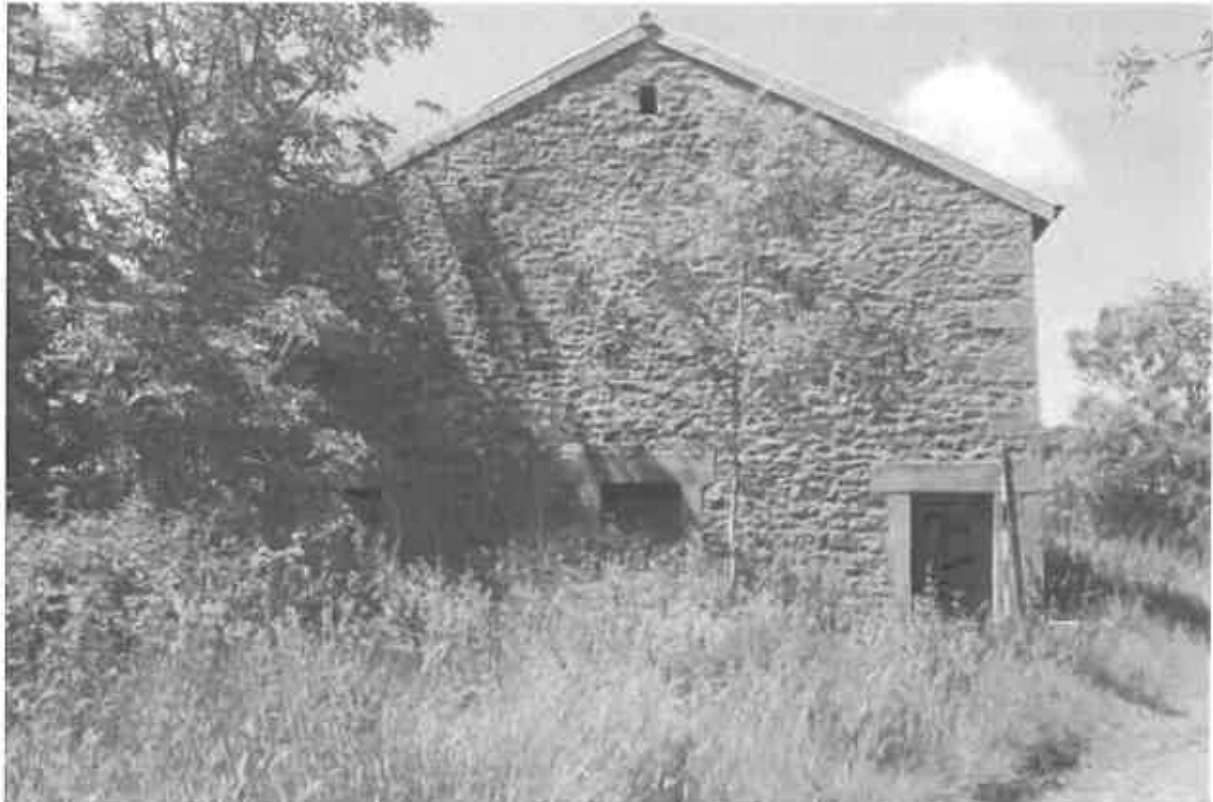
The south east gable, which is in coursed rubble, has three openings at ground level. It should be noted that as the barn is situated on a gently sloping site these doors are at a lower level than the entrance through the cart entrance. All three entrances are

approximately 180cm in height and 90-993cm in width. Each has stone reveals, rebated internally by approximately 10cm. All entrances have timber vertical plank doors, supported upon two strap and band hinges, with catches set within the rebates at approximately 104cm. The reveals are boasted faced stone with boasted (Ching, 1995, p. 237) faced lintels over.

Figure 24 The south east gable, with the three entrances to the base and the owl hole towards the ridge.

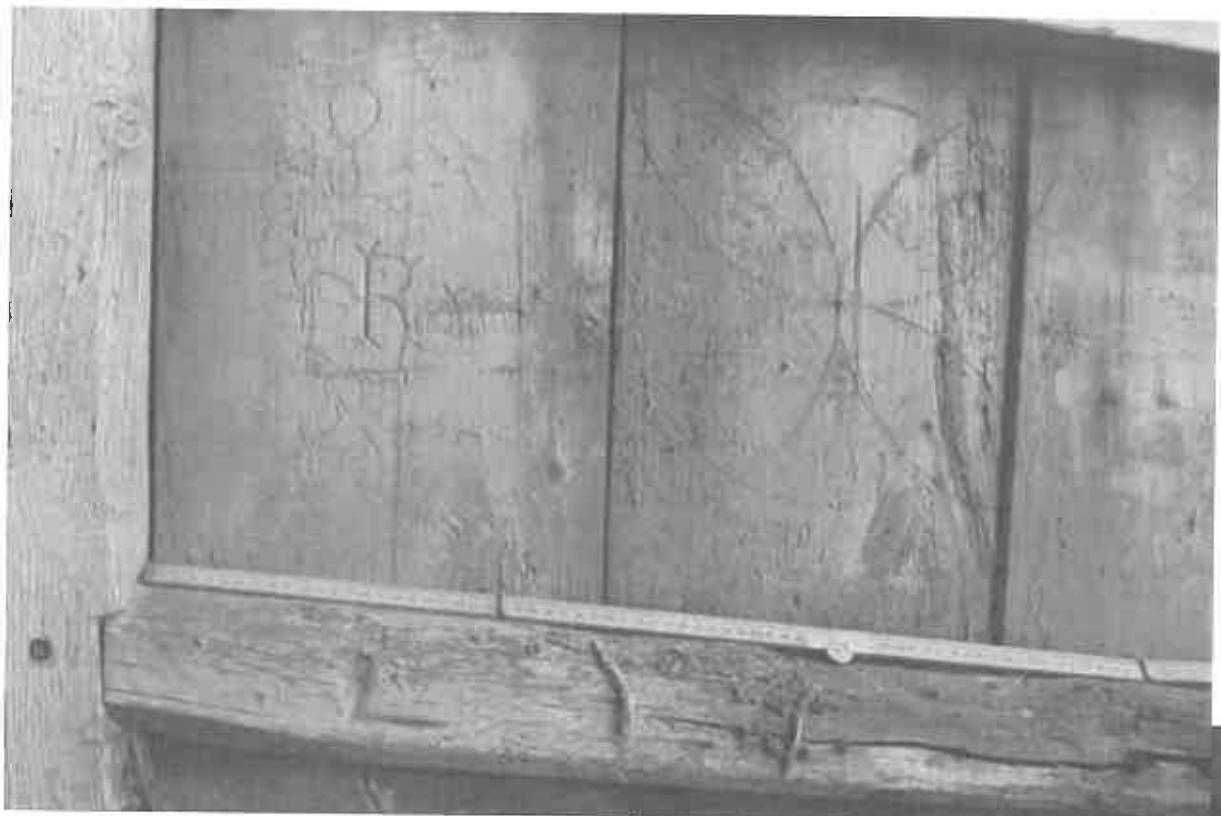
The main room within the barn has a compacted earth floor. The cart entrance, as already described, has slots within the base stones, considered to be associated with planks used during the threshing or winnowing process (Brunskill, 1982, p. 38). The remains of the timber doors, which open outwards as expected in a barn used for winnowing or threshing (Brunskill, 1982) have markings etched into the timber, with the 'R' matching the font design of the 'R' above the doorway to the south east gable (figures 25, 31). The circular pattern is also seen to the north west side of the northern most tie beam to the roof structure (figure 32).

Figures 31 and 32 The patterns cut into the cart entrance door and to the tie beam to the roof structure.

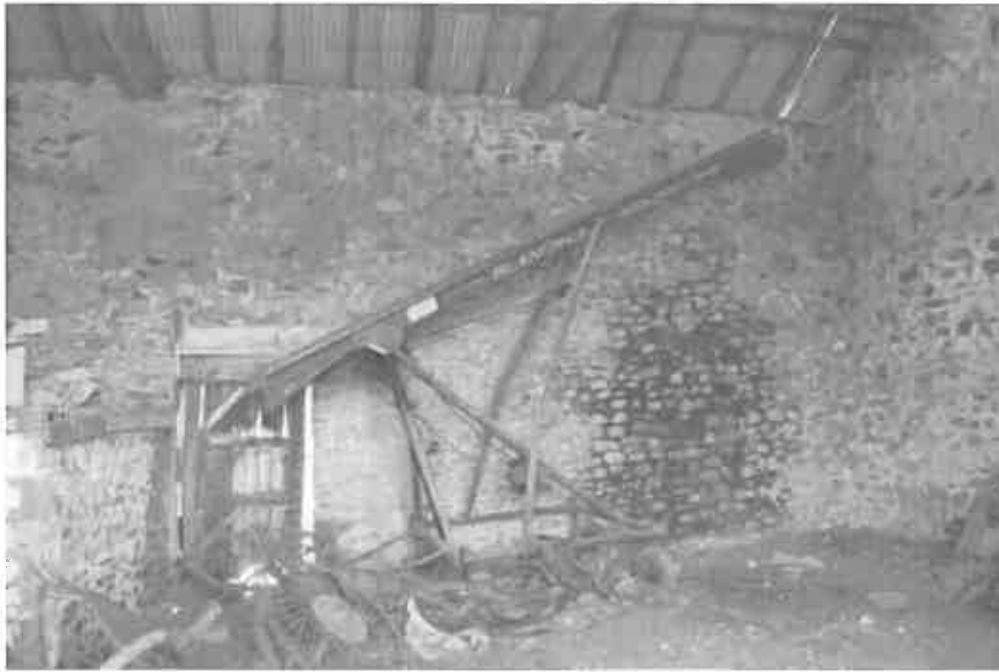
Continuing along this elevation the remainder is blind and constructed in a similar manner, in predominantly coursed rubble stone (figure 39).

Figure 39 The north west elevation showing the door way and the coursed rubble construction.

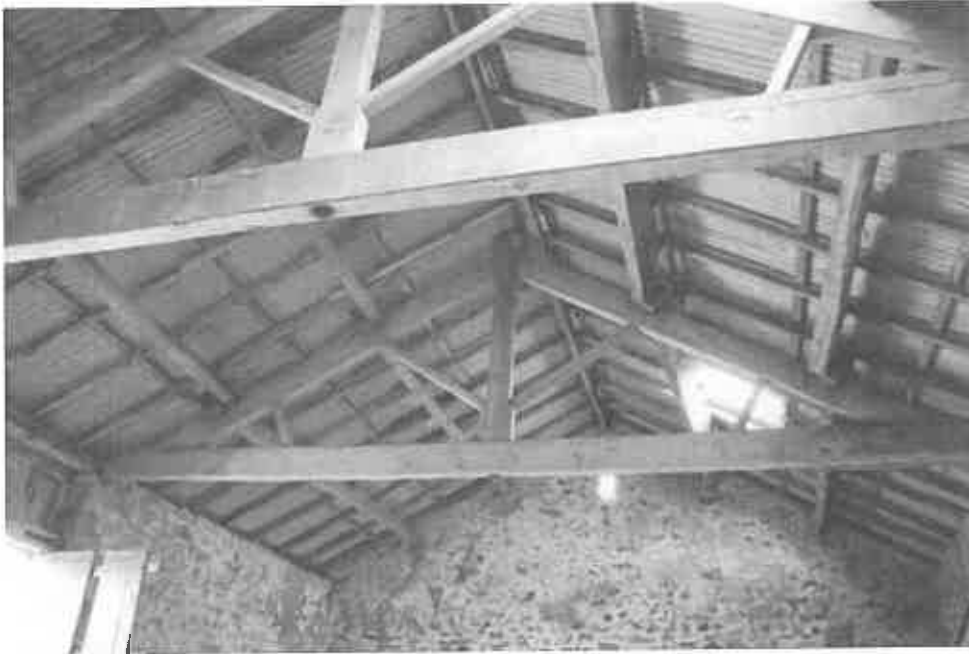
As previously referred to the roof is supported upon the gables and two timber king post frames (Alcock, et al., 1996, p. F9), forming three bays. The main king posts have raised areas for supporting the inclined struts leading to the principal rafters and are sometimes referred to as joggle posts (Ching, 1995, p. 210). A detailed inspection of these was not possible but the timbers appear finished rather than rough-hewn and support two sets of purlins per pitch. The purlins are a combination of planed and rough-hewn timbers indicating re-use and replacement. The purlins are staggered (Alcock, et al., 1996, p. F12 D), to the south west pitch, in that there are overlaps at the junctions, as illustrated in figure 40 below, and support the rafters, which in turn support further horizontal timbers (3 per pitch) which have been applied to fix and support the corrugated asbestos cement roof. The purlins to the north east pitch are staggered with the exception that one purlin to the upper run is supported by a cleat (Alcock, et al., 1996, p. F12 D&c)

It should also be noted that the ridge plank is not sited in its original position but is instead offset to the southwest of the original king posts. This is attributed to the re-roofing of the barn and the installation of new timbers.

Figure 40 The roof structure, with staggered back purlins.

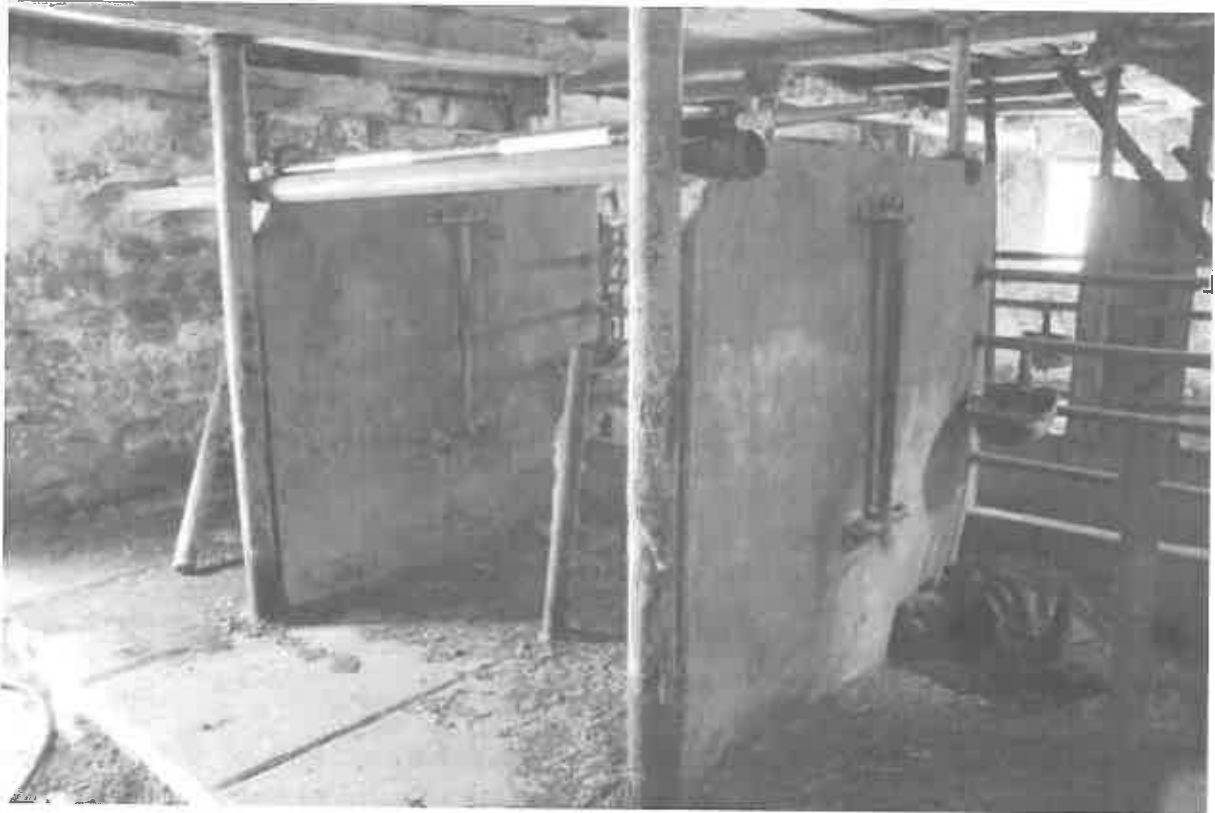
The area to the south east of the shippon comprises three concrete cattle stalls (figure 41) set parallel with the south east gable. The floor is of concrete and is formed so as to provide drainage. On entering this area from the doorway to the south east gable there is an area of concrete floor that inclines down towards the said entrance. Proceeding 142cm in from the north east elevation the floor then rises 10cm and continues for a further 189cm at which point there is the low concrete back panel to the stalls. The stalls are formed in concrete and are set approximately 137cm and 287cm in from the internal elevation of the south east gable. They are 127cm in height, 138 cm in width, and 14cm in depth. They have a slight curve to the outer corner, and this also abuts a metal 8cm diameter pole that acts as a support to the timber beams that in turn support the floor joists to the 'deck' above. At this location the height between the floor and the underside of the beams is low at approximately 166cm. The beams supporting the joists are approximately 16cm in depth. The floor within each stall is grooved to aid in the run off of urine etc. To the inner faces of the stalls are metal posts for the tethering of cattle.

Figure 41 The concrete stalls within the shippon.

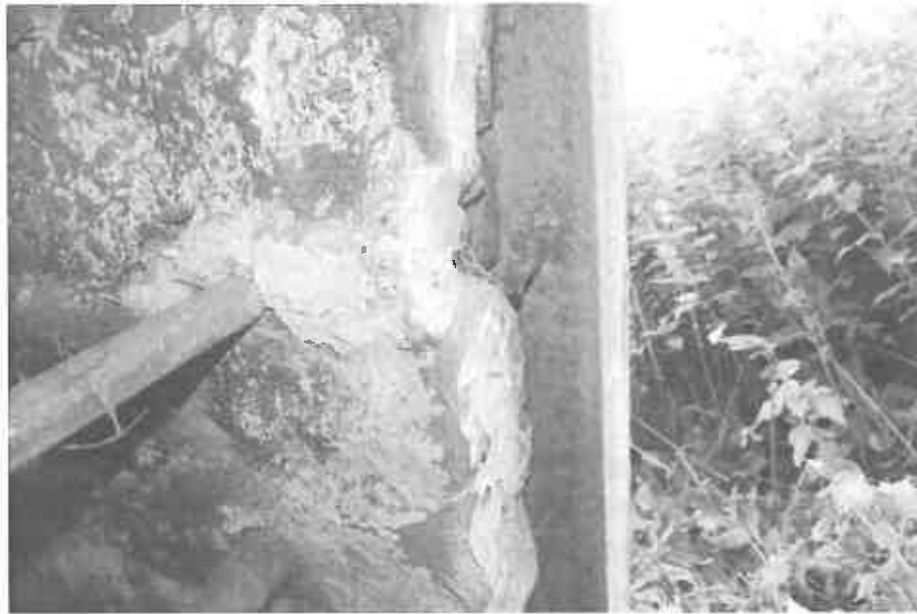
The wall to the south west elevation is formed again in coursed stone rubble. The internal door reveals to the outer doors to this area of the barn are rebated, as shown below, with pitch faced external reveals followed by the unfinished stone of the internal face of the gable wall. The gable end wall (south east) is approximately 53cm on sectional measurement.

Figure 47 The rebate to the door opening to the right at the gable end.

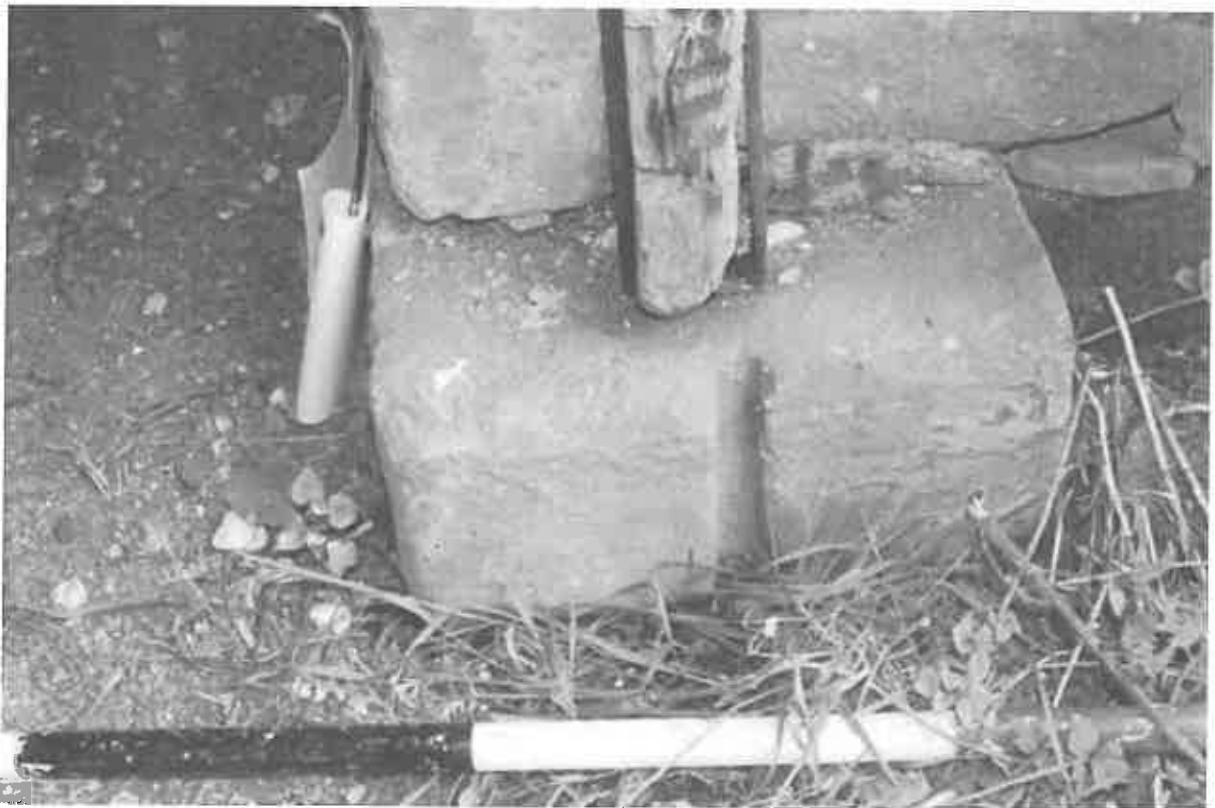
4 The base quoin and slot to the right hand jamb to the cart entrance.

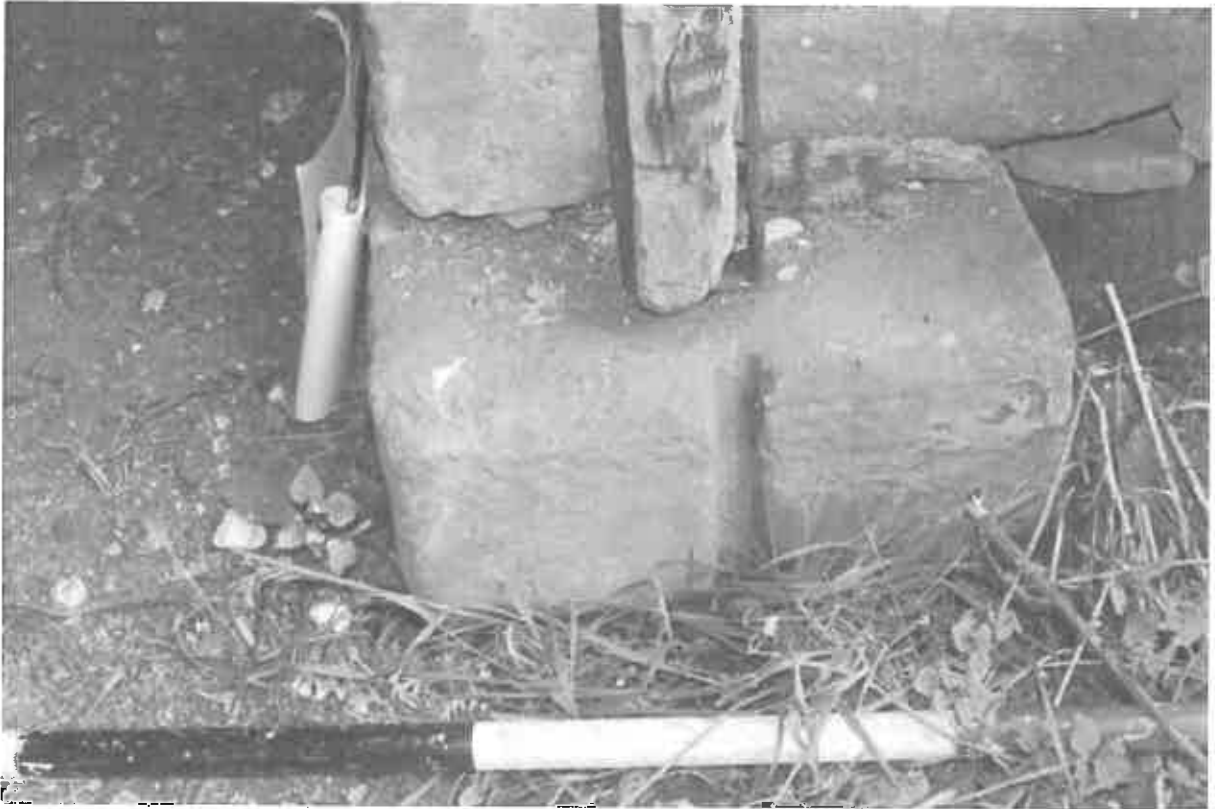
36 The base quoin to the northern side of the cart entrance. The slot or groove for a plank is clearly visible.

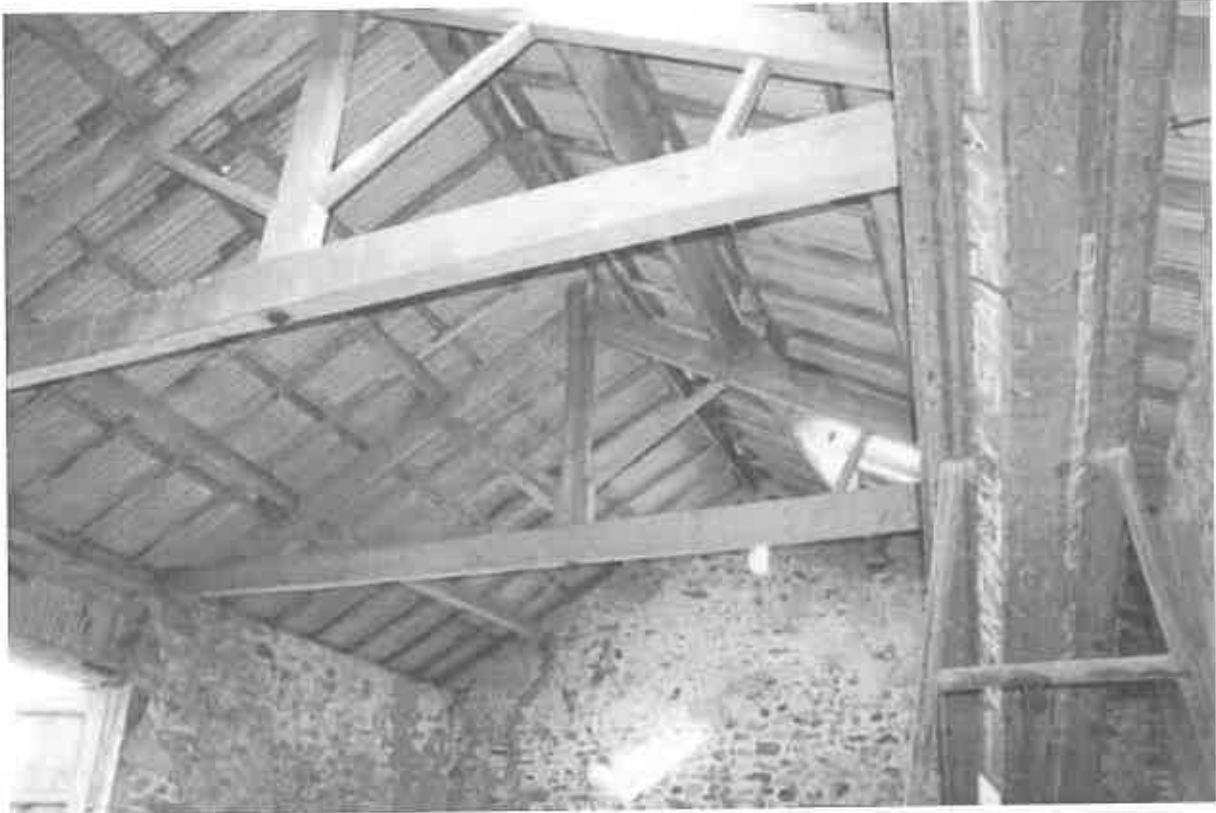
48 The roof structure as viewed towards the south east, showing the tie beam, bracing struts, king joggle post, principal rafters and purlins.

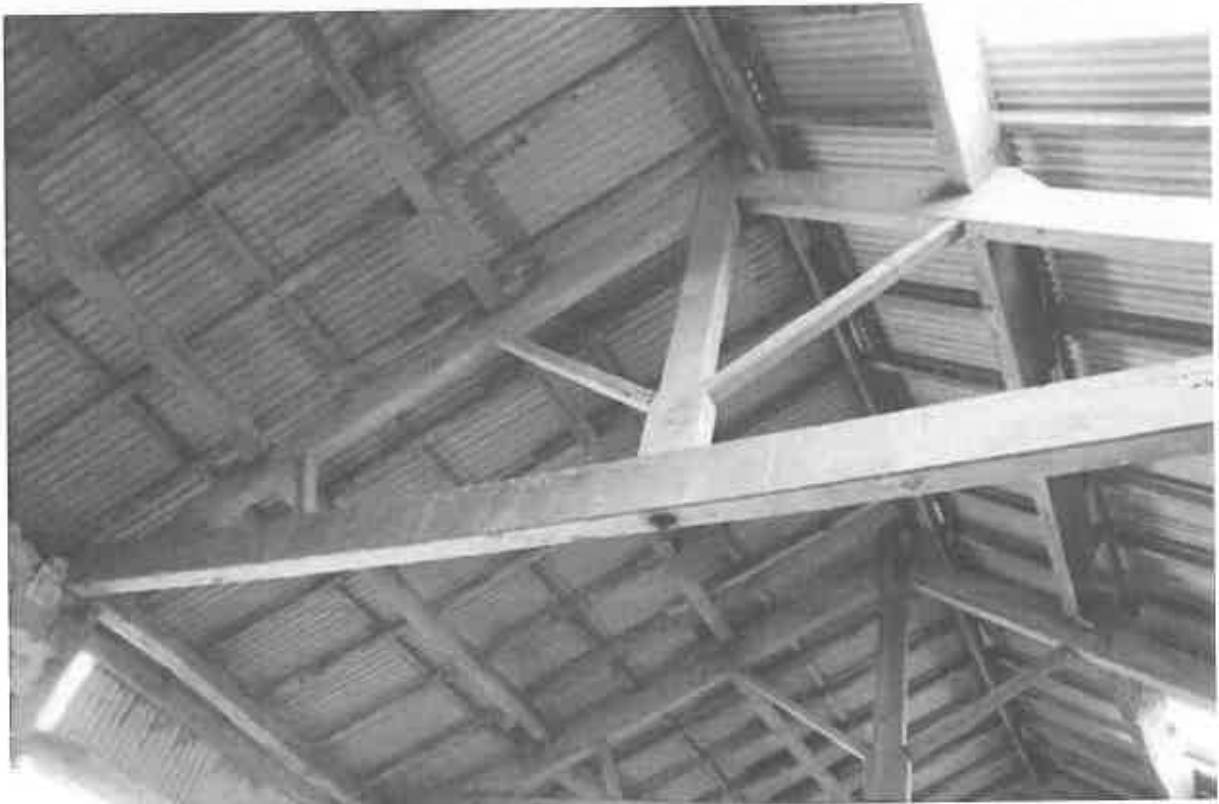
49 The roof structure to the north of the cart entrance, showing the king joggle post and the cleated back purlins.

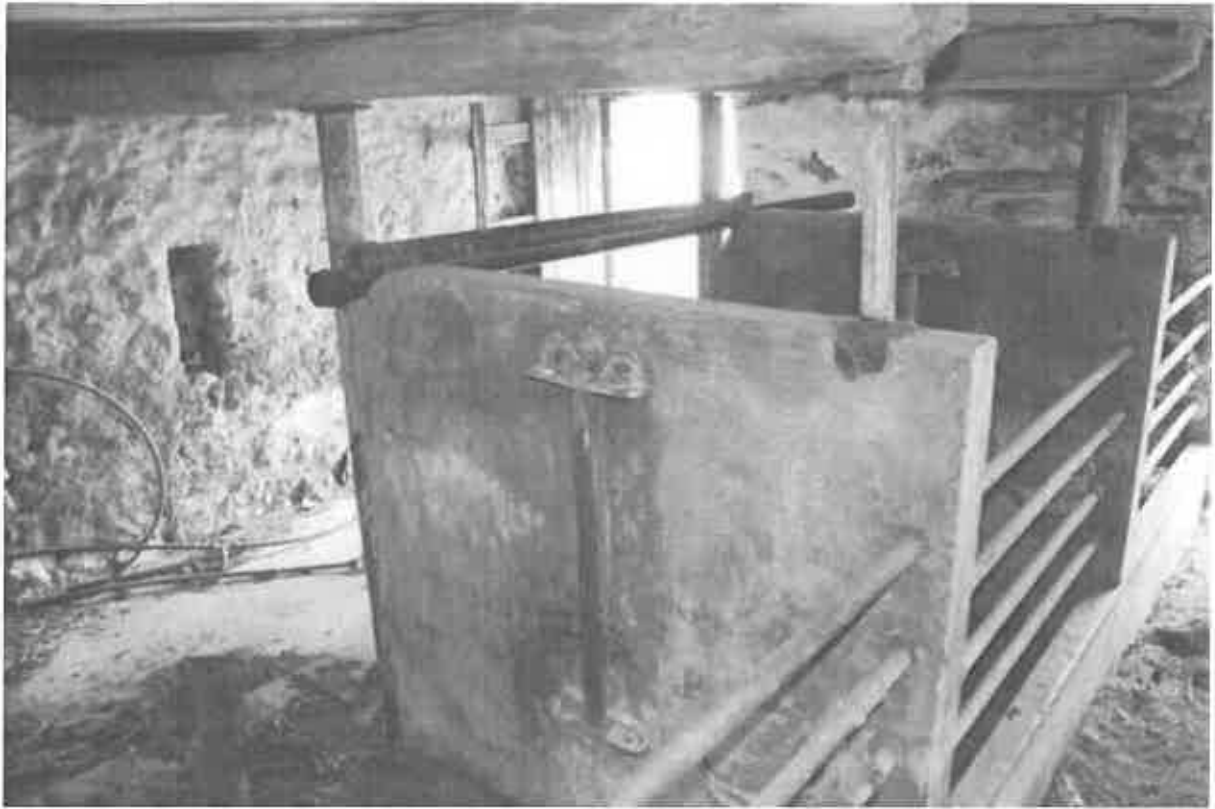
54 A view across the shippon towards the south east corner, showing the concrete stall dividers, the attached metal tethering bars, the recess to the north west wall, the metal posts off the end of the stalls that support the beams and thereafter floor joists.

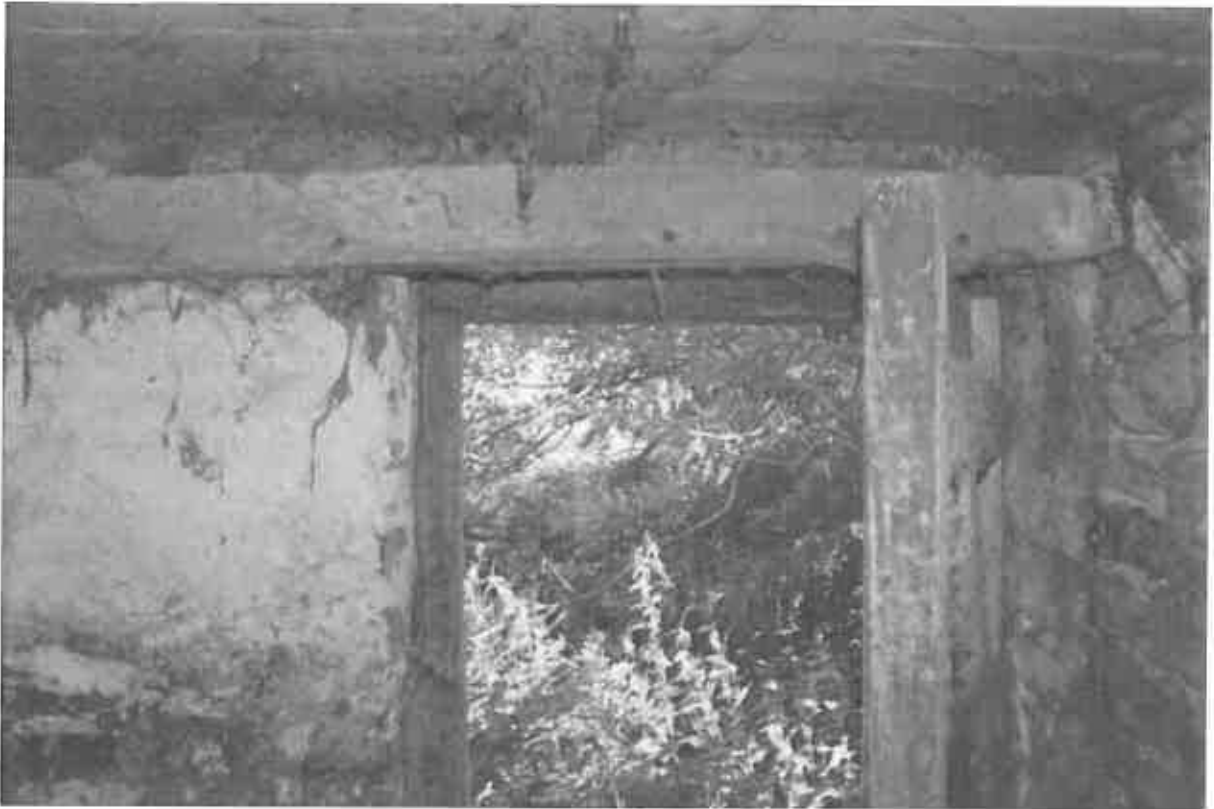
65 The timber beam over the door opening showing notches to the vertical face and the rebate to the stone jamb. The door also opens back against the external elevation.

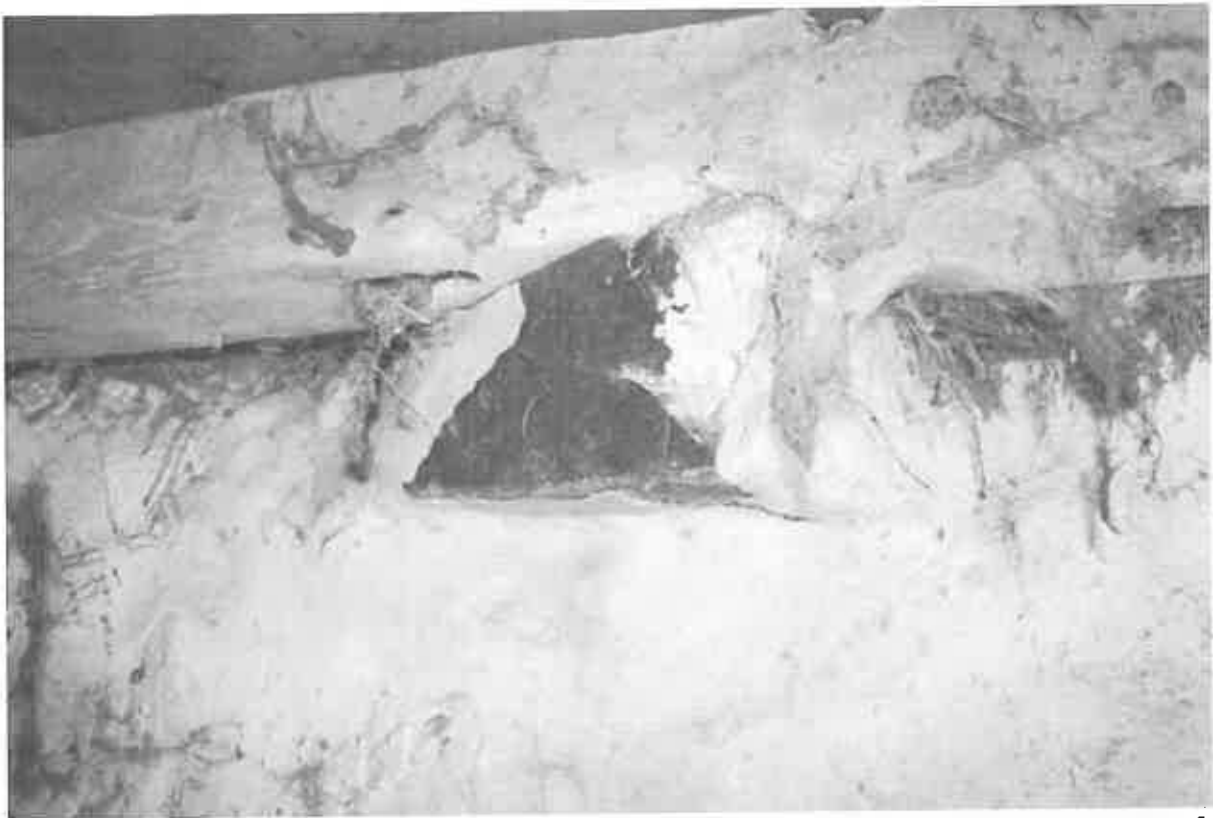
68 The stone to between the central door and the door opening to the south west corner of the gable. This may have been a corbel, but it stands in isolation.

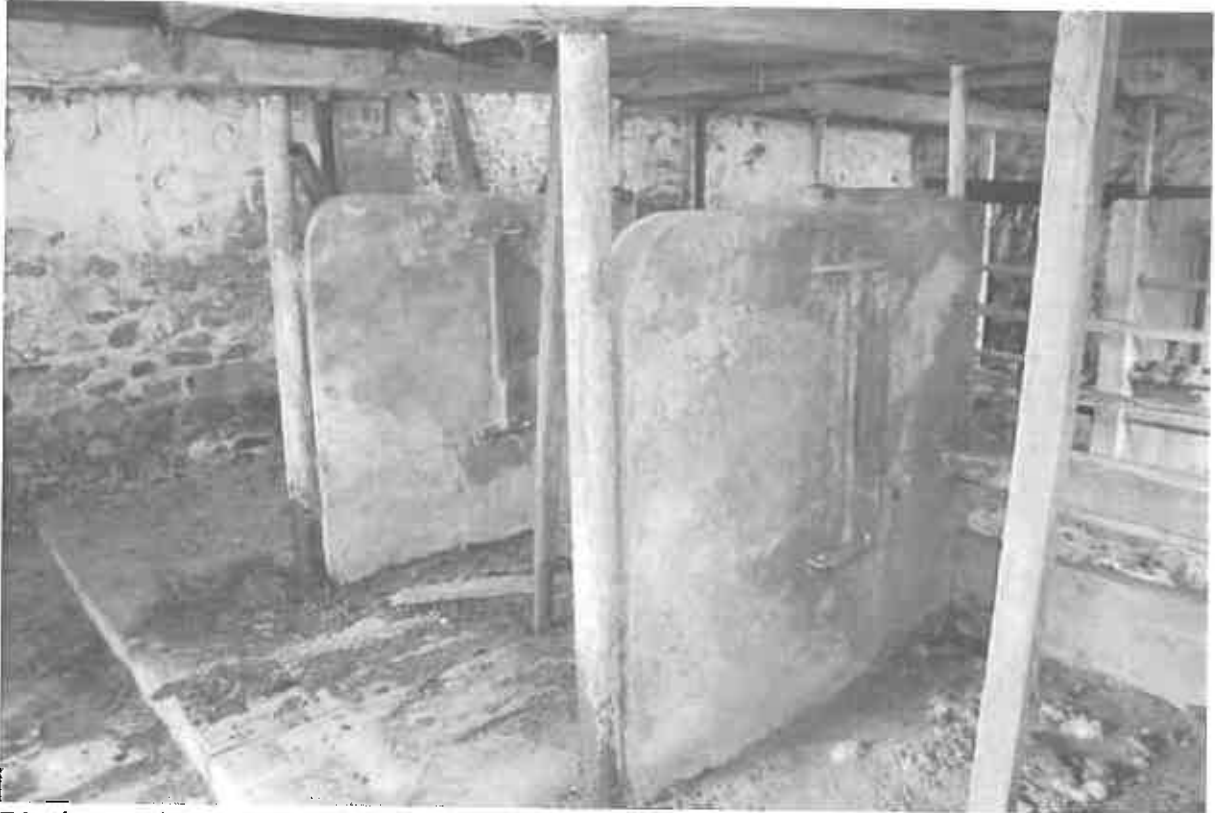
74 The south west side of the shippon as viewed back towards the main barn area. The step up in the concreted floor is visible, and also shown are the additional posts to support the upper 'deck' located mid way between stall dividers.
